## ASBESTOS SURVEY REPORT

725 SW 3rd Street  
Ocala, FL 34471

August 01, 2025

Chris Ritko  
Asbestos Building Inspector  
196473

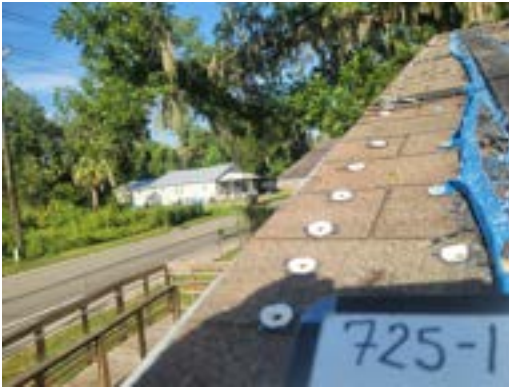
| <b>Bulk Collection and Sample Analysis Results</b> | | | | | | |
|---|---|---|---|---|---|---|
| 725-1-1 | Asphalt Shingle/Black | Intact | No | None Detected | Typical Exterior Roof | NA |
| 725-1-1 | Tar/Black | Intact | No | None Detected | Typical Exterior Roof | NA |
| 725-1-2 | Asphalt Shingle/Black | Intact | No | None Detected | Typical Exterior Roof | NA |
| 725-1-2 | Tar/Black | Intact | No | None Detected | Typical Exterior Roof | NA |

725-1  
Asphalt Shingle/Tar  
Typical Exterior Roof

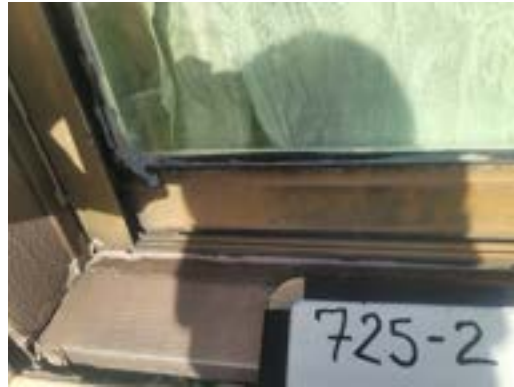
| <b>Bulk Collection and Sample Analysis Results</b> | | | | | | |
|---|---|---|---|---|---|---|
| 725-2-1 | Caulk/Gray | Intact | No | None Detected | Typical Exterior Windows | NA |
| 725-2-2 | Caulk/Gray | Intact | No | None Detected | Typical Exterior Windows | NA |

725-2  
Caulk  
Typical Exterior Windows

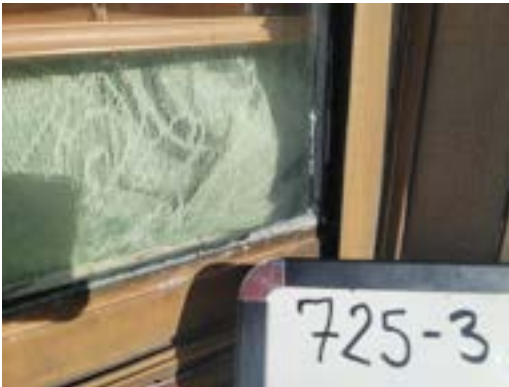
| <b>Bulk Collection and Sample Analysis Results</b> | | | | | | |
|---|---|---|---|---|---|---|
| 725-3-1 | Glazing/Gray/Green | Intact | No | None Detected | Typical Exterior Windows | NA |
| 725-3-2 | Glazing/Gray/Green | Intact | No | None Detected | Typical Exterior Windows | NA |

725-3  
Glazing  
Typical Exterior Windows

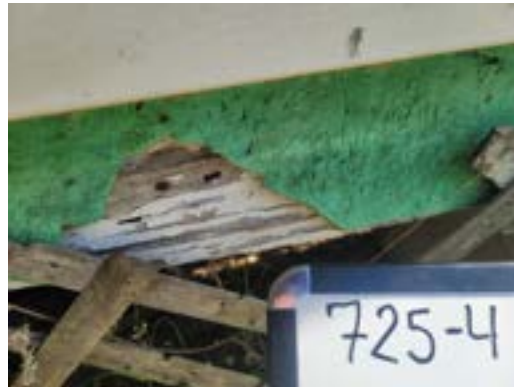
| <b>Bulk Collection and Sample Analysis Results</b> | | | | | | |
|---|---|---|---|---|---|---|
| 725-4-1 | House Wrap/Foam/Green | Intact | No | None Detected | Typical Exterior Walls | NA |
| 725-4-2 | House Wrap/Foam/Green | Intact | No | None Detected | Typical Exterior Walls | NA |

725-4  
House Wrap  
Typical Exterior Walls

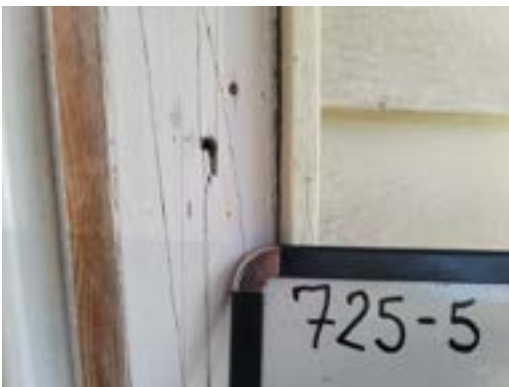
| <b>Bulk Collection and Sample Analysis Results</b> | | | | | | |
|---|---|---|---|---|---|---|
| 725-5-1 | Caulk/White | Intact | No | None Detected | Exterior Front Door | NA |

| <i>Sample Number</i> | <i>Description</i> | <i>Condition</i> | <i>Friable</i> | <i>Asbestos Percent and Type</i> | <i>Location/ Amount</i> | <i>NESHAP Category</i> |
|---|---|---|---|---|---|---|
| 725-5-1 | Brittle/Brown | Intact | No | None Detected | Exterior Front Door | NA |
| 725-5-2 | Caulk/White | Intact | No | None Detected | Exterior Front Door | NA |
| 725-5-2 | Brittle/Brown | Intact | No | None Detected | Exterior Front Door | NA |

725-5  
Caulk  
Exterior Front Door

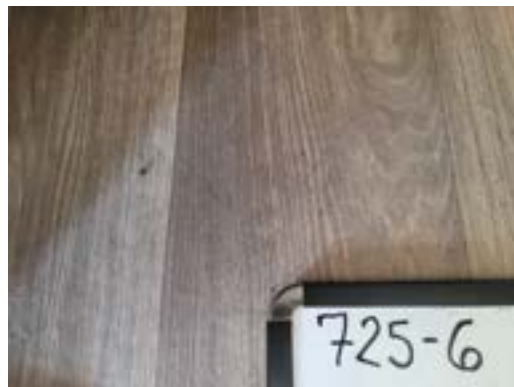
| <i>Sample Number</i> | <i>Description</i> | <i>Condition</i> | <i>Friable</i> | <i>Asbestos Percent and Type</i> | <i>Location/ Amount</i> | <i>NESHAP Category</i> |
|---|---|---|---|---|---|---|
| 725-6-1 | Rolled Flooring/Gray | Intact | No | None Detected | Interior Living Room | NA |
| 725-6-2 | Rolled Flooring/Gray | Intact | No | None Detected | Interior Living Room | NA |

725-6  
Rolled Flooring  
Interior Living Room

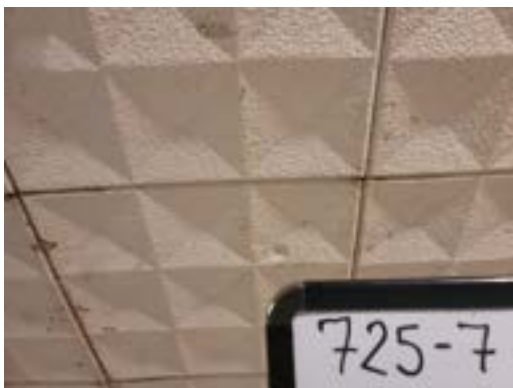
| <i>Sample Number</i> | <i>Description</i> | <i>Condition</i> | <i>Friable</i> | <i>Asbestos Percent and Type</i> | <i>Location/ Amount</i> | <i>NESHAP Category</i> |
|---|---|---|---|---|---|---|
| 725-7-1 | 12"x12" Ceiling Tile/White | Intact | No | None Detected | Interior Living Room | NA |
| 725-7-2 | 12"x12" Ceiling Tile/White | Intact | No | None Detected | Interior Living Room | NA |

725-7  
12"x12" Ceiling Tile  
Interior Living Room

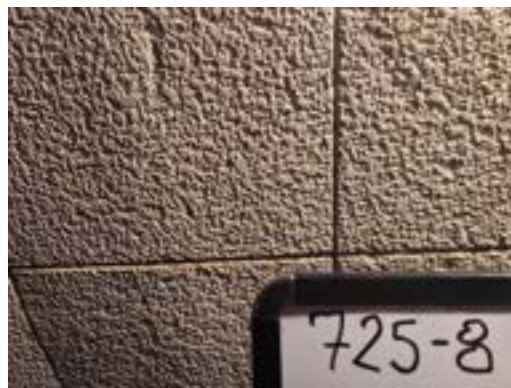
| <i>Sample Number</i> | <i>Description</i> | <i>Condition</i> | <i>Friable</i> | <i>Asbestos Percent and Type</i> | <i>Location/ Amount</i> | <i>NESHAP Category</i> |
|---|---|---|---|---|---|---|
| 725-8-1 | 12"x12" Ceiling Tile/White | Intact | No | None Detected | Interior SE Bedroom/<br>E Bedroom | NA |
| 725-8-2 | 12"x12" Ceiling Tile/White | Intact | No | None Detected | Interior SE Bedroom/<br>E Bedroom | NA |

725-8  
12"x12" Ceiling Tile  
Interior SE Bedroom, E Bedroom

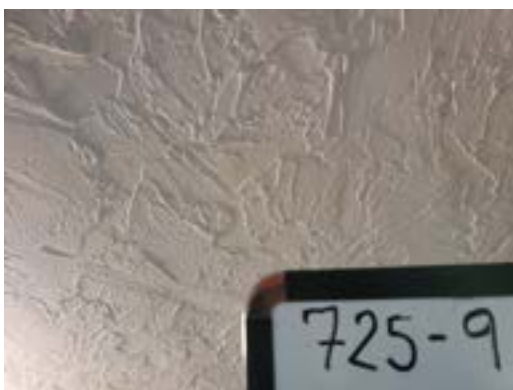
| <i>Sample Number</i> | <i>Description</i> | <i>Condition</i> | <i>Friable</i> | <i>Asbestos Percent and Type</i> | <i>Location/ Amount</i> | <i>NESHAP Category</i> |
|---|---|---|---|---|---|---|
| 725-9-1 | Joint Compound/White | Intact | No | None Detected | Typical Interior Walls/Ceilings | NA |
| 725-9-1 | Drywall/Gray/Brown | Intact | No | None Detected | Typical Interior Walls/Ceilings | NA |
| 725-9-2 | Joint Compound/White | Intact | No | None Detected | Typical Interior Walls/Ceilings | NA |
| 725-9-2 | Drywall/Gray/Brown | Intact | No | None Detected | Typical Interior Walls/Ceilings | NA |
| 725-9-3 | Joint Compound/White | Intact | No | None Detected | Typical Interior Walls/Ceilings | NA |
| 725-9-3 | Drywall/Gray/Brown | Intact | No | None Detected | Typical Interior Walls/Ceilings | NA |

725-9  
Joint Compound/Drywall  
Typical Interior Walls/Ceilings

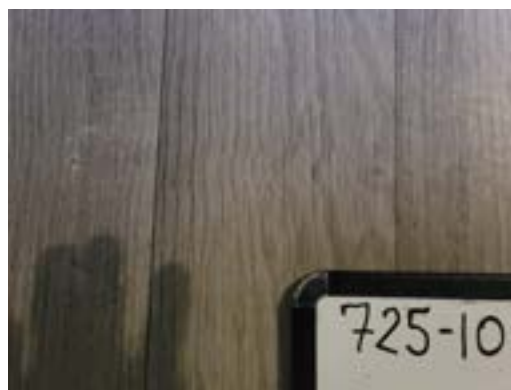
| <i>Sample Number</i> | <i>Description</i> | <i>Condition</i> | <i>Friable</i> | <i>Asbestos Percent and Type</i> | <i>Location/ Amount</i> | <i>NESHAP Category</i> |
|---|---|---|---|---|---|---|
| 725-10-1 | Rolled Flooring/Gray | Intact | No | None Detected | Interior Kitchen | NA |
| 725-10-2 | Rolled Flooring/Gray | Intact | No | None Detected | Interior Kitchen | NA |

725-10  
Rolled Flooring  
Interior Kitchen

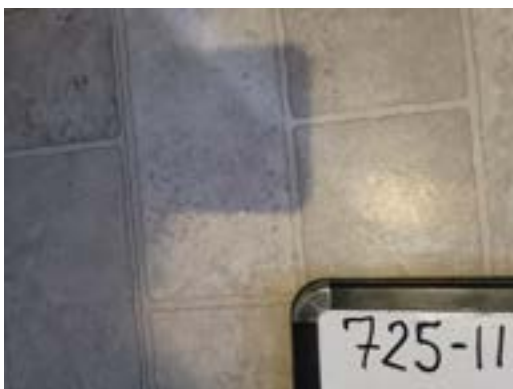
| <i>Sample Number</i> | <i>Description</i> | <i>Condition</i> | <i>Friable</i> | <i>Asbestos Percent and Type</i> | <i>Location/ Amount</i> | <i>NESHAP Category</i> |
|---|---|---|---|---|---|---|
| 725-11-1 | 12"x12" Floor Tile/Gray | Intact | No | None Detected | Interior Bathroom | NA |

| <i>Sample Number</i> | <i>Description</i> | <i>Condition</i> | <i>Friable</i> | <i>Asbestos Percent and Type</i> | <i>Location/ Amount</i> | <i>NESHAP Category</i> |
|---|---|---|---|---|---|---|
| 725-11-1 | Adhesive/Clear | Intact | No | None Detected | Interior Bathroom | NA |
| 725-11-2 | 12"x12" Floor Tile/Gray | Intact | No | None Detected | Interior Bathroom | NA |
| 725-11-2 | Adhesive/Clear | Intact | No | None Detected | Interior Bathroom | NA |

725-11  
12"x12" Floor Tile/Mastic  
Interior Bathroom

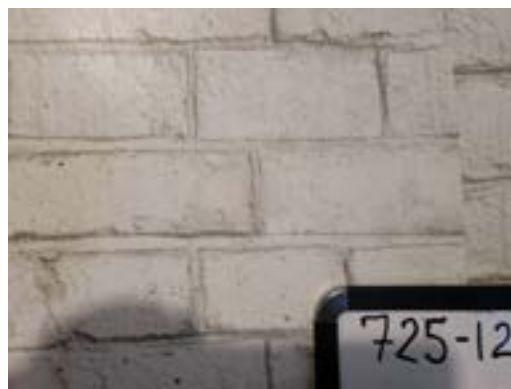
| <i>Sample Number</i> | <i>Description</i> | <i>Condition</i> | <i>Friable</i> | <i>Asbestos Percent and Type</i> | <i>Location/ Amount</i> | <i>NESHAP Category</i> |
|---|---|---|---|---|---|---|
| 725-12-1 | Wallpaper/White | Intact | No | None Detected | Interior Bathroom<br>N Wall | NA |
| 725-12-1 | Adhesive/Clear | Intact | No | None Detected | Interior Bathroom<br>N Wall | NA |
| 725-12-2 | Wallpaper/White | Intact | No | None Detected | Interior Bathroom<br>N Wall | NA |
| 725-12-2 | Adhesive/Clear | Intact | No | None Detected | Interior Bathroom<br>N Wall | NA |

725-12  
Wallpaper/Adhesive  
Interior Bathroom N Wall

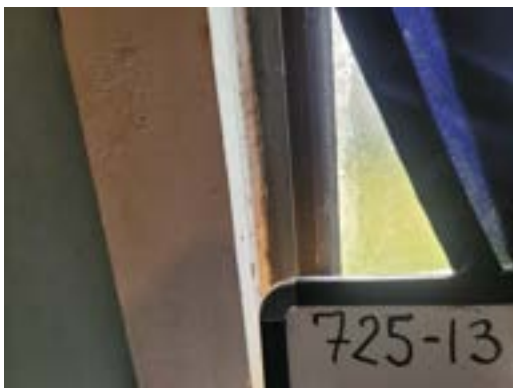
| <i>Sample Number</i> | <i>Description</i> | <i>Condition</i> | <i>Friable</i> | <i>Asbestos Percent and Type</i> | <i>Location/ Amount</i> | <i>NESHAP Category</i> |
|---|---|---|---|---|---|---|
| 725-13-1 | Caulk/White | Intact | No | None Detected | Typical Interior<br>Windows | NA |
| 725-13-2 | Caulk/White | Intact | No | None Detected | Typical Interior<br>Windows | NA |

725-13  
Caulk  
Typical Interior Windows

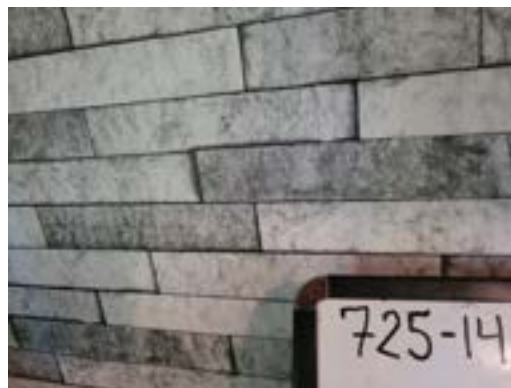
| <i>Sample Number</i> | <i>Description</i> | <i>Condition</i> | <i>Friable</i> | <i>Asbestos Percent and Type</i> | <i>Location/ Amount</i> | <i>NESHAP Category</i> |
|---|---|---|---|---|---|---|
| 725-14-1 | Wallpaper/Gray | Intact | No | None Detected | Interior<br>Kitchen Walls | NA |
| 725-14-1 | Adhesive/Clear | Intact | No | None Detected | Interior<br>Kitchen Walls | NA |
| 725-14-2 | Wallpaper/Gray | Intact | No | None Detected | Interior<br>Kitchen Walls | NA |
| 725-14-2 | Adhesive/Clear | Intact | No | None Detected | Interior<br>Kitchen Walls | NA |

725-14  
Wallpaper/Adhesive  
Interior Kitchen Walls

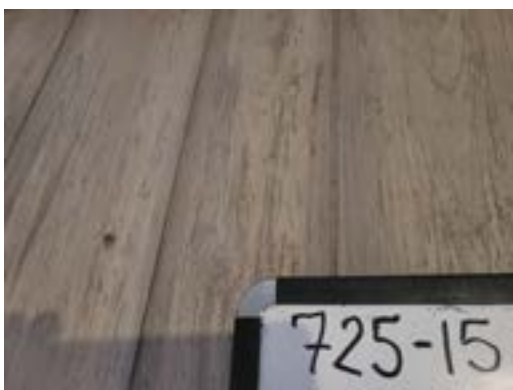
| <i>Sample Number</i> | <i>Description</i> | <i>Condition</i> | <i>Friable</i> | <i>Asbestos Percent and Type</i> | <i>Location/ Amount</i> | <i>NESHAP Category</i> |
|---|---|---|---|---|---|---|
| 725-15-1 | Paneling Laminate | Intact | No | None Detected | Interior<br>Utility Porch Walls | NA |
| 725-15-2 | Paneling Laminate | Intact | No | None Detected | Interior<br>Utility Porch Walls | NA |

725-15  
Paneling Laminate  
Interior Utility Porch Walls

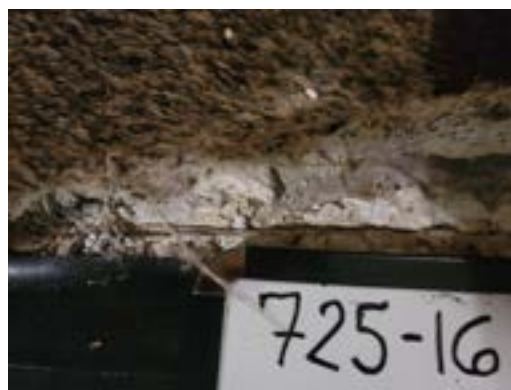
| <i>Sample Number</i> | <i>Description</i> | <i>Condition</i> | <i>Friable</i> | <i>Asbestos Percent and Type</i> | <i>Location/ Amount</i> | <i>NESHAP Category</i> |
|---|---|---|---|---|---|---|
| 725-16-1 | Floor Leveling<br>Compound/White | Intact | No | None Detected | Interior<br>NE Bedroom | NA |
| 725-16-2 | Floor Leveling<br>Compound/White | Intact | No | None Detected | Interior<br>NE Bedroom | NA |

725-16  
Floor Leveling Compound  
Interior NE Bedroom

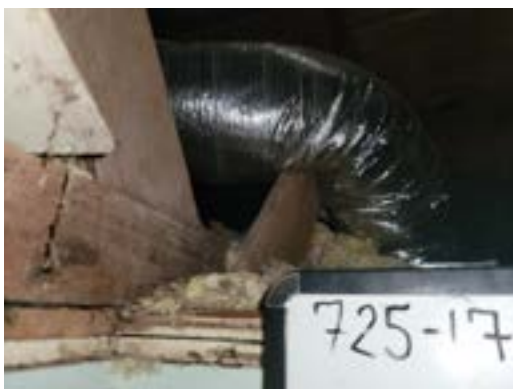
| <i>Sample Number</i> | <i>Description</i> | <i>Condition</i> | <i>Friable</i> | <i>Asbestos Percent and Type</i> | <i>Location/ Amount</i> | <i>NESHAP Category</i> |
|---|---|---|---|---|---|---|
| 725-17-1 | Insulation/Yellow | Intact | No | None Detected | Interior Attic<br>Crawlspace | NA |

| <i>Sample Number</i> | <i>Description</i> | <i>Condition</i> | <i>Friable</i> | <i>Asbestos Percent and Type</i> | <i>Location/ Amount</i> | <i>NESHAP Category</i> |
|---|---|---|---|---|---|---|
| 725-17-2 | Insulation/Yellow | Intact | No | None Detected | Interior Attic Crawlspace | NA |

725-17  
Insulation  
Interior Attic Crawlspace
