June 4, 2025

Project:  
Asbestos Survey for Renovation-House  
Louise West  
812 NW 2<sup>nd</sup> St.  
Ocala, FL 34475

Client:  
City of Ocala  
Community Development Services Department  
201 SE 3<sup>rd</sup> St.  
Ocala, FL 34471

Asbestos Survey for Renovation-House  
Louise West  
812 NW 2<sup>nd</sup> St.  
Ocala, FL 34475

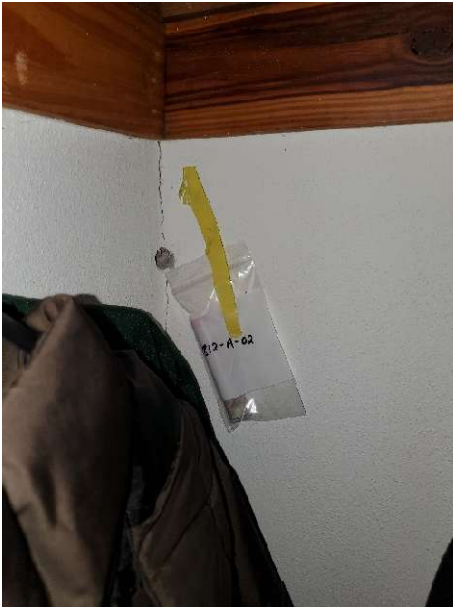
**Sample 812-A-02**  
**Typical Plaster Sample**

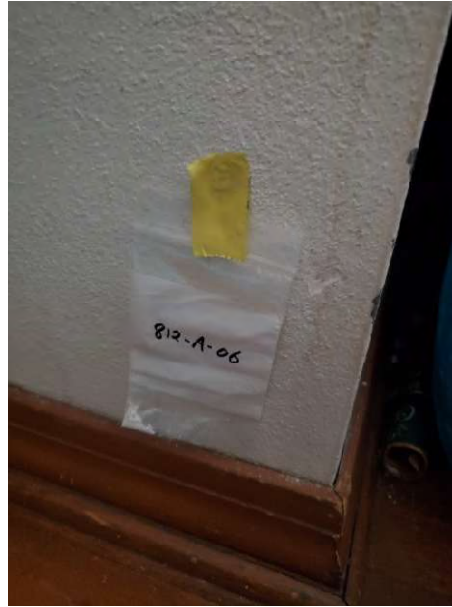
**Sample 812-A-06**  
**Typical Wall Texture Sample**

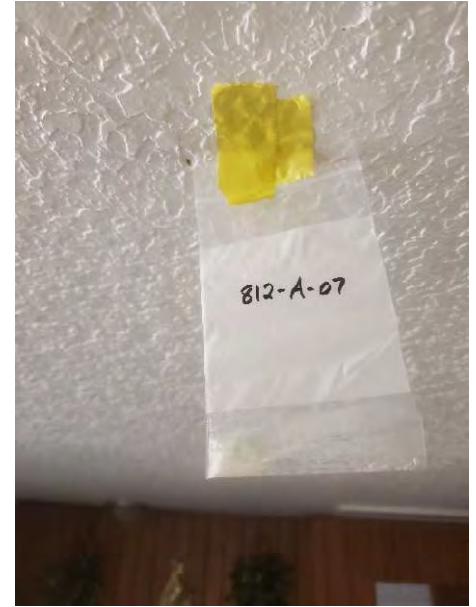
**Sample 812-A-07**  
**Typical Knockdown Ceiling  
Texture Sample**

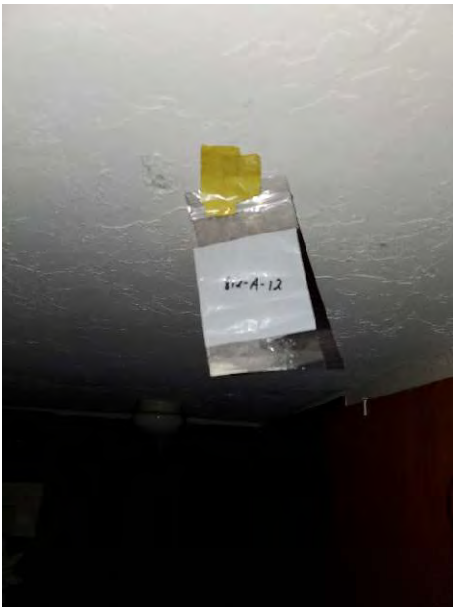
**Sample 812-A-12**  
**Typical Ceiling Texture Sample**

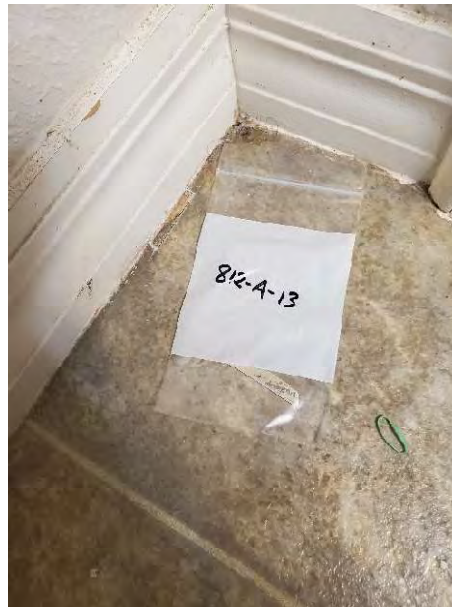
**Sample 812-A-13**  
**Typical Rolled Flooring Sample**

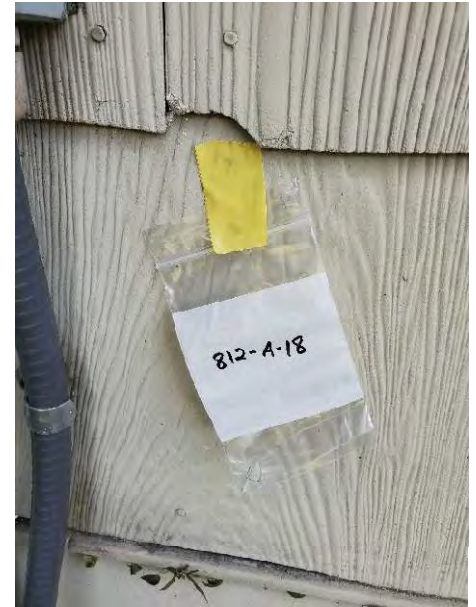
Sample No.	Location	Asbestos Component	Asbestos Qty	Friable	Amount
812-A-16	Exterior	Cementitious Siding (Transite)	15% Chrysotile	No*	+/- 1,500 Ft <sup>2</sup>

\* Category II, non-friable ACM. Category II materials that have a high probability of being crumbled, pulverized, or reduced to powder as part of demolition must be removed before demolition begins.

1. Cementitious (Transite) Siding was detected on the structure. The EPA NESHAP (40 CFR Part 61, Appendix A to Subpart M) classifies cementitious asbestos (Transite) as a Category II, non-friable ACM. **Category II materials that have a high probability of being crumbled, pulverized, or reduced to powder as part of demolition must be removed before demolition begins.**

**Sample 812-A-18**  
**Typical Cementitious Siding  
Sample**

- Abate all exterior “Transite” siding prior to the demolition of the structure.

Abate all Non-Friable Asbestos Containing Material prior to any renovation or demolition that may impact the Cementitious Siding. Abatement should be performed by a Florida Licensed Asbestos Abatement Contractor.

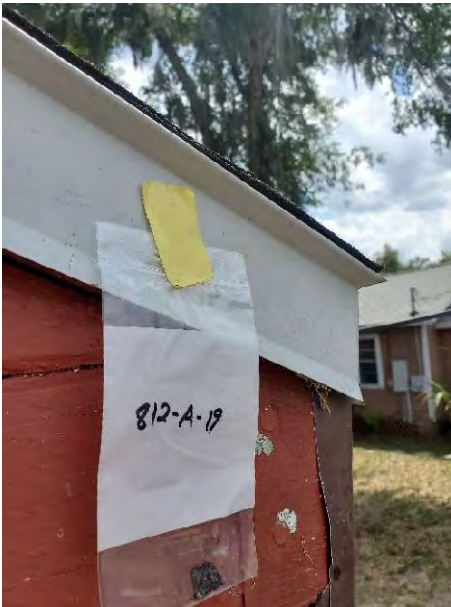
**Sample 812-A-19**  
**Typical Asphalt Roofing Sample**

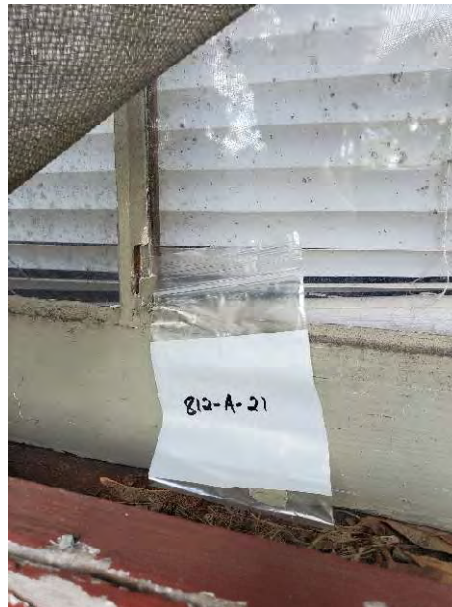
**Sample 812-A-21**  
**Typical Window Glazing Sample**

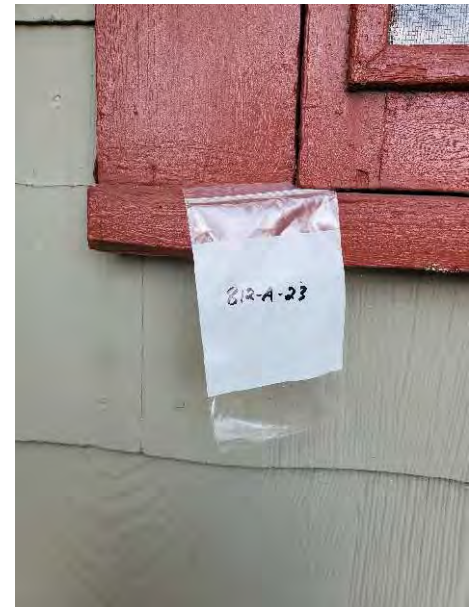
**Sample 812-A-23**  
**Typical Window Caulking Sample**

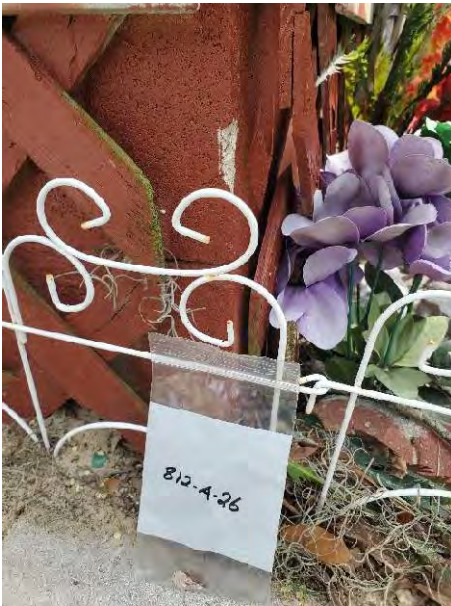
**Sample 812-A-26**  
**Typical CMU Block Sample**

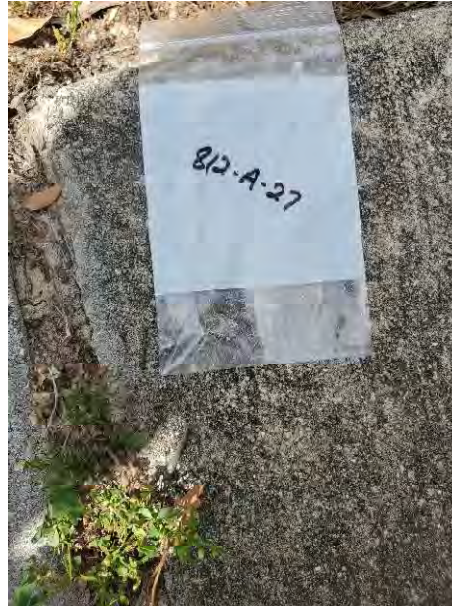
**Sample 812-A-27**  
**Typical Concrete Sample**
