December 16, 2025

Project:  
Asbestos Survey for Renovation-House  
Mae Etta Green Wigington  
123 SW 11<sup>th</sup> Ave.  
Ocala, FL 34471

## Exhibit D - Asbestos Survey Report

Asbestos Survey for Renovation-House  
Mae Etta Green Wigington  
123 SW 11<sup>th</sup> Ave.  
Ocala, FL 34471

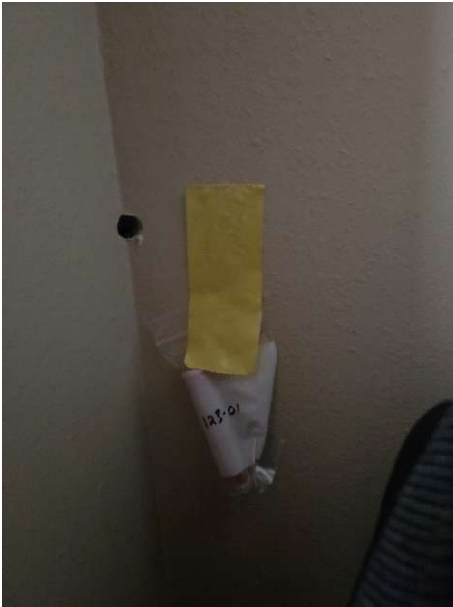
Sample 123-01  
Typical Drywall & Joint Compound  
Sample

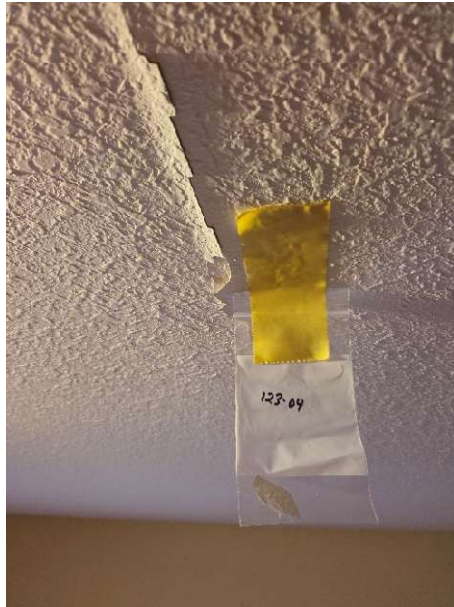
Sample 123-04  
Typical Ceiling Texture Sample

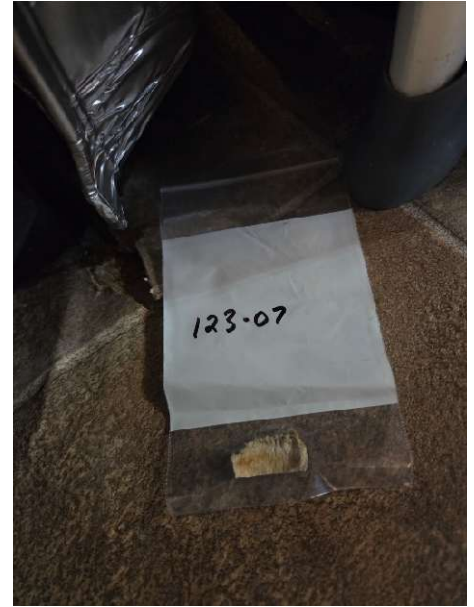
Sample 123-07  
Typical Rolled Vinyl Flooring  
Sample

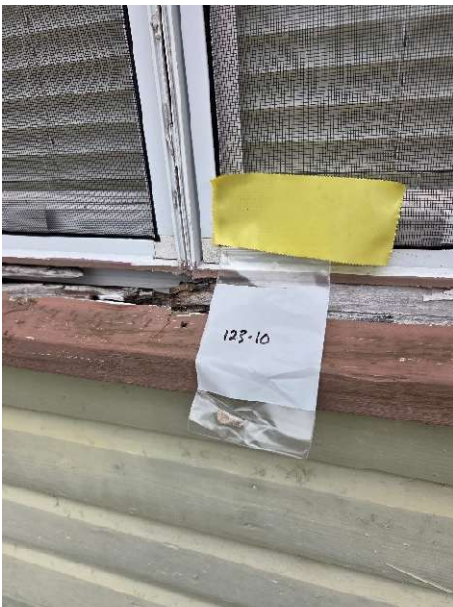
Sample 123-10  
Typical Exterior Caulking Sample

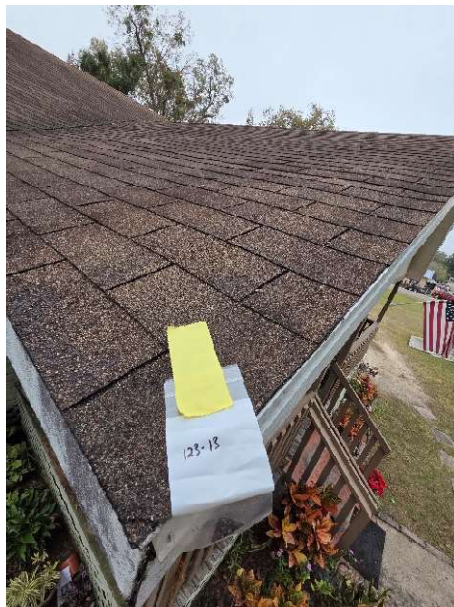
Sample 123-13  
Asphalt Shingle Roofing Sample

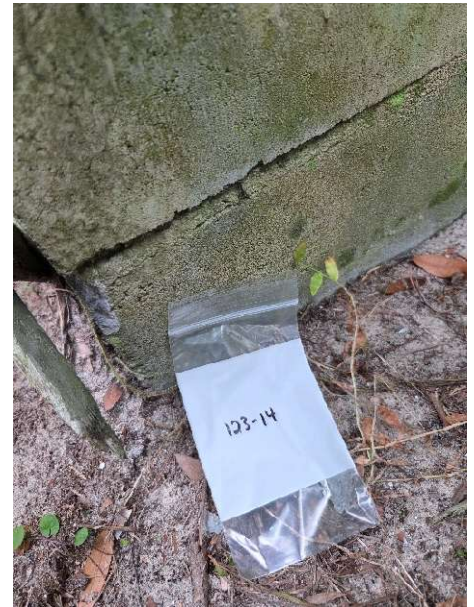
Sample 123-14  
CMU Block Sample
