Project:  
Asbestos Survey for Renovation-House  
Cieara Parker  
1704 SW 5<sup>th</sup> Place  
Ocala, FL 34471

Client:  
City of Ocala  
Community Development Services Department  
201 SE 3<sup>rd</sup> St.  
Ocala, FL 34471

Asbestos Survey for Renovation-House  
Cieara Parker  
1704 SW 5<sup>th</sup> Place  
Ocala, FL 34471

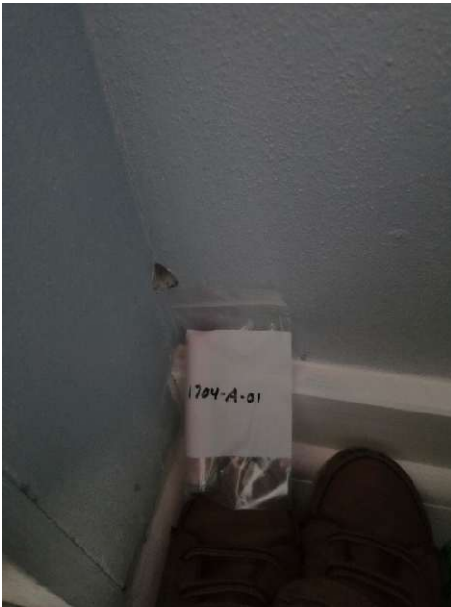
**Sample 1794-01**  
**Typical Plaster Sample**

| Lab Sample Number | Client Sample Number | Layer Type | Lab Gross Description | Asbestos | Other Materials |
|---|---|---|---|---|---|
| 26-05-03011-001 | 1704-A-01 | | Blue Paint-Like; White Granular; Gray Powdery; Inhomogeneous | NAD | 1% Cellulose<br>99% Non-Fibrous |

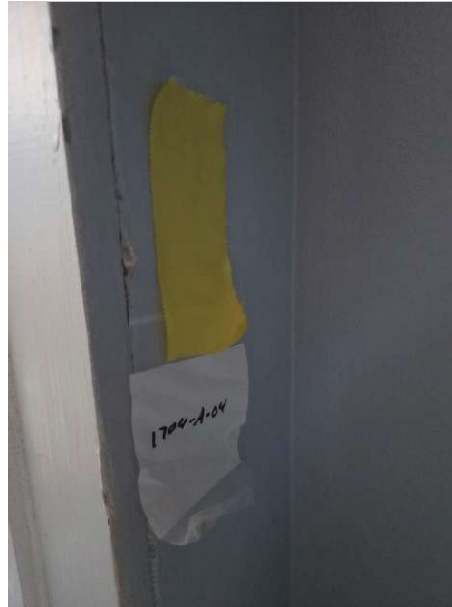
**Sample 1704-04**  
**Typical Wall Texture Sample**

| Lab Sample Number | Client Sample Number | Layer Type | Lab Gross Description | Asbestos | Other Materials |
|---|---|---|---|---|---|
| 26-05-03011-004 | 1704-A-04 | | Blue Paint-Like; Off-White Granular; Inhomogeneous | NAD | 100% Non-Fibrous |

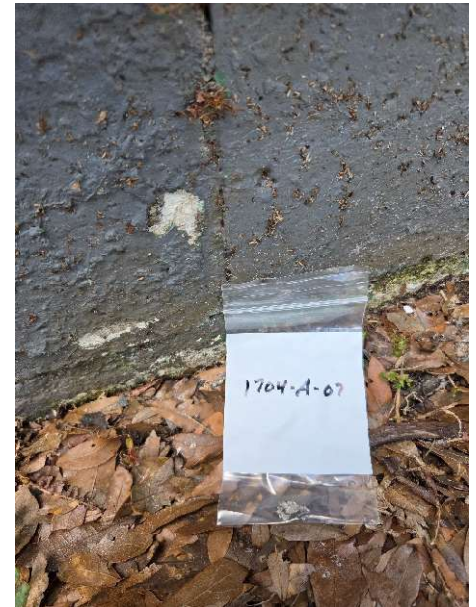
**Sample 1704-07**  
**Typical Stucco Sample**

| Lab Sample Number | Client Sample Number | Layer Type | Lab Gross Description | Asbestos | Other Materials |
|---|---|---|---|---|---|
| 26-05-03011-007 | 1704-A-07 | | Gray/Green/Yellow/White Pliable Paint-Like; Brown Brittle Granular; Inhomogeneous | NAD | 100% Non-Fibrous |

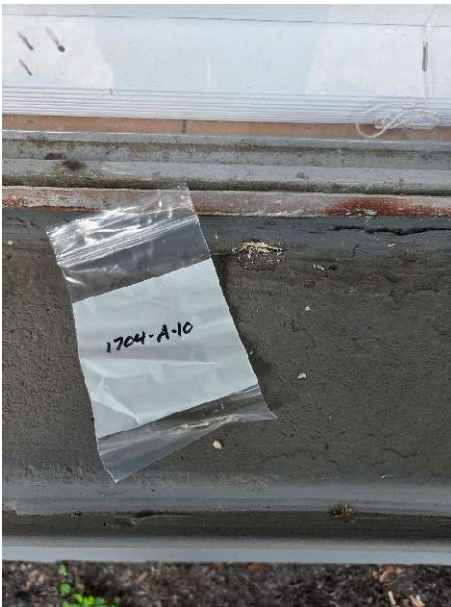
**Sample 1704-10**  
**Typical Exterior Caulking Sample**

| Sample No. | Location | Asbestos Component | Asbestos Qty | Friable | Amount |
|---|---|---|---|---|---|
| 1704-10 | Exterior | Exterior Caulking | 2% Chrysotile | No | +/- 200 Lft |

1. Non-Friable Asbestos Containing Material was detected in the Exterior Caulking.

| Lab Sample Number | Client Sample Number | Layer Type | Lab Gross Description | Asbestos | Other Materials |
|---|---|---|---|---|---|
| 26-05-03011-010 | 1704-A-10 | | Gray/Green Pliable Paint-Like; Beige Dense Chalky; Inhomogeneous | 2% Chrysotile | 98% Non-Fibrous |

Abate all Non-Friable Asbestos Containing Material prior to any renovation that may impact the Exterior Caulking. Abatement should be performed by a Florida Licensed Asbestos Abatement Contractor.

Non-Friable Asbestos Containing Material was detected in the Exterior Caulking. The EPA NESHAP (40 CFR Part 61, Appendix A to Subpart M) classifies these materials as a Category I, non-friable ACM. Removal is not required by NESHAP provided the renovation activities do not subject this material to cutting, sanding, grinding, abrading, or otherwise rendering them friable during renovation.

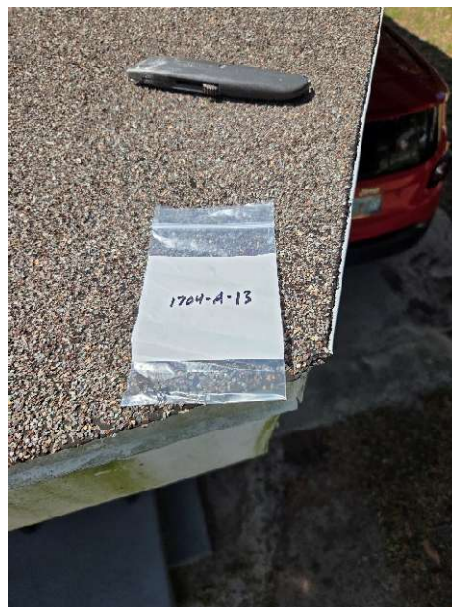
**Sample 1704-13**  
**Typical Rolled Asphalt Roofing Sample**

| Lab Sample Number | Client Sample Number | Layer Type | Lab Gross Description | Asbestos | Other Materials |
|---|---|---|---|---|---|
| 26-05-03011-013 | 1704-A-13 | | Gray/Brown Aggregate;<br>Black Tar-Like;<br>Inhomogeneous | NAD | 2% Synthetic<br>98% Non-Fibrous |

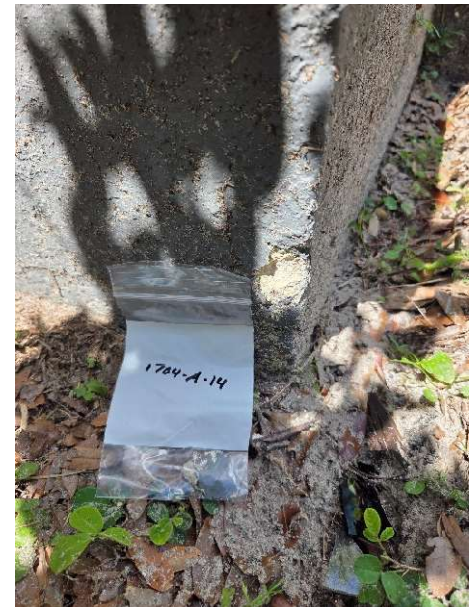
**Sample 1704-14**  
**CMU Block Sample**

| Lab Sample Number | Client Sample Number | Layer Type | Lab Gross Description | Asbestos | Other Materials |
|---|---|---|---|---|---|
| 26-05-03011-014 | 1704-A-14 | | Gray/Green Pliable Paint-<br>Like; Off-White to Off-Gray<br>Cementitious;<br>Inhomogeneous | NAD | 100% Non-Fibrous |

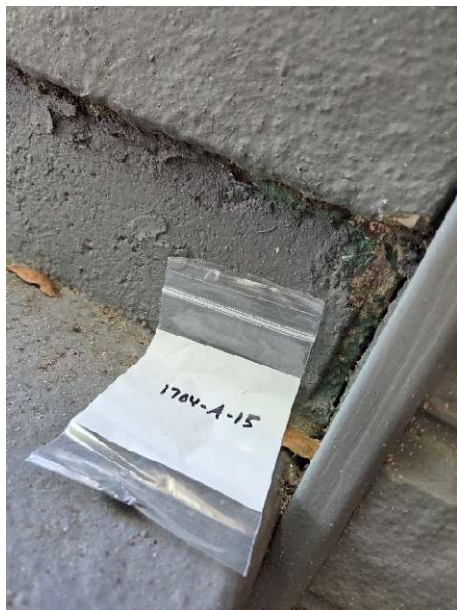
**Sample 1704-15**  
**Concrete Sample**

| Lab Sample Number | Client Sample Number | Layer Type | Lab Gross Description | Asbestos | Other Materials |
|---|---|---|---|---|---|
| 26-05-03011-015 | 1704-A-15 | | Gray/Green Pliable Paint-<br>Like; Off-White to Off-<br>Gray/Brown Cementitious;<br>Inhomogeneous | NAD | 100% Non-Fibrous |
