June 5, 2025

Project: LEAD - BASED PAINT INSPECTION & RISK ASSESSMENT REPORT
Louise West
812 NW 2nd St.
Ocala, FL 34475

Louise West
812 NW 2nd St.
Ocala, FL 34475

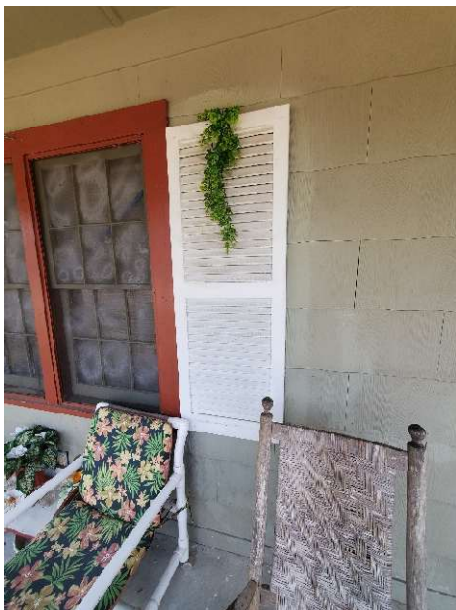
Reading No	Time	COMPONENT	FEATURE	SUBSTRATE	SIDE	COLOR	CONDITION	ROOM	Results	PbC
411	5/27/2025 12:13	WINDOW	TRIM	WOOD	EXT A	WHITE	INTACT	EXTERIOR	Positive	1.9
420	5/27/2025 12:20	ROOF	SOFFIT	WOOD	EXT A	GRAY	INTACT	EXTERIOR	Positive	1.4
433	5/27/2025 12:27	ROOF	SOFFIT	WOOD	EXT B	GRAY	INTACT	EXTERIOR	Positive	1.8
445	5/27/2025 12:34	ROOF	SOFFIT	WOOD	EXT C	GRAY	INTACT	EXTERIOR	Positive	1.2
460	5/27/2025 12:42	ROOF	SOFFIT	WOOD	EXT D	GRAY	INTACT	EXTERIOR	Positive	1.5

Window Trim Positive

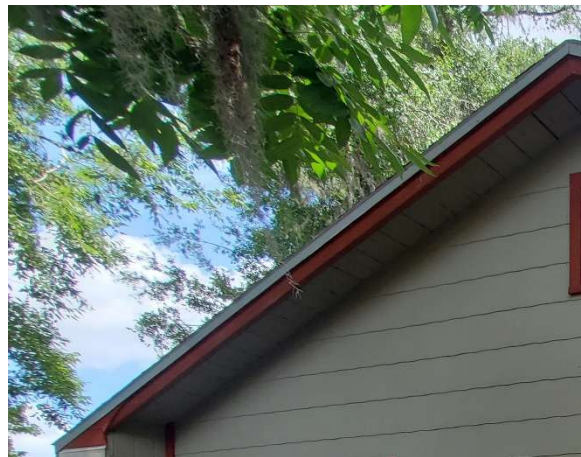
Typical Soffit Positive
