LEAD-BASED PAINT RISK ASSESSMENT REPORT

631-633 W Silver Springs Place
Ocala, FL 34475

PERFORMED ON:
February 26, 2026

Re: Lead-Based Paint Inspection/Risk Assessment Report

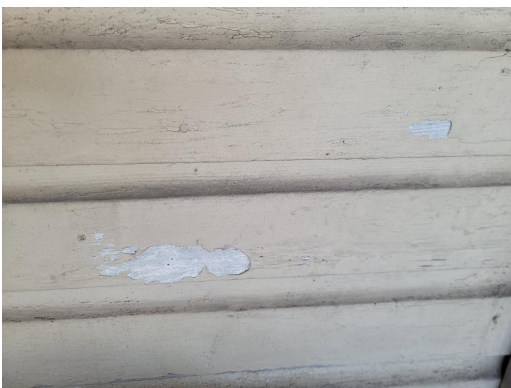
Read No.	Wall	Structure	Location	Member	Paint Cond	Substrate	Paint Color	Lead (mg/cm ²)	Mode
001 Exterior									
005	A	Wall	L Ctr		D	Wood	Tan	3.4	QM
017	B	Corner	Lft		D	Wood	Green	4.3	QM
016	B	Wall	U Ctr		D	Wood	Tan	2.0	QM

Exterior(001) A-Wall, Center
Wood Siding
Lead-Positive, Deteriorated

- Option A. Paint film stabilization of siding by application of 1 coat of Kilz primer or equivalent over a LSWP prepared surface and 2 top coats of exterior exposure residential paint following manufacturer's recommendations. Color chosen by owner. (IC)
- Option B. Enclosure of walls with house wrap and vinyl siding using LSWP.
- Option C. Remove lead-based paint chemically and repaint using LSWP.

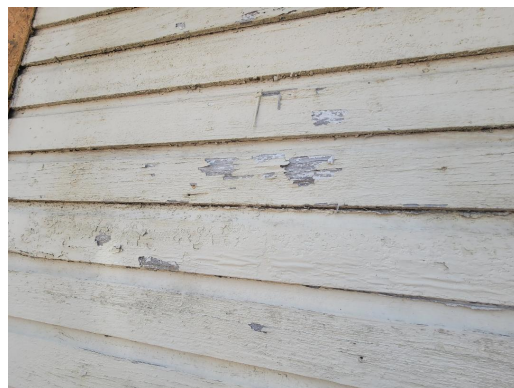
Exterior(001) B-Wall, Center
Wood Siding
Lead-Positive, Deteriorated

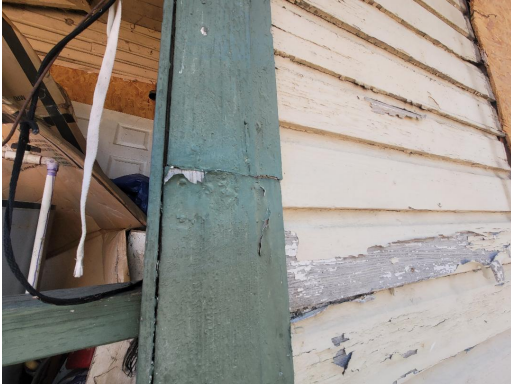
Exterior(001) B-Wall, Left
Wood Corner
Lead-Positive, Deteriorated
