LEAD-BASED PAINT INSPECTION REPORT

1941 NW 5th Street
Ocala, FL 34475

PERFORMED ON:
October 10, 2022

Debra Koontz
Certified Risk Assessor
LBP-R-I191376-2

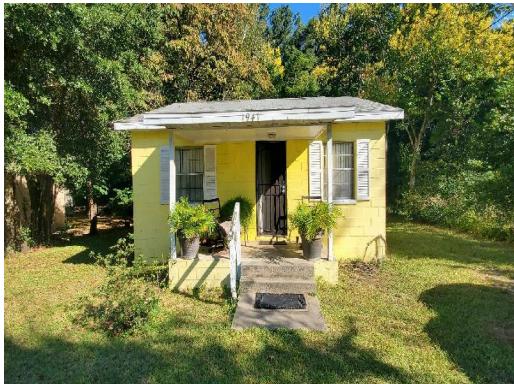
Exterior(008) A-Wall

| Read No. | Wall | Structure | Location | Member | Paint Cond | Substrate | Paint Color | Lead (mg/cm ²) | Mode |
|---|---|---|---|---|---|---|---|---|---|
| 073 | A | Wall | U Lft | | I | Block | yellow | -0.3 | QM |
| 074 | B | Wall | L Ctr | | D | Block | yellow | -0.3 | QM |

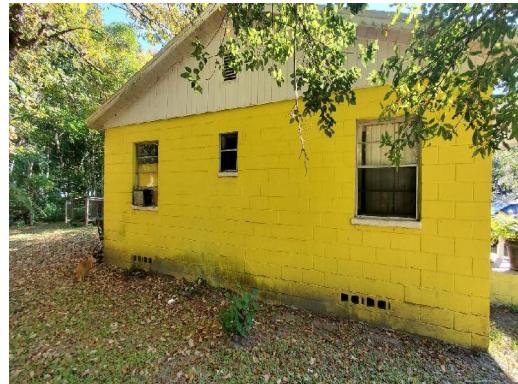
Exterior(008) B-Wall

| Read No. | Wall | Structure | Location | Member | Paint Cond | Substrate | Paint Color | Lead (mg/cm ²) | Mode |
|---|---|---|---|---|---|---|---|---|---|
| 075 | B | Window | Rgt | Sill | I | Concrete | white | 0.3 | QM |

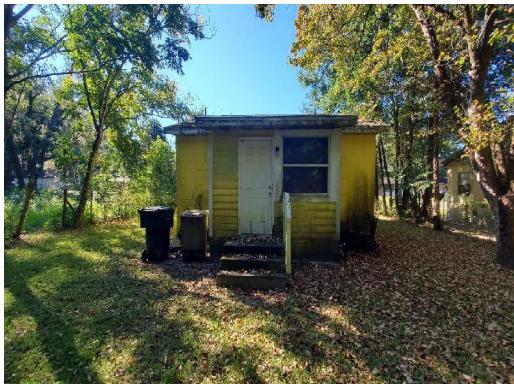
Exterior(008) C-Wall

| Read No. | Wall | Structure | Location | Member | Paint Cond | Substrate | Paint Color | Lead (mg/cm ²) | Mode |
|---|---|---|---|---|---|---|---|---|---|
| 080 | C | Wall | U Ctr | | I | Wood | yellow | -0.2 | QM |
| 079 | C | Window | Ctr | Casing | I | Wood | white | -0.3 | QM |
| 076 | C | Window | Rgt | Sill | D | Concrete | white | -0.1 | QM |

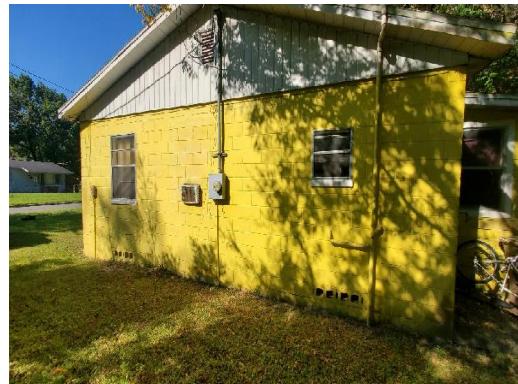
Exterior(008) D-Wall

| Read No. | Wall | Structure | Location | Member | Paint Cond | Substrate | Paint Color | Lead (mg/cm ²) | Mode |
|---|---|---|---|---|---|---|---|---|---|
| 081 | D | Wall | U Ctr | | I | Block | yellow | -0.4 | QM |
| 082 | D | Window | Lft | Sill | I | Concrete | white | -0.1 | QM |
