LEAD-BASED PAINT RISK ASSESSMENT REPORT

3410 NE 12th Street
Ocala, FL 34470

PERFORMED ON:
February 24, 2025

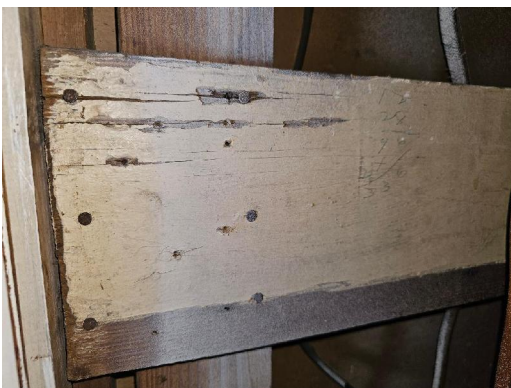
Read No.	Wall	Structure	Location	Member	Paint Cond	Paint Substrate	Paint Color	Lead (mg/cm ²)	Lead Mode
Interior Room 005 Hallway									
042	A	cl shf support	Lft		D	Wood	white	4.9	QM

Hallway(005) A-Wall, Left
Wood Closet Shelf Support
Lead-Positive, Deteriorated

- Option A. Impact/friction control and paint film stabilization of all lead-positive components by application of 1 coat of Kilz primer or equivalent over a LSWP prepared surface and 2 top coats of interior exposure residential paint following manufacturer's recommendations. Color chosen by owner.(IC)
- Option B. Remove all lead-positive components using LSWP and replace with new.
- Option C. Remove lead-based paint chemically and repaint using LSWP.
