## LEAD-BASED PAINT RISK ASSESSMENT REPORT

617 NW 1st Street  
Ocala, FL 34475

PERFORMED ON:  
May 05, 2025

Debra Koontz  
Certified Risk Assessor  
LBP-R-1191376-3

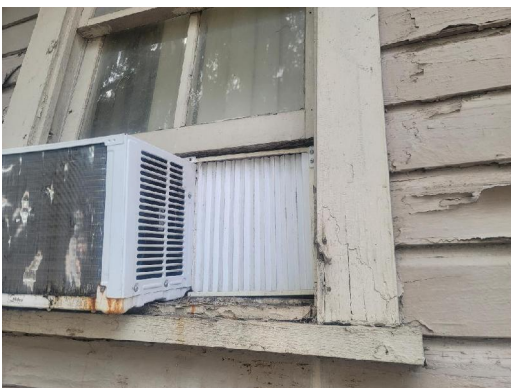
**Exterior(001) D-Wall, Center  
Wood Window Components  
Lead-Positive, Deteriorated**

- Option A. Paint film stabilization of lead-positive components by application of Kilz primer or equivalent over a LSWP prepared surface and 2 top coats of an interior exposure paint following manufacturer's recommendations. Impact/friction control measures should be taken as necessary. (IC)
- Option B. Removal of positive components and replacement with material similar in appearance, composition, and finish using LSWP.
- Option C. Encapsulation of lead-positive components by application of LBC (Lead Barrier Compound) using LSWP.
- Option D. Remove lead-based paint from all window components chemically and repaint using LSWP.

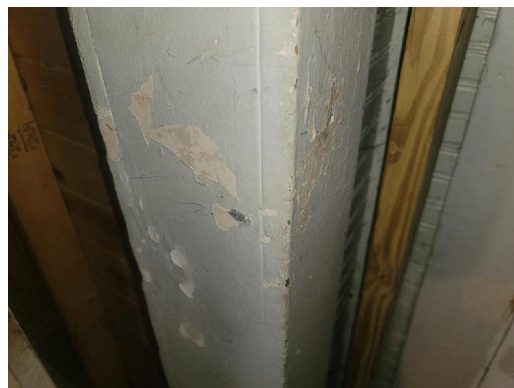
**Hallway(005) A-Wall, Center  
Wood Door Jamb, Casing  
Lead-Positive, Deteriorated**

- Option A. Impact/friction control and paint film stabilization of lead-positive components. Re-hang door and install stop cushioning using LSWP. (IC)
- Option B. Remove door, jamb and casing using LSWP. Install new pre-hung door.
- Option C. Removal of lead-positive components and replacement with material similar in appearance, composition and finish using LSWP.
- Option D. Remove lead-based paint from all door components chemically and repaint using LSWP.
