May 22, 2026

Client: City of Ocala  
Community Development Services Department  
201 SE 3<sup>rd</sup> St.  
Ocala, FL 34471

Project: LEAD - BASED PAINT INSPECTION & RISK ASSESSMENT REPORT  
Cieara Parker  
1704 SW 5<sup>th</sup> Place  
Ocala, FL 34471

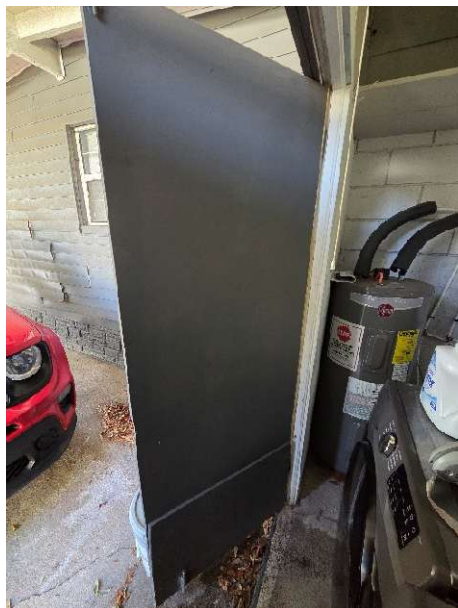
Door & Door Casing Positive

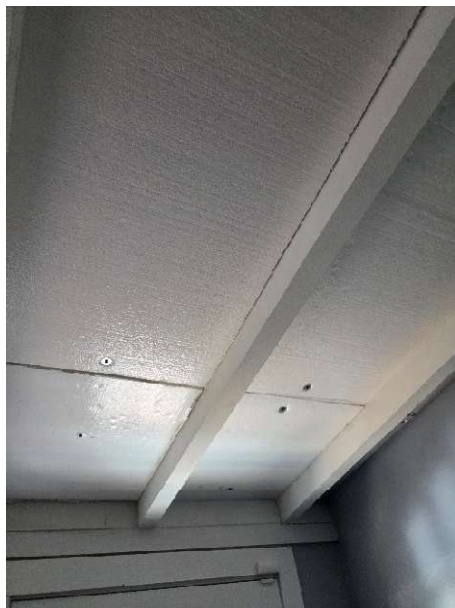
Typical Ceiling Rafters Positive

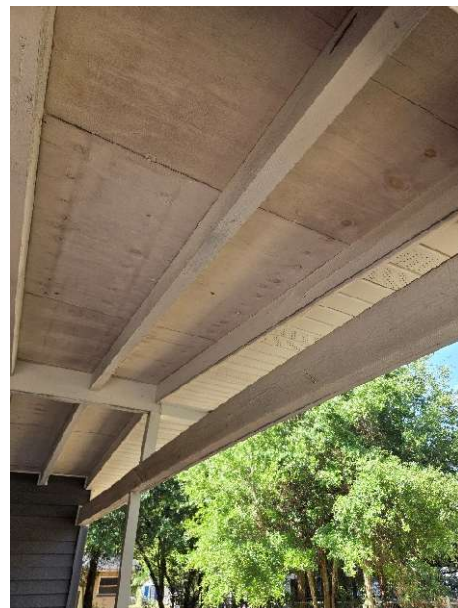
Porch Rafters & Beams Positive

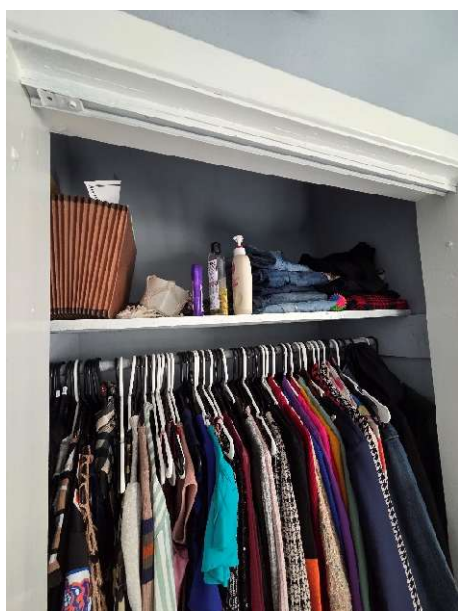
Closet Shelf Positive

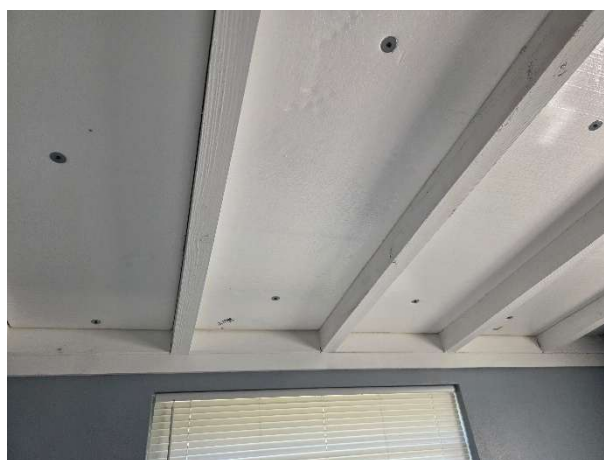
Wall Upper Trim Positive
