LEAD-BASED PAINT RISK ASSESSMENT REPORT

2801 SW 14th Street
Ocala, FL 34474

PERFORMED ON:
April 18, 2022

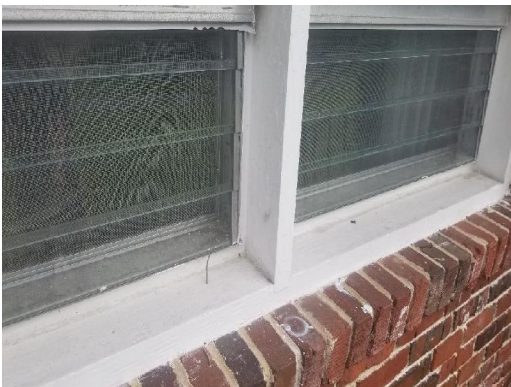
Read					Paint		Paint	Lead	
No.	Wall	Structure	Location	Member	Cond	Substrate	Color	(mg/cm ²)	Mode
012	Exterior								
143	A	Window	Lft	Jamb	I	Wood	White	2.5	QM

Exterior(012) A-Wall, Left
Wood Window Jambs
Lead-Positive, Intact

- Option A. Paint film stabilization of all lead-positive window jambs by application of 1 coat of Kilz primer or equivalent over a LSWP prepared surface and 2 top coats of exterior exposure residential paint following manufacturer's recommendations. Color chosen by owner. (IC)
- Option B. Enclosure of all lead-positive window jambs with metal coil stock using LSWP.
- Option D. Removal of lead-positive window jambs and replacement with material similar in appearance, composition and finish using LSWP.
- Option E. Remove lead-based paint chemically and repaint using LSWP.
