In-Depth Inspection Report for

City of Ocala

Windstream EWT 35' x 146'-6"
200,000 Gallons Steel Elevated

Inspection Date: 9/14/20

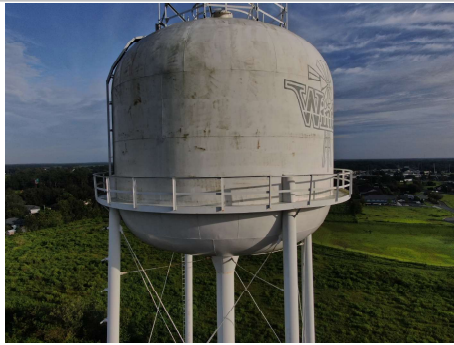
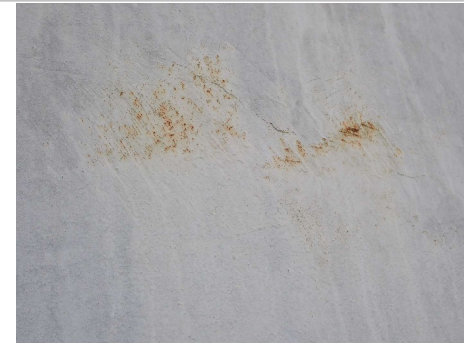
Wall Panel Condition

Overall Condition: Good

- Additional Notes:**
- Consistent ratings throughout
 - Minor to moderate mildew staining present
 - Signs of coating failure noted throughout
 - Minor unlocalized corrosion present
 - Corrosive staining isolated where coating has failed
 - Moderate checking & pinholing noted in coating

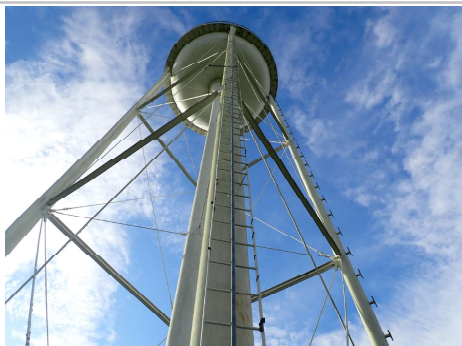
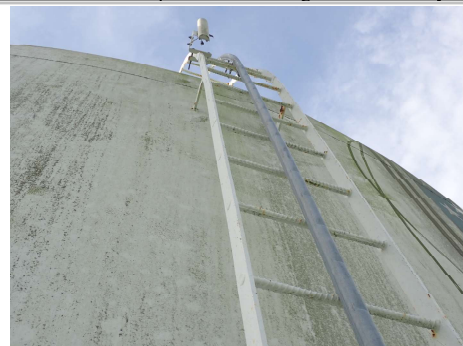
Access Ladder Condition

Overall Condition: Good

- Additional Notes:**
- Consistent ratings throughout both ladders
 - Minor signs of coating failure present
 - Rating consistent throughout balcony & handrails
 - Corrosive / mildew staining throughout (minor)
 - Unlocalized minor d-lamination present
 - No protective coating noted on safety climb

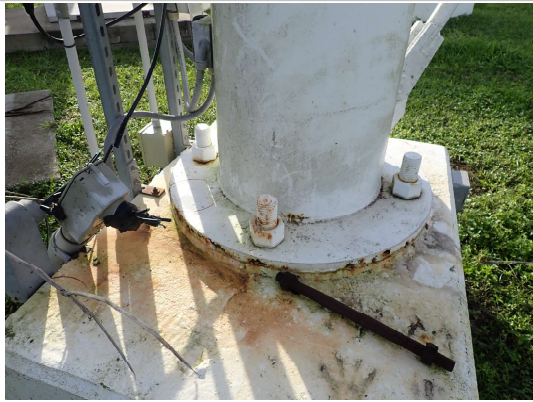
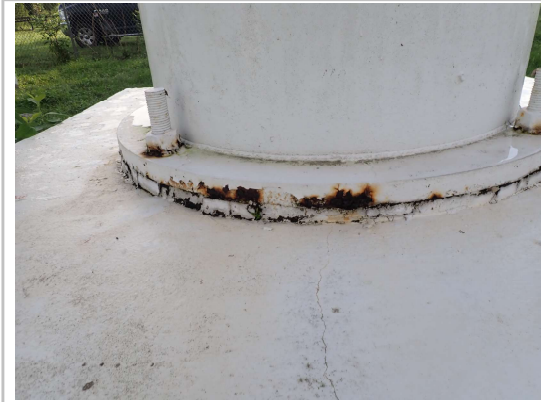
Overall Condition: Good

Additional Notes: - Each leg equipped w/ concrete foundation
 - Ratings consistent throughout all foundations
 - Corrosion isolated on hardware & seams
 - Minor signs of coating failure present

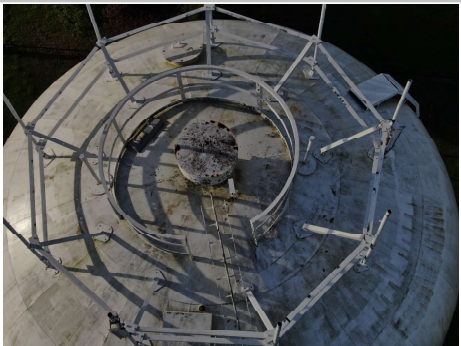
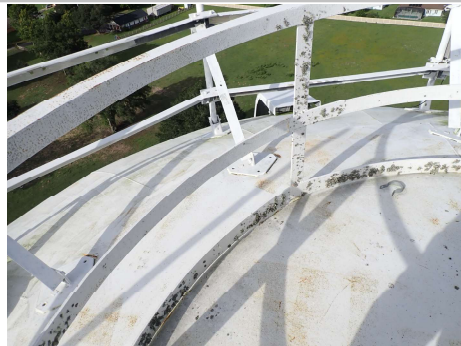
Overall Condition: Good

- Additional Notes:**
- Equipped w/ hand-rails & antenna mounts
 - Ratings consistent throughout
 - Minor to moderate organic growth throughout
 - Unlocalized corrosion noted throughout

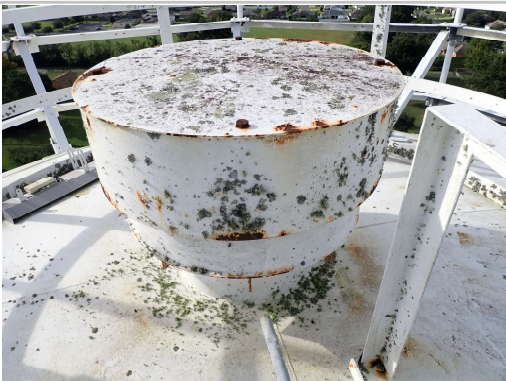
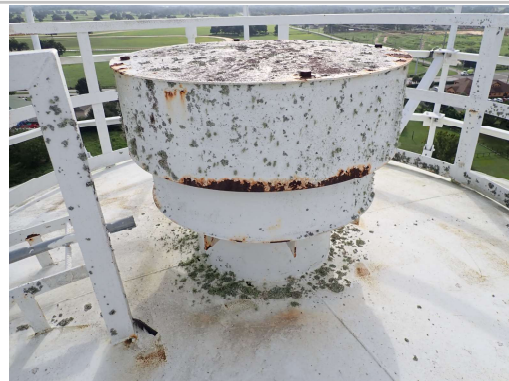
Vent Condition

Overall Condition: Good to Fair

- Additional Notes:**
- Consistent ratings throughout
 - Moderate organic growth present
 - Signs of coating failure noted throughout
 - Minor checking / pinholing present in coating
 - Corrosion unlocalized throughout

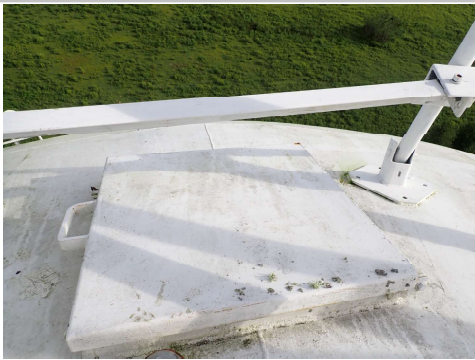
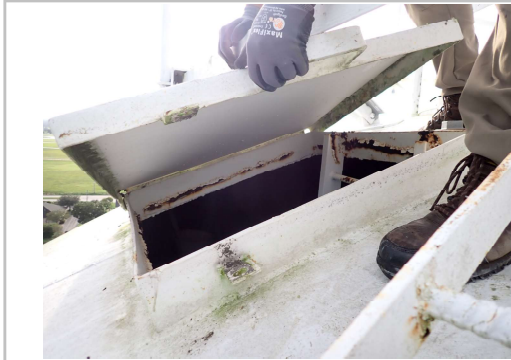
Corrosion:
 None/NA
 Uniform Surface Corrosion: Extensive: < 1%
 Concentrated Cell Corrosion: Few Isolated: < 0.1%
 Rust Noduling/Pitting: N/A Depth: N/A
 Galvanic: N/A
 De-alloying: Extensive: < 1%
 Intergranular: N/A
 Stress Corrosion Cracking: N/A
 Erosion Corrosion: N/A
Seams/Welds Condition: Good
 Insects, Dirt or Debris Present Under Hatch? Y N
 Any irregularities or structural deficiencies? Y N
 Description: N/A
Overall Condition: Good
Additional Notes: - Partially obstructed by antenna railing
 - Consistent ratings throughout
 - Minor organic growth isolated on hatch lid
 - No gasket present on hatch lid
 - Corrosion localized on seams & underneath lid

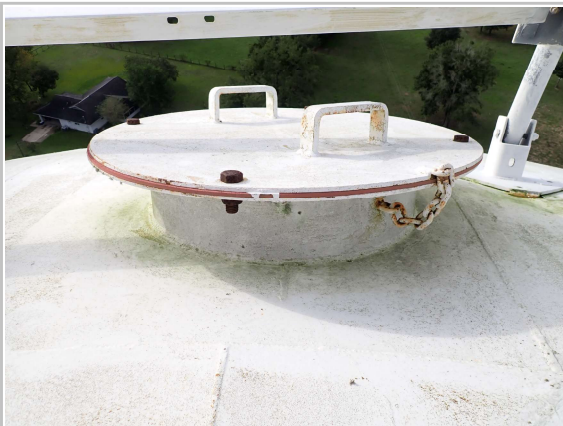
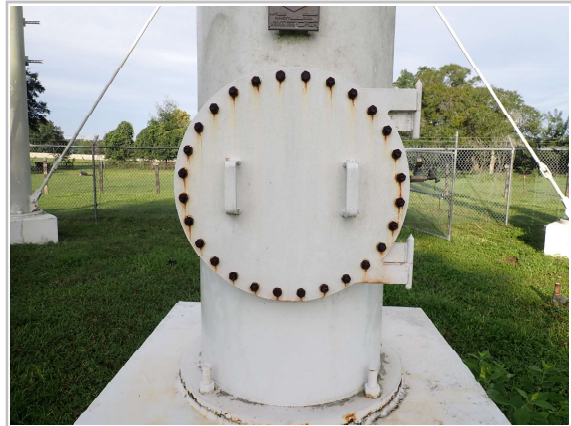
Manway Condition

Corrosion:
 None/NA
 Uniform Surface Corrosion: Minute: < 0.03%
 Concentrated Cell Corrosion: Extensive: < 1%
 Rust Noduling/Pitting: N/A Depth: N/A
 Galvanic: N/A
 De-alloying: N/A
 Intergranular: N/A
 Stress Corrosion Cracking: N/A
 Erosion Corrosion: N/A
Overall Condition: Good
Additional Notes: - Equipped w/ two(2) manways (equivalent ratings)
 - Minor signs of coating failure throughout
 - Corrosion mainly localized on hardware
 - Minor sags & runs / chalking present throughout

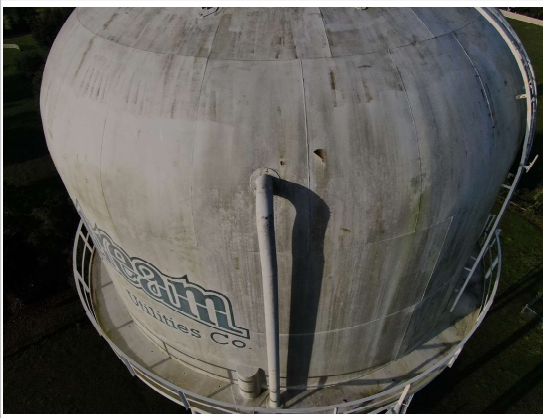
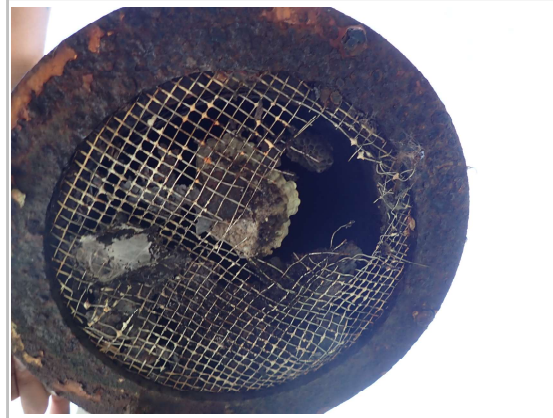
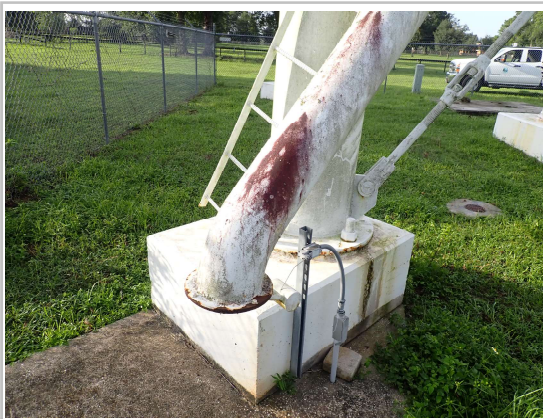
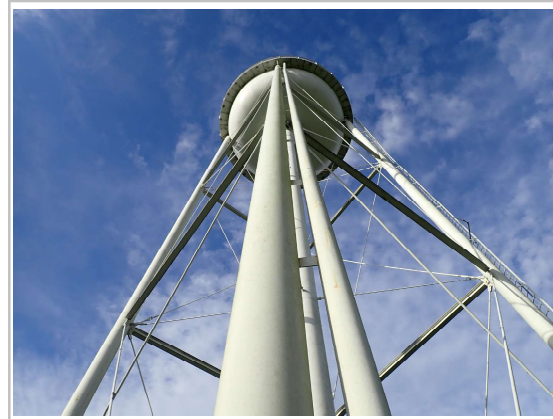
Overflow Structure Condition

Overall Condition: Good to Fair

- Additional Notes:**
- Overflow pipe penetrates through upper tank wall
 - Equipped w/ splash-pad at ground level discharge
 - Screen damaged at discharge opening
 - Insects present in piping due to voids in screen
 - Localized corrosion present at discharge penetration
 - Signs of coating failure noted throughout

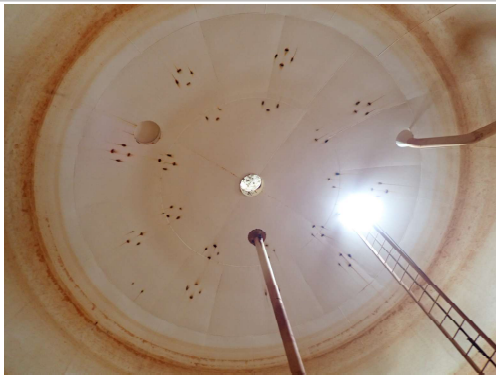
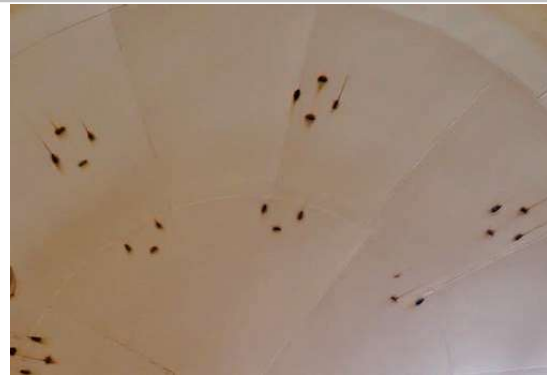
Roof Condition

Overall Condition: Good

- Additional Notes:**
- Minimal discrepancies to be noted
 - Minute signs of coating failure present
 - Corrosion isolated on seams / exterior welds / vent (isolated corrosion determined from ext. welds)
 - Minor corrosive staining noted throughout

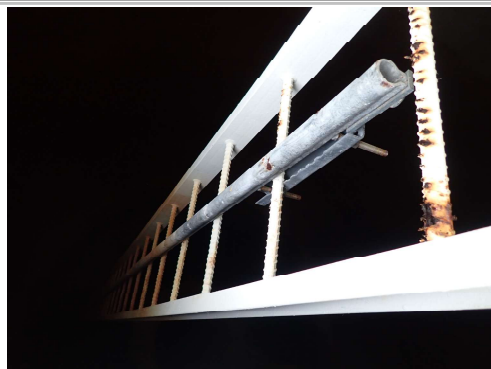
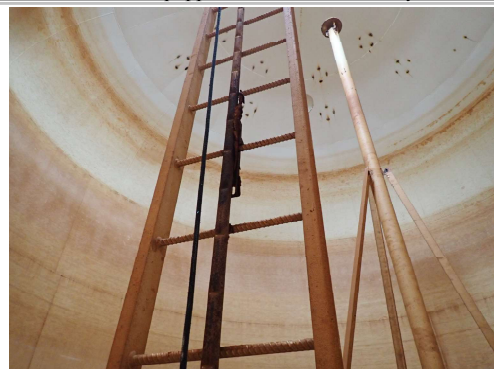
Ladder Condition

- Additional Notes:**
- Consistent ratings throughout (both ladders)
 - Wet riser equipped w/ secondary int. access ladder
 - Corrosion isolated on hardware & failed coating
 - Equipped w/ notched rail safety climb

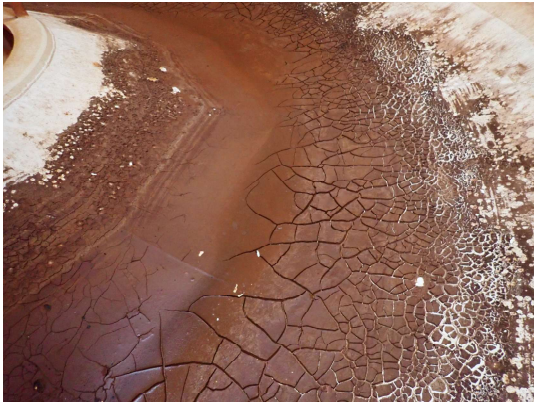
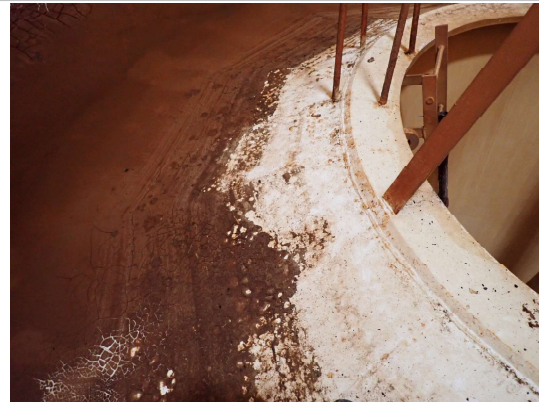
Floor Condition

Overall Condition: Good

Additional Notes: * Unable to fully evaluate due to sediment *
 - Rating consistent throughout
 - Heavy sediment accumulation & staining present
 - Moderate signs of coating failure throughout
 - Corrosion noted in areas w/ coating failure present

1. Routine Inspect every 3-5 years per AWWA recommendations & FAC Rule 62-555.350
2. Perform interior clean to remove all accumulated sediments throughout tanks floor
3. Rehabilitate / blast & re-coat, interior protective coating throughout all extremities of tank
4. Replace damaged screen on exterior overflow discharge & install gasket on roof access hatch
5. Pressure wash exterior surfaces to remove mildew staining / touch-up coating failure as needed

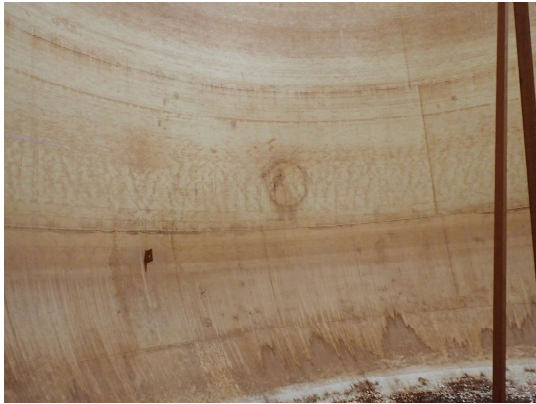
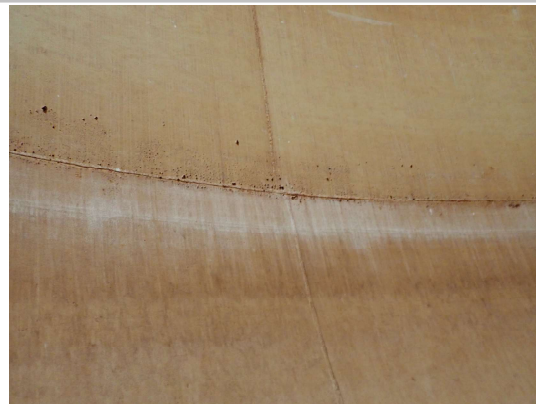
Overall Condition: Good to Fair

- Additional Notes:**
- Consistent ratings throughout
 - Moderate to heavy sediment staining noted
 - Unlocalized coating failure present throughout
 - Moderate to heavy blistering noted in coating
 - D-lamination present in areas w/ heavy blisters
 - Corrosion localized in areas w/ coating failure

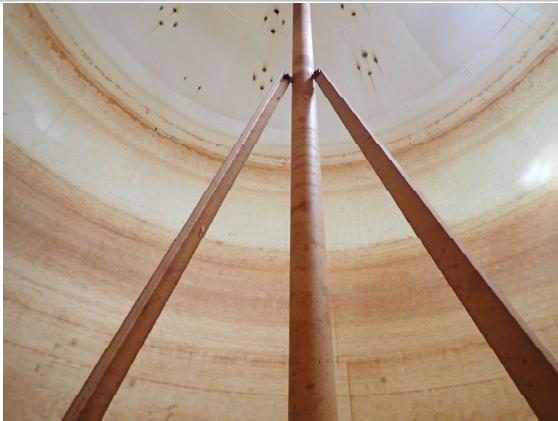
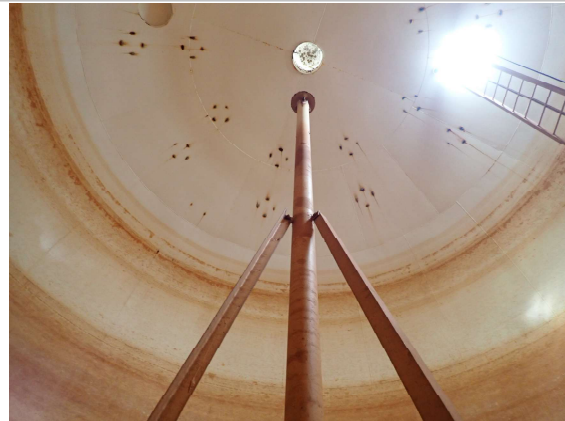
Inlet Condition

Overall Condition: Good

Additional Notes: - High-fill inlet pipe penetrates into wet riser
 - Equipped w/ three(3) stand-off supports
 - Minor corrosion/unlocalized throughout
 - Minor blistering / coating failure noted

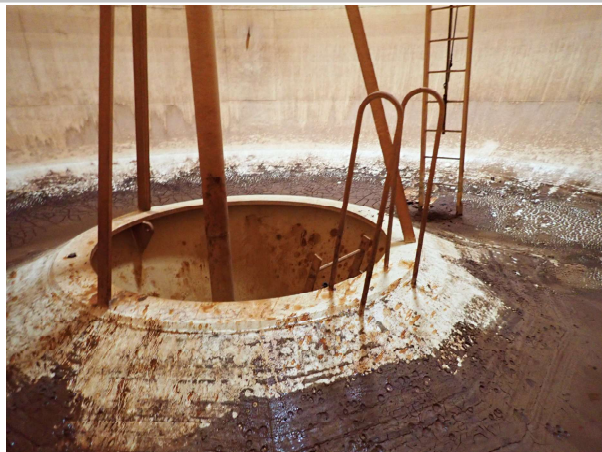
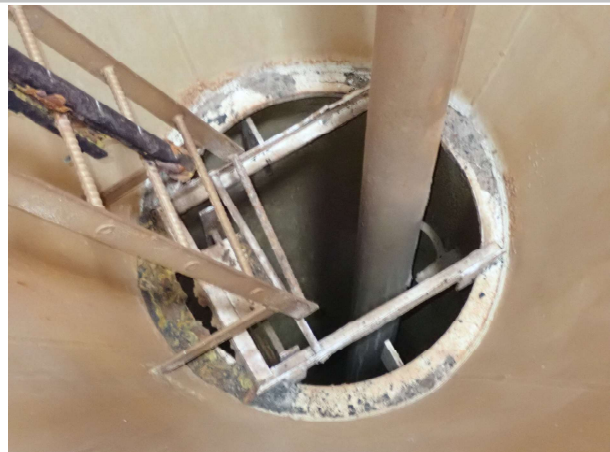
Outlet Condition

Overall Condition: Good

Additional Notes: - Wet riser functions as outlet & drain
 - Penetrates through center floor
 - Equipped w/ access ladder
 - See riser pipe below for additional ratings

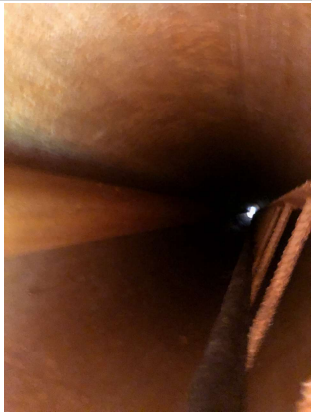
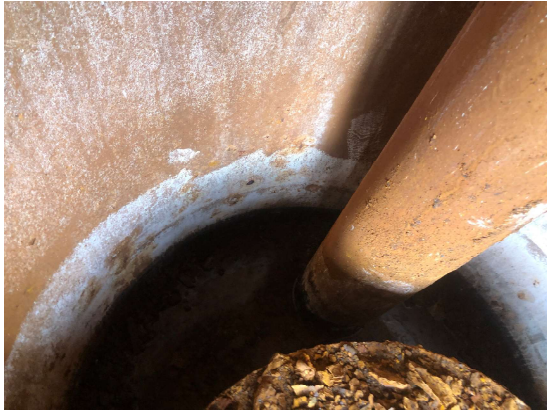
Riser Pipe Condition

Corrosion:
 None/NA
 Uniform Surface Corrosion: To Extent of 3%
 Concentrated Cell Corrosion: To Extent of 3%
 Rust Noduling/Pitting: None, or < 0.01% Depth: N/A
 Galvanic: N/A
 De-alloying: N/A
 Intergranular: N/A
 Stress Corrosion Cracking: N/A
 Erosion Corrosion: N/A
Overall Condition: Good
Additional Notes: - Equipped w/ secondary internal access ladder
 - Ratings consistent throughout penetration
 - Corrosion localized on ladder & safety climb
 - Heavy sediment staining / minor corrosive staining

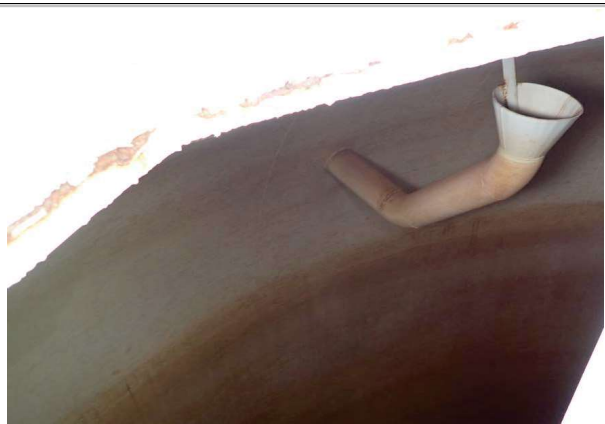
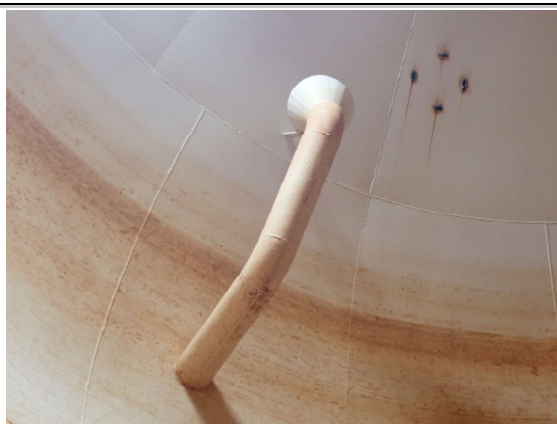
Overflow Condition

Corrosion:
 None/NA
 Uniform Surface Corrosion: Extensive: < 1%
 Concentrated Cell Corrosion: Minute: < 0.03%
 Rust Noduling/Pitting: N/A Depth: N/A
 Galvanic: N/A
 De-alloying: N/A
 Intergranular: N/A
 Stress Corrosion Cracking: N/A
 Erosion Corrosion: N/A
Overall Condition: Good
Additional Notes: - Minimal discrepancies to be noted
 - Pipe penetrates through upper wall of tank
 - Signs of coating failure on upper extremities
 - Minute signs of isolated corrosion noted
 - Minor sediment / corrosive staining present

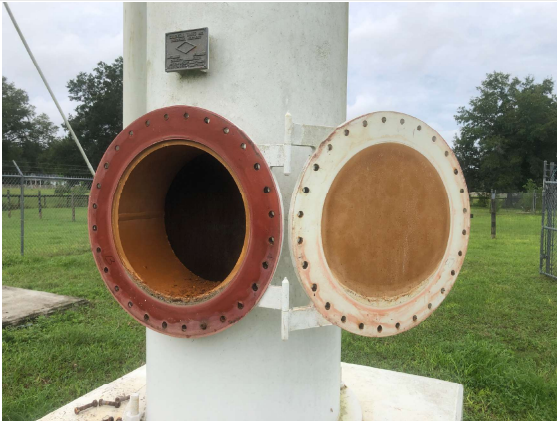
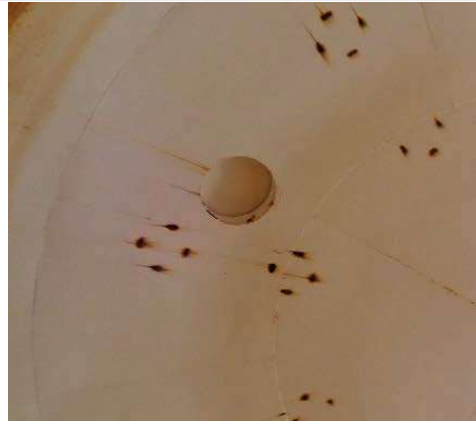
Overall Condition: Good

Additional Notes: - Equipped w/ two(2) manways (roof & wet riser)
 - Both share similar / consistent ratings
 - Minor corrosion & corrosive staining present
 - Sediment staining isolated on wet riser manway

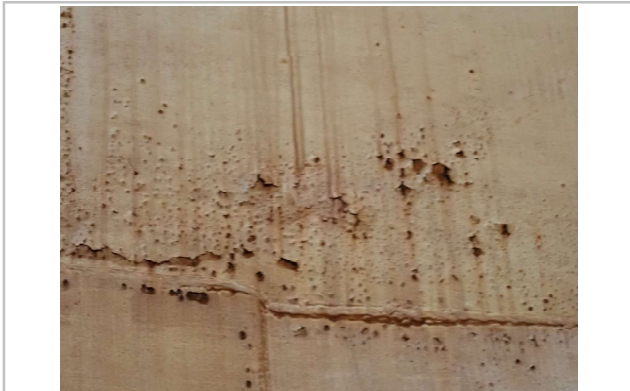
Internal walls (corrosion / d-lamination)
