Project:  
Asbestos Survey for Renovation-House  
Sheryl Martin  
1213 NW 9<sup>th</sup> St.  
Ocala, FL 34475

# Exhibit D - Asbestos Survey Report

Contract# CDS/260362

Asbestos Survey for Renovation-House

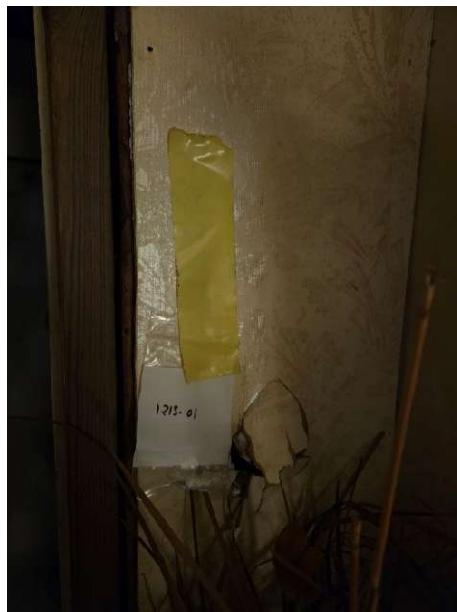
Sample 1213-01  
Typical Drywall & Joint Compound  
Sample

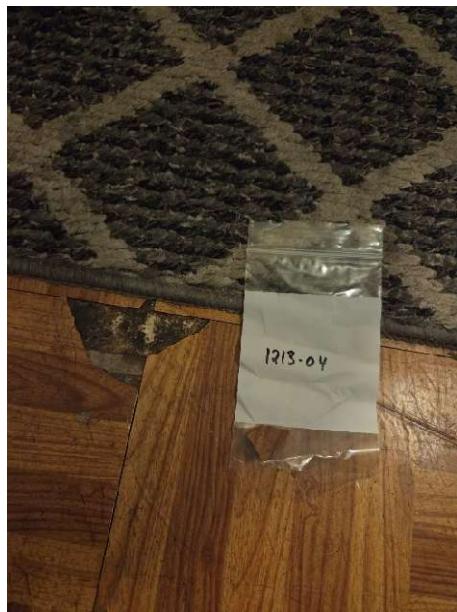
Sample 1213-04  
Typical 12"x 12" Vinyl Floor Tile  
Sample

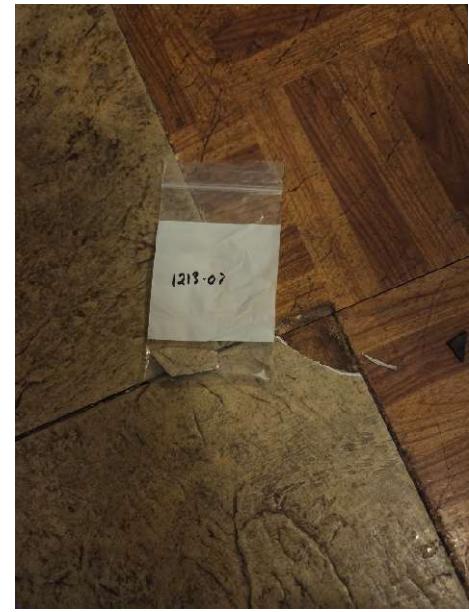
Sample 123-07  
Typical 12"x 12" Vinyl Floor Tile  
Sample

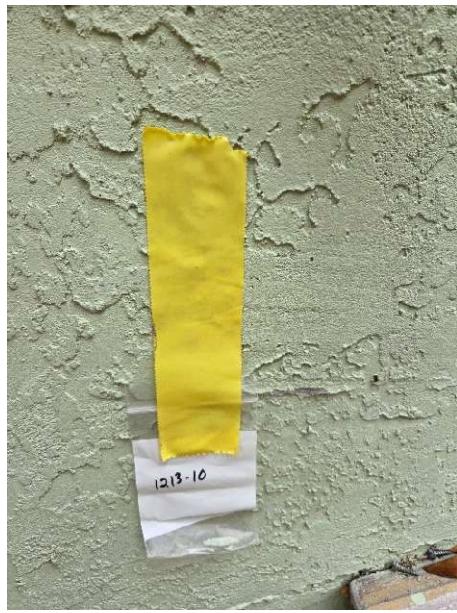
Sample 1213-10  
Typical Stucco Sample

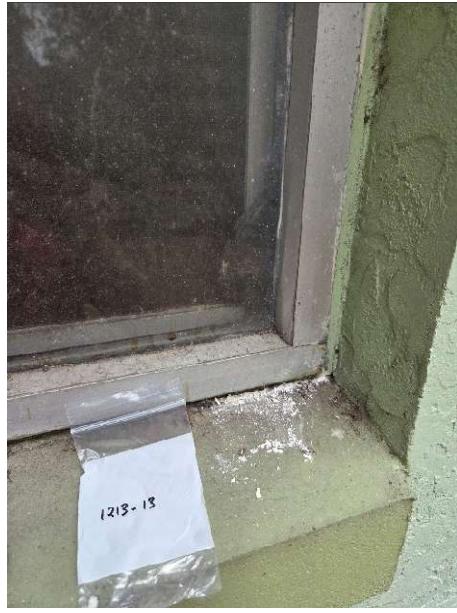
Sample 1213-13  
Typical Exterior Caulking Sample

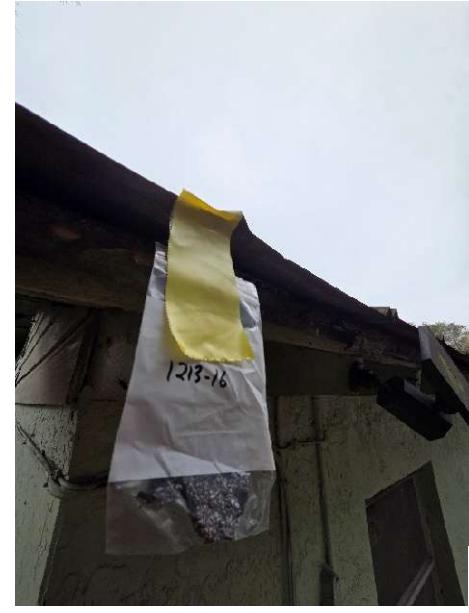
Sample 1213-16  
Asphalt Roofing Sample

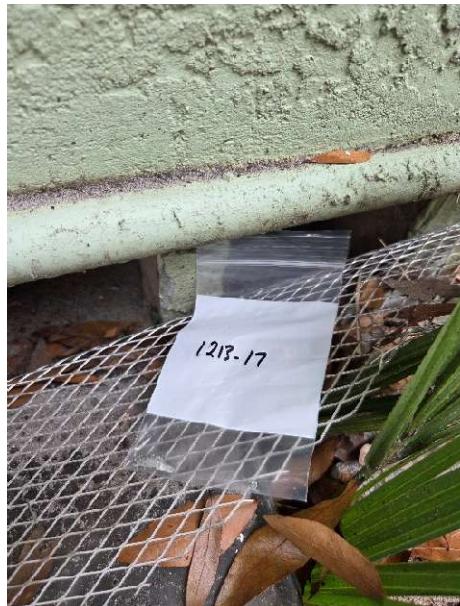
Sample 1213-17  
CMU Block Sample

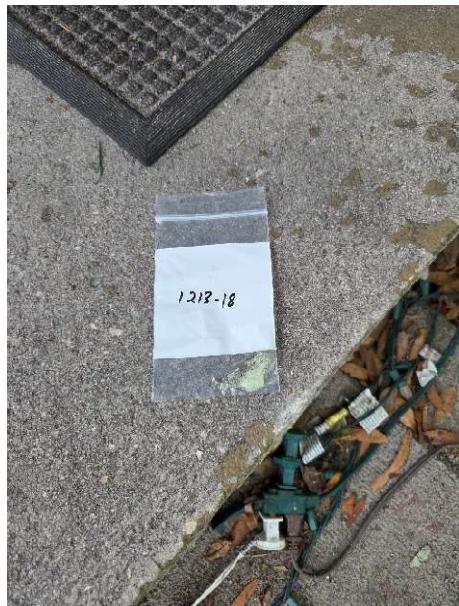
Sample 1213-18  
Concrete Sample
