Asbestos Survey for Renovation-House
Keysha Brathwaite
2832 NE 18th Ct.
Ocala, FL 34470

Exhibit D - Asbestos Survey Report

Asbestos Survey for Renovation-House

Keysha Brathwaite
2832 NE 18th Ct.
Ocala, FL 34470

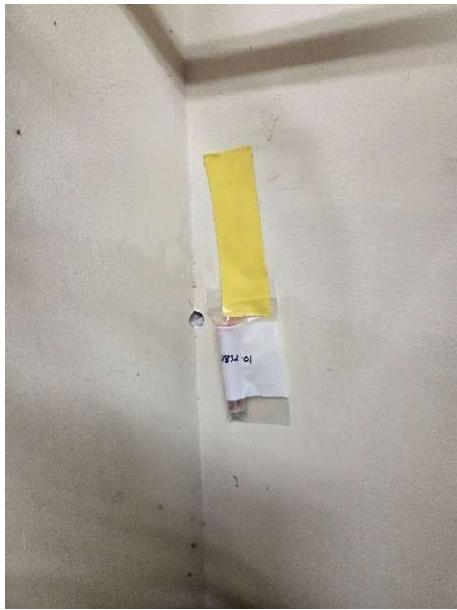
Sample 2832-01
Typical Drywall Sample

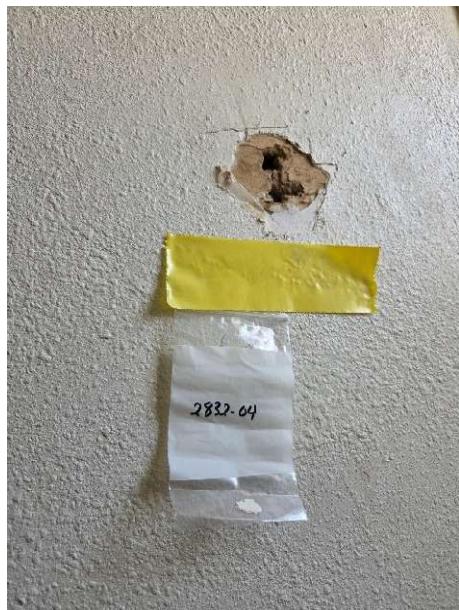
Sample 2832-04
Typical Wall Texture Sample

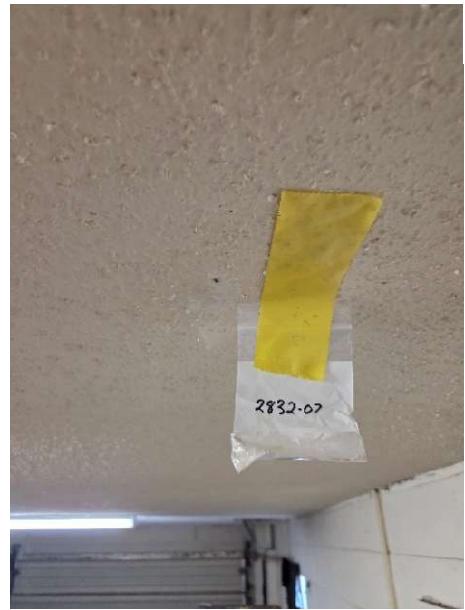
Sample 2832-07
Typical Popcorn Ceiling Texture Sample

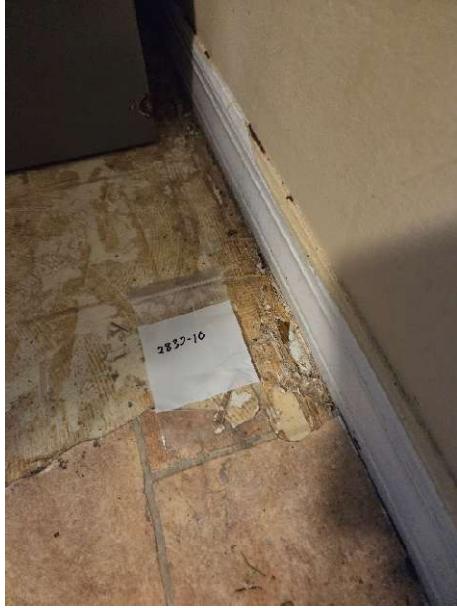
Sample 2832-10
Typical Rolled Vinyl Flooring
(Tan) Sample

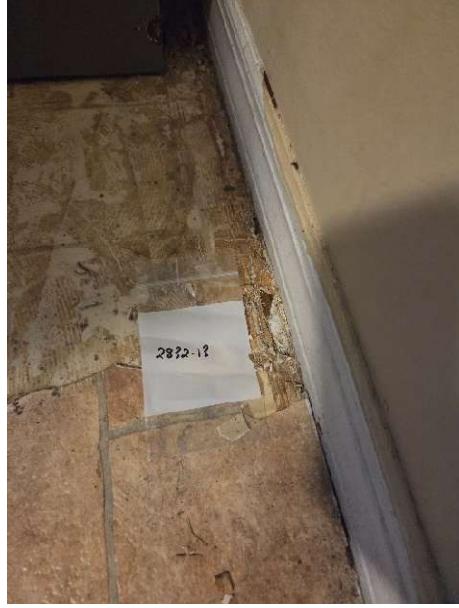
Sample 2832-13
Typical Rolled Vinyl Flooring
(Off-White) Sample

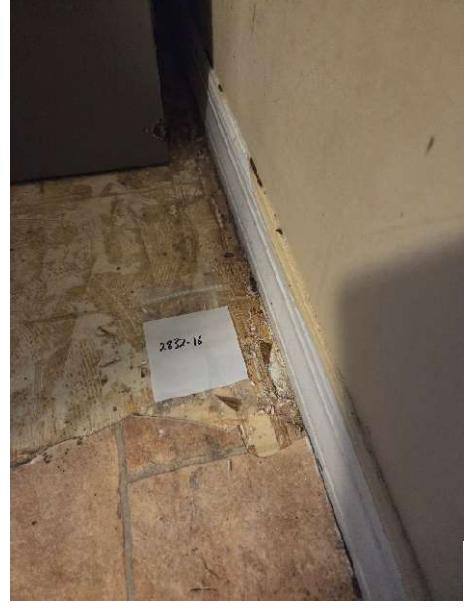
Sample No.	Location	Asbestos Component	Asbestos Qty	Friable	Amount
2832-16	Kitchen	Rolled Vinyl Flooring (Brown)	18% Chrysotile	No	+/- 200 Ft ²

1. Non-Friable Asbestos Containing Material was detected in the Rolled Vinyl Flooring.

Sample 2832-16
Typical Rolled Vinyl Flooring
(Brown) Sample

Abate all Non-Friable Asbestos Containing Material prior to any renovation that may impact the Rolled Vinyl Flooring. Abatement should be performed by a Florida Licensed Asbestos Abatement Contractor.

Non-Friable Asbestos Containing Material was detected in the Rolled Vinyl Flooring. The EPA NESHAP (40 CFR Part 61, Appendix A to Subpart M) classifies these materials as a Category I, non-friable ACM. Removal is not required by NESHAP provided the renovation activities do not subject this material to cutting, sanding, grinding, abrading, or otherwise rendering them friable during renovation.

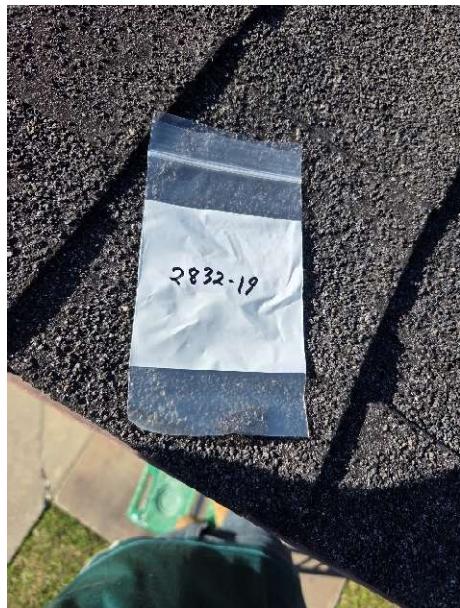
Sample 2832-19
Asphalt Roofing Sample

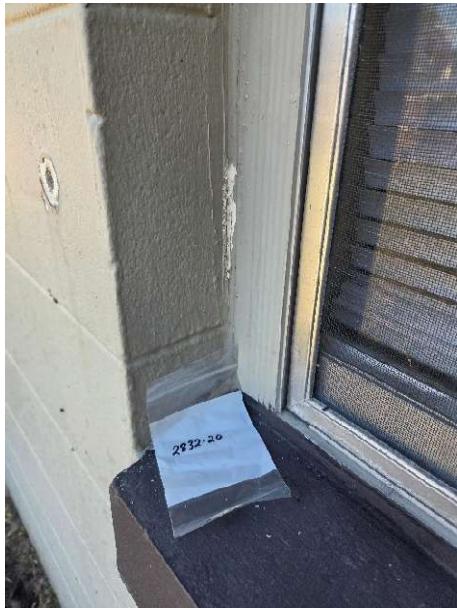
Sample 2832-20
Typical Exterior Caulking
Sample

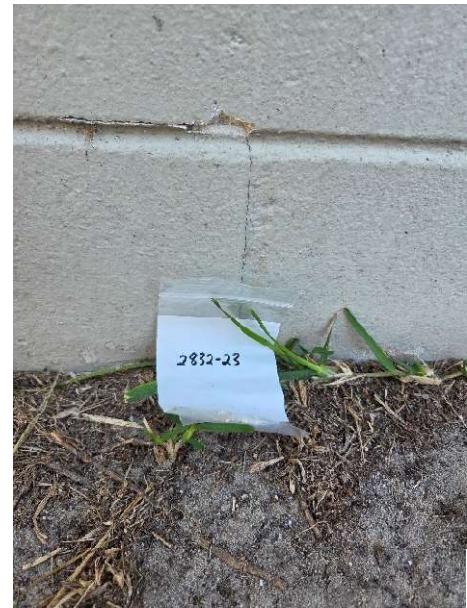
Sample 2832-23
CMU Block Sample

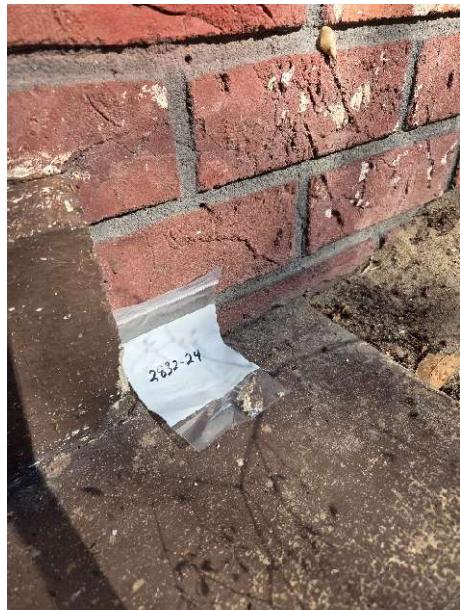
Sample 2832-24
Concrete Sample
