Asbestos Survey for Renovation-House

Mary C. & Roy A. Stokes  
2905 NW 4<sup>th</sup> Ave.  
Ocala, FL 34475

City of Ocala  
Community Development Services Department  
201 SE 3<sup>rd</sup> St.  
Ocala, FL 34471

Asbestos Survey for Renovation-House  
Mary C. & Roy A. Stokes  
2905 NW 4<sup>th</sup> Ave.  
Ocala, FL 34475

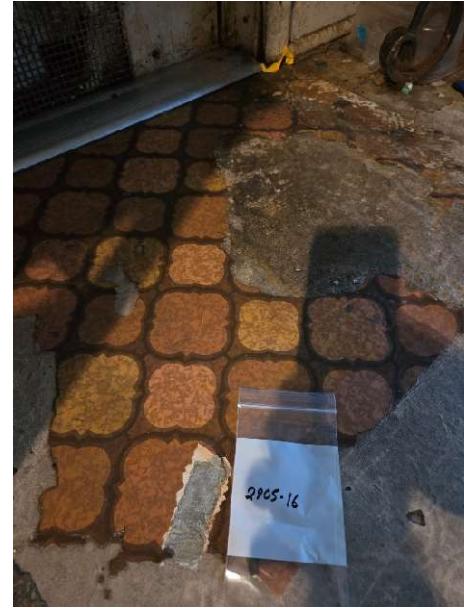
**Sample 2905-16**  
Typical Rolled Vinyl Flooring Sample

Sample No.	Location	Asbestos Component	Asbestos Qty	Friable	Amount
2905-16	Kitchen, dining	<b>Rolled Vinyl Flooring (Brown)</b>	20% Chrysotile	No	+/- 200 Ft <sup>2</sup>

1. Non-Friable Asbestos Containing Material was detected in the Rolled Vinyl Flooring.

Non-Friable Asbestos Containing Material was detected in the Rolled Vinyl Flooring. The EPA NESHAP (40 CFR Part 61, Appendix A to Subpart M) classifies these materials as a Category I, non-friable ACM. Removal is not required by NESHAP provided the renovation activities do not subject this material to cutting, sanding, grinding, abrading, or otherwise rendering them friable during renovation.

Abate all Non-Friable Asbestos Containing Material prior to any renovation that may impact the Rolled Vinyl Flooring. Abatement should be performed by a Florida Licensed Asbestos Abatement Contractor.
