**LEAD-BASED PAINT
RISK ASSESSMENT REPORT**

1010 SW 5th Street
Ocala, FL 34471

PERFORMED ON:
August 13, 2024

Re: Lead-Based Paint Inspection/Risk Assessment Report

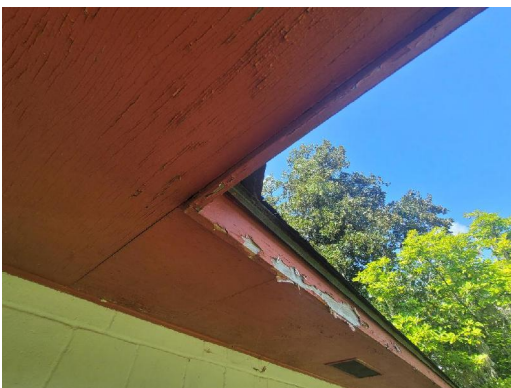
Exterior(001) A-Wall
Wood Soffit, Fascia
Lead-Positive, Deteriorated
(Typical Exterior)

- Option A. Paint film stabilization of all lead positive components by application of 1 coat of Kilz primer or equivalent over a LSWP prepared surface and 2 top coats of exterior exposure residential paint following manufacturer’s recommendations. Color chosen by owner. (IC)
- Option B. Enclosure of all lead-positive components with metal coil stock using LSWP.
- Option C. Encapsulation of lead-positive components by application of LBC (Lead Barrier Compound) over a LSWP prepared surface.
- Option D. Removal of lead-positive components and replacement with material similar in appearance, composition and finish using LSWP.
- Option E. Remove lead-based paint chemically and repaint using LSWP.

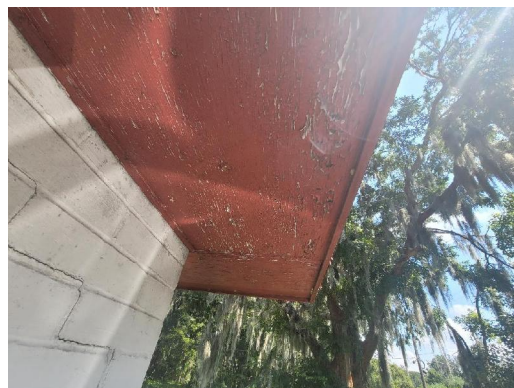
Exterior(001) B-Wall
Wood Soffit
Lead-Positive, Deteriorated
(Typical Exterior)

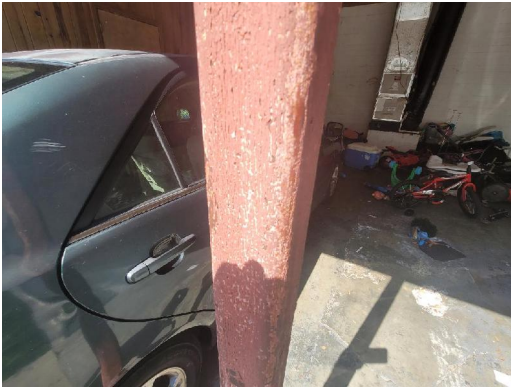
Exterior(001) B-Wall, Right
Metal Post
Lead-Positive, Deteriorated

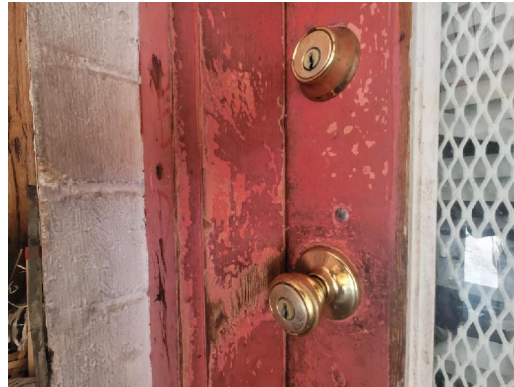
Exterior(001) B-Wall, Right
Wood Door Jamb
Lead-Positive, Deteriorated

- Option A. Friction control and paint film stabilization of lead-positive door components by application of 1 coat of Kilz primer or equivalent over a LSWP prepared surface and 2 top coats of exterior exposure residential paint following manufacturer’s recommendations. Color chosen by owner. (IC)
- Option B. Remove lead-positive components and install a new steel insulated door including new jambs, casing, and threshold using LSWP.
- Option C. Remove lead-based paint chemically and repaint using LSWP.

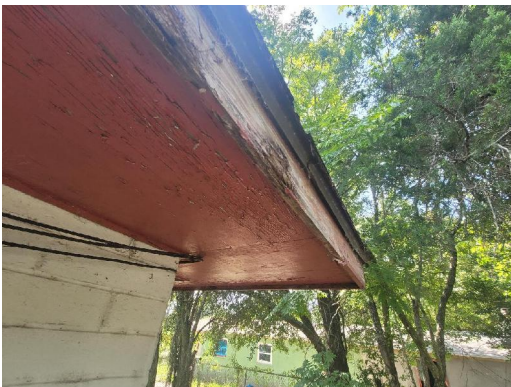
Exterior(001) D-Wall
Wood Soffit, Fascia
Lead-Positive, Deteriorated
(Typical Exterior)
