MOLD ASSESSMENT REPORT

Ava Clarke
2612 NE 22nd Avenue
Ocala, FL 34470
352-456-1040

July 02, 2024

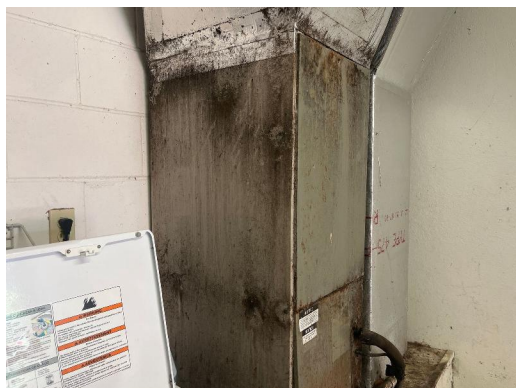
Interior Garage
HVAC air handler, duct
Visible microbial growth (>10 sq ft)

- Inspection and cleaning of the HVAC system(s), including air handler(s), ductwork, vents, filters, exhaust systems, etc., by a licensed and insured HVAC contractor is recommended.
-
- Post-remediation clearance evaluation should be performed by a Florida-licensed Mold Assessor.
 - Following post-remediation clearance evaluation, disassemble and bag containment materials. Dispose of containment materials according to proper disposal protocol.
-

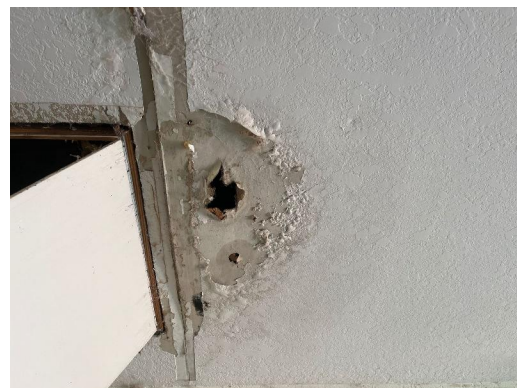
Interior Garage
West drywall ceiling
Visible water damage
Visible microbial growth (>10 sq ft)

- Remove all affected wood baseboard.
 - Remove all affected drywall ceiling and walls.
 - Remove all affected insulation, if applicable.
 - Properly bag and dispose of all contaminated waste materials.
 - Treat and encapsulate all newly-exposed framing components with two coats of an EPA-registered mold resistant coating to prevent mold growth, if applicable.
-

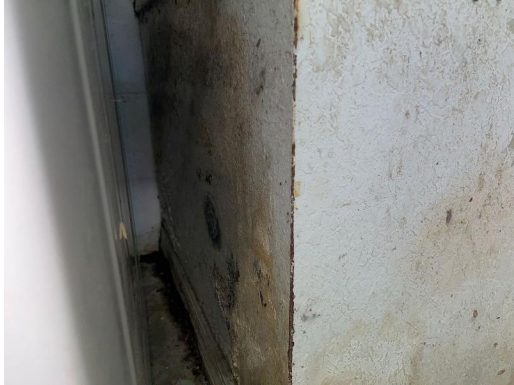
Interior Garage
North drywall wall
Visible water damage
Visible microbial growth (>10 sq ft)

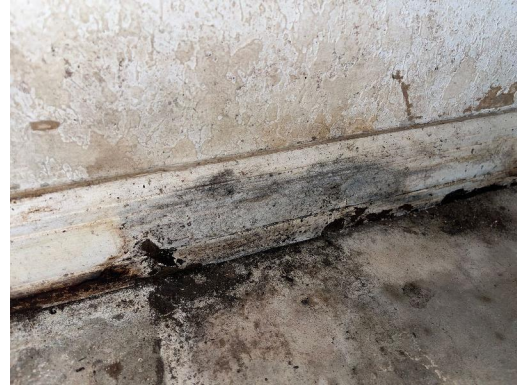
Interior Garage
West lower drywall, wood baseboard
Visible water damage
Visible microbial growth (>10 sq ft)

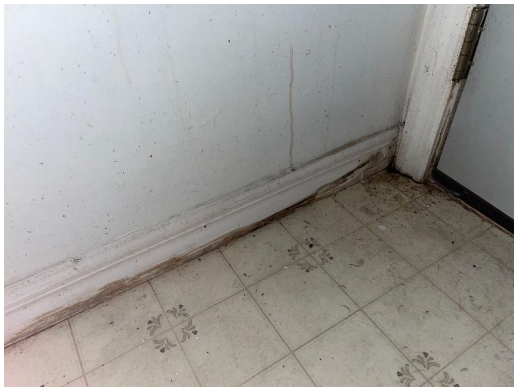
Interior Kitchen
East lower drywall, wood baseboard
Visible water damage
Visible microbial growth (>10 sq ft)

- Remove all affected wood baseboard.
- Remove all affected drywall. Drywall should be removed to a minimum of two feet (2') from floor level. This height may increase depending on the scope of affected areas discovered during the remediation process.
- Properly bag and dispose of all contaminated waste materials.
- Treat and encapsulate all newly-exposed framing components with two coats of an EPA-registered mold resistant coating to prevent mold growth, if applicable.

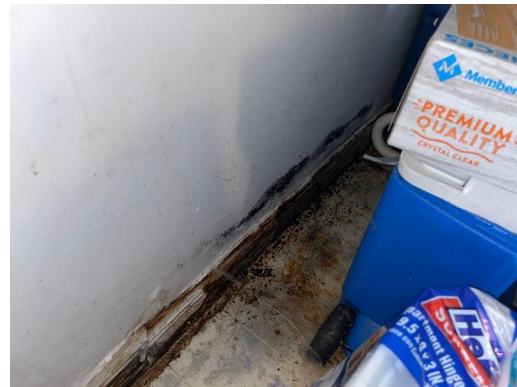
Interior Kitchen
South lower drywall, wood baseboard
Visible water damage
Visible microbial growth (>10 sq ft)

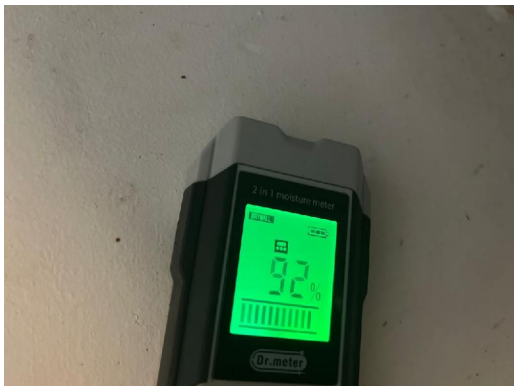
Interior Room Name	Drying Standard	Location	Moisture Content (%)
Kitchen	>15%	South lower drywall wall	92

Interior Kitchen
South lower drywall wall
Elevated moisture content (92%)

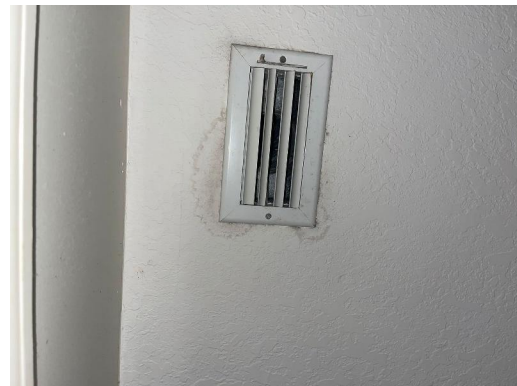
Interior Hall Bathroom
West drywall ceiling
Visible water damage
Visible microbial growth

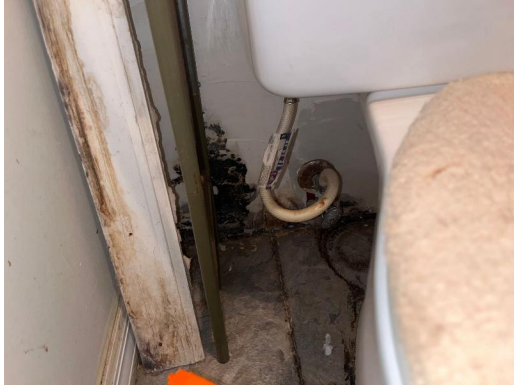
Interior Master Bathroom
West lower drywall, wood baseboard
Visible water damage
Visible microbial growth (>10 sq ft)

- Remove all affected wood baseboard.
 - Remove all affected drywall ceiling and walls.
 - Properly bag and dispose of all contaminated waste materials.
 - Treat and encapsulate all newly-exposed framing components with two coats of an EPA-registered mold resistant coating to prevent mold growth, if applicable.
-

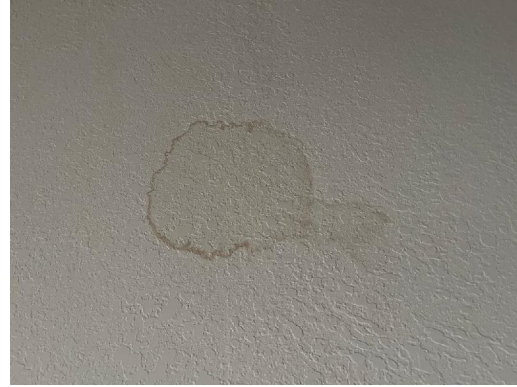
Interior Master Bedroom
West drywall ceiling
Visible water damage

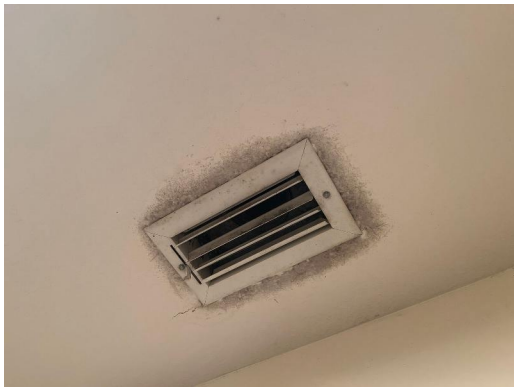
Interior Master Bedroom
Drywall ceiling, metal HVAC vent
Visible microbial growth
