December 11, 2025

Client: City of Ocala
Community Development Services Department
201 SE 3rd St.
Ocala, FL 34471

Project: LEAD - BASED PAINT INSPECTION REPORT
Mary C. & Roy A. Stokes
2905 NW 4th Ave.
Ocala, FL 34475

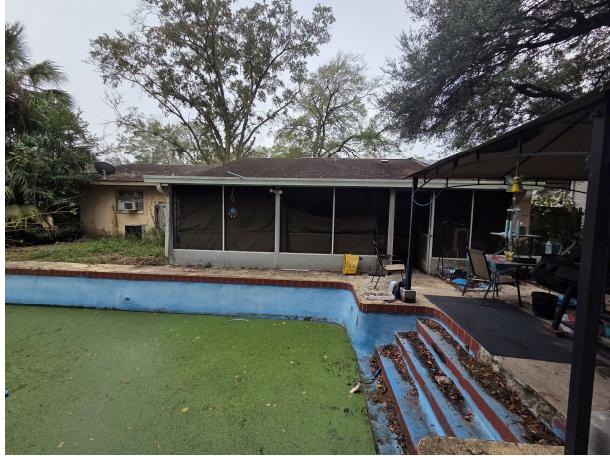
Side C

- All windows are aluminum with marble sills.
- Exterior Side C-Porch building components are factory finished.
- No access to rooms 8 & 9, (Dogs). All painted building components in rooms 8 & 9 are assumed to be painted with Lead-Based Paint unless tested.
