## ASBESTOS SURVEY REPORT

1560 NW 14th Street  
Ocala, FL 34475

April 19, 2024

On April 19, 2024 an Asbestos Survey was performed at 1560 NW 14th Street, Ocala, FL 34475. The property is a single-family detached dwelling. It is approximately 1,092 square feet and was constructed in 2011.

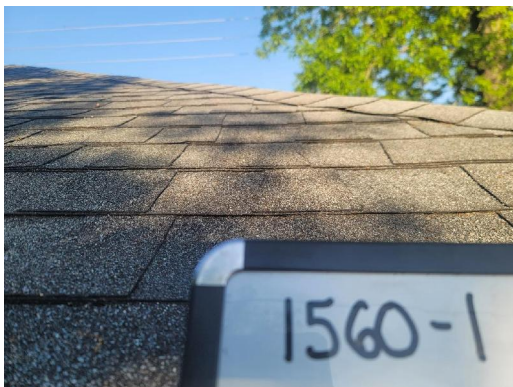
| <b><i>Bulk Collection and Sample Analysis Results</i></b> | | | | | | |
|---|---|---|---|---|---|---|
| 1560-1-1 | Asphalt Shingle/Black | Intact | No | None Detected | Typical Exterior Roof | NA |
| 1560-1-2 | Asphalt Shingle/Black | Intact | No | None Detected | Typical Exterior Roof | NA |
| 1560-1-2 | Flashing/Black | Intact | No | None Detected | Typical Exterior Roof | NA |

1560-1  
Asphalt Shingle/Flashing  
Typical Exterior Roof

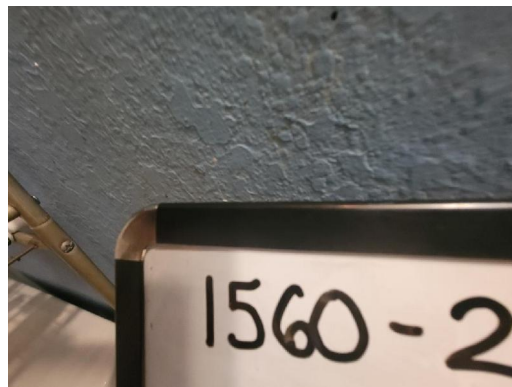
| <b><i>Bulk Collection and Sample Analysis Results</i></b> | | | | | | |
|---|---|---|---|---|---|---|
| 1560-2-1 | Joint Compound/White | Intact | No | None Detected | Typical Interior Walls/Ceilings | NA |
| 1560-2-1 | Drywall/White/Brown | Intact | No | None Detected | Typical Interior Walls/Ceilings | NA |
| 1560-2-2 | Joint Compound/White | Intact | No | None Detected | Typical Interior Walls/Ceilings | NA |
| 1560-2-2 | Drywall Mud/White | Intact | No | None Detected | Typical Interior Walls/Ceilings | NA |
| 1560-2-3 | Joint Compound/White | Intact | No | None Detected | Typical Interior Walls/Ceilings | NA |
| 1560-2-3 | Drywall Mud/White | Intact | No | None Detected | Typical Interior Walls/Ceilings | NA |

1560-2  
Joint Compound/Drywall  
Typical Interior Walls/Ceilings
