## ASBESTOS SURVEY REPORT

110 SW 24th Avenue  
Ocala, FL 34475

May 05, 2025

Chris Ritko  
Asbestos Building Inspector  
196473

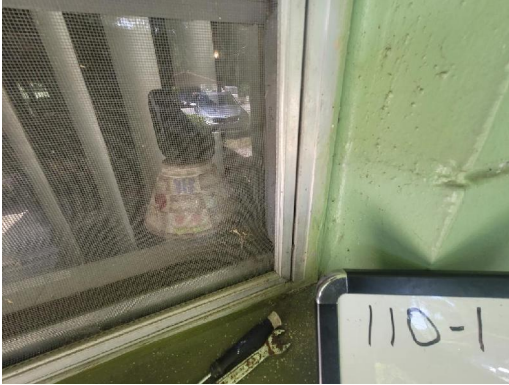
110-1  
Caulk  
Typical Exterior Windows

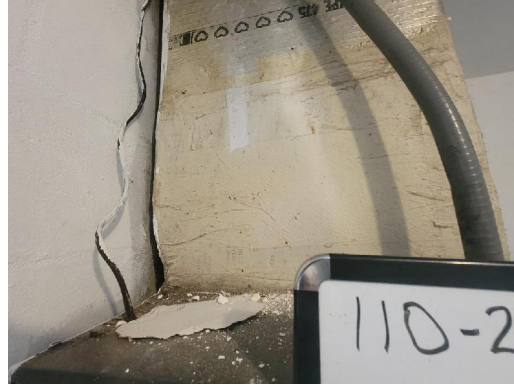
110-2  
Duct Mastic  
Typical Interior HVAC

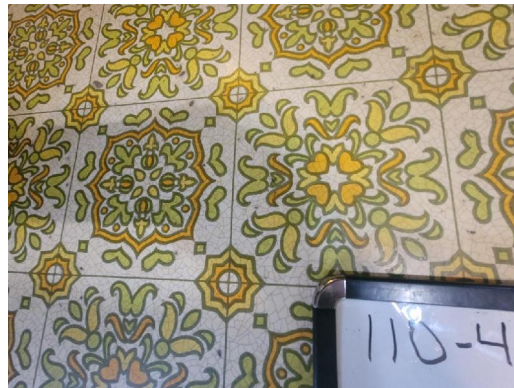
110-4  
Rolled Flooring (20% Chrysotile)  
Interior Kitchen  
(Appx 200 sq ft)

The 12" x 12" Vinyl Floor Tile (VFT), rolled vinyl flooring, and mastics associated with VFTs are NESHAP Category I non-friable ACMs. NESHAP Category I non-friable ACMs are not required to be removed prior to demolition of the building, provided that wet-demolition practices are implemented during renovations and resulting debris from the structure is properly transported to a landfill permitted for disposal of ACM. If NESHAP Category I non-friable ACMs are in poor condition and become friable during demolition, the material must be treated as a RACM and be removed by a licensed asbestos abatement contractor and disposed of at a class one landfill prior to renovation, remodeling, or demolition of the building.

If asbestos containing materials identified within, or on, the property will be disturbed or otherwise caused to become friable within the scope of the renovation, they should be removed from the structures prior to the maneuvers taking place according to applicable regulations.

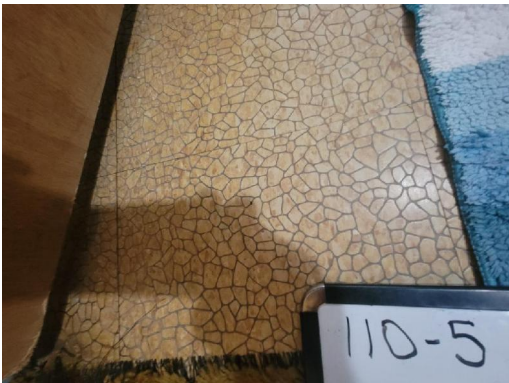
<b>110-5-1</b>	<b>12"x12" Floor Tile/ Tan/Pink</b>	<b>Intact</b>	<b>No</b>	<b>2% Chrysotile</b>	<b>Interior Bathroom/Hall (Appx 180 sq ft)</b>	<b>Category I</b>
<b>110-5-1</b>	<b>Mastic/Black</b>	<b>Intact</b>	<b>No</b>	<b>4% Chrysotile</b>	<b>Interior Bathroom/Hall (Appx 180 sq ft)</b>	<b>Category I</b>
<b>110-5-2</b>	<b>12"x12" Floor Tile/ Tan/Pink</b>	<b>Intact</b>	<b>No</b>	<b>Not Analyzed/ Positive Stop</b>	<b>Interior Bathroom/Hall (Appx 180 sq ft)</b>	<b>Category I</b>
<b>110-5-2</b>	<b>Mastic/Black</b>	<b>Intact</b>	<b>No</b>	<b>Not Analyzed/ Positive Stop</b>	<b>Interior Bathroom/Hall (Appx 180 sq ft)</b>	<b>Category I</b>
110-6-1	12"x12" Floor Tile/ Brown/Black	Intact	No	None Detected	Interior Bedroom B	NA
110-6-1	Adhesive/Clear	Intact	No	None Detected	Interior Bedroom B	NA
110-6-2	12"x12" Floor Tile/ Brown/Black	Intact	No	None Detected	Interior Bedroom B	NA
110-6-2	12"x12" Floor Tile/ Brown/Black	Intact	No	None Detected	Interior Bedroom B	NA

110-5  
12"x12" Floor Tile (2% Chrysotile)  
Mastic (4% Chrysotile)  
Interior Bathroom/Hall  
(Appx 180 sf)

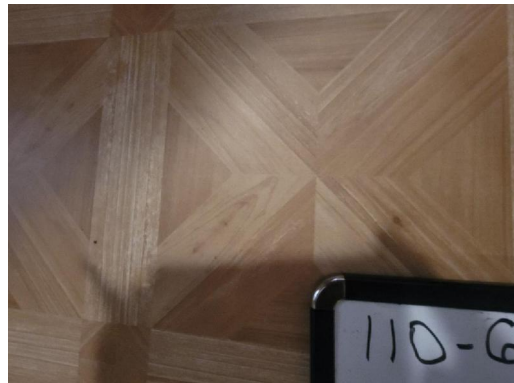
110-6  
12"x12" Floor Tile/Adhesive  
Interior Bedroom B

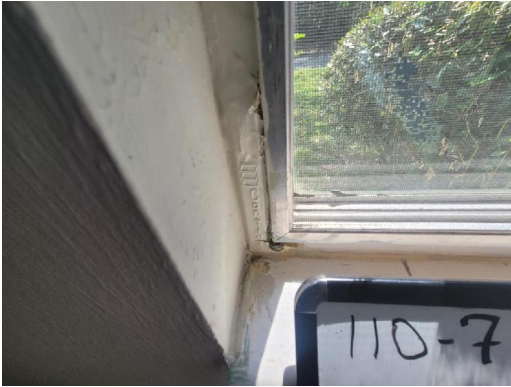
110-7-1	Caulk/Cream	Intact	No	None Detected	Typical Interior Windows	NA
110-7-1	Fibrous Wrap/Cream	Intact	No	None Detected	Typical Interior Windows	NA
110-7-1	Adhesive/Yellow	Intact	No	None Detected	Typical Interior Windows	NA
110-7-2	Caulk/Cream	Intact	No	None Detected	Typical Interior Windows	NA

110-7  
Caulk/Wrap/Adhesive  
Typical Interior Windows

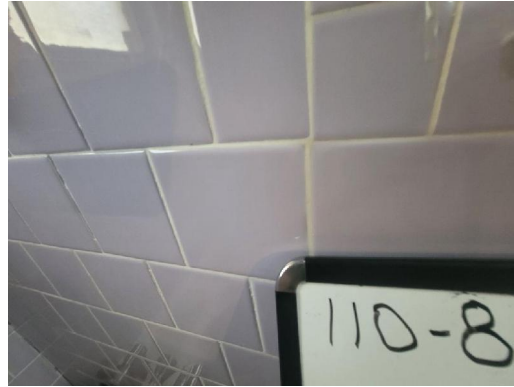
<i>Sample Number</i>	<i>Description</i>	<i>Condition</i>	<i>Friable</i>	<i>Asbestos Percent and Type</i>	<i>Location/ Amount</i>	<i>NESHAP Category</i>
110-8-1	Grout/White	Intact	No	None Detected	Interior Bathroom Tile Walls	NA
110-8-2	Grout/White	Intact	No	None Detected	Interior Bathroom Tile Walls	NA

110-8  
Grout  
Interior Bathroom Wall Tile
