## ASBESTOS SURVEY REPORT

2109 SW 6th Street  
Ocala, FL 34471

January 29, 2025

On January 29, 2025 an Asbestos Survey was performed at 2109 SW 6th Street, Ocala, FL 34471. The property is a single-family detached dwelling. It is approximately 936 square feet and was constructed in 1970.

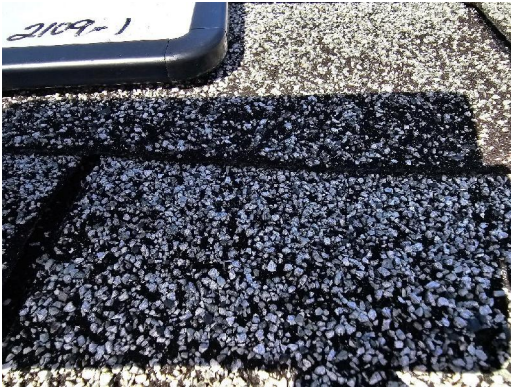
2109-1  
Asphalt Shingle  
Typical Exterior Roof

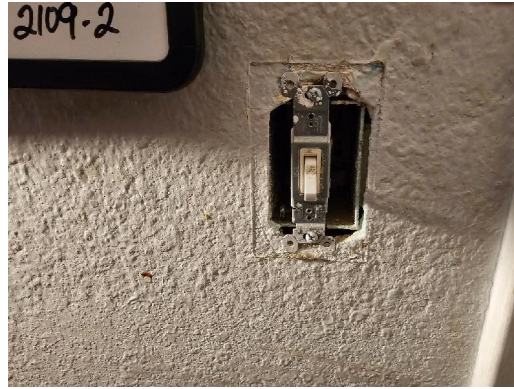
2109-2  
Drywall/Joint Compound  
Typical Interior

TBG recommends that HA-2109-2 be considered an ACM and treated as a National Emission Standard for Hazardous Air Pollutants (NESHAP) Category II non-friable ACM. NESHAP Category II non-friable ACMs must be evaluated on a case-by-case basis. If NESHAP Category II non-friable ACMs are likely to become crushed, pulverized or reduced to powder during renovation activities, they should be removed by a licensed asbestos abatement contractor and disposed of at a class one landfill prior to renovation, remodeling, or demolition of the building. If NESHAP Category II non-friable ACMs are in poor condition and become friable during demolition, the material must be treated as a Regulated Asbestos Containing Material (RACM) and be removed by a licensed asbestos abatement contractor and disposed of at a class one landfill prior to renovation, remodeling, or demolition of the building.

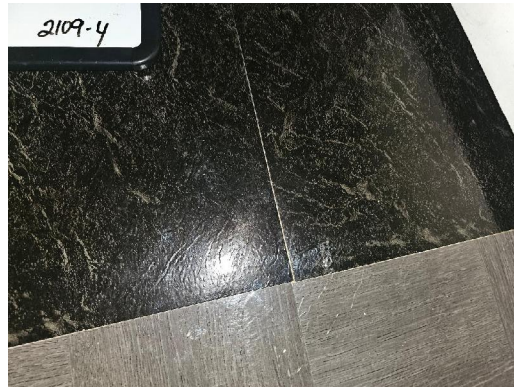
2109-4-1	12"x12" Floor Tile/Black	Intact	No	None Detected	Typical Interior	NA
2109-4-1	Adhesive/Clear	Intact	No	None Detected	Typical Interior	NA
2109-4-2	12"x12" Floor Tile/Black	Intact	No	None Detected	Typical Interior	NA

2109-4  
12"x12" Floor Tile/Adhesive  
Typical Interior

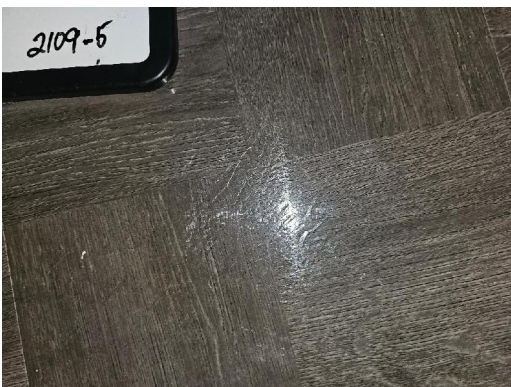
2109-5  
12"x12" Floor Tile/Adhesive  
Typical Interior

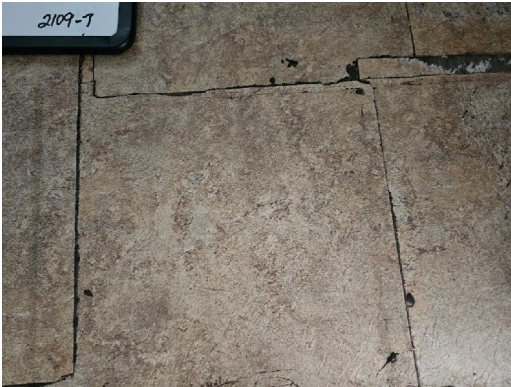
<b>2109-7-1</b>	<b>12"x12" Floor Tile/Cream</b>	<b>Intact</b>	<b>No</b>	<b>2% Chrysotile</b>	<b>Typical Interior (Appx 40 sq ft)</b>	<b>Category I</b>
2109-7-1	Adhesive/Clear	Intact	No	None Detected	Typical Interior	NA
<b>2109-7-2</b>	<b>12"x12" Floor Tile/Cream</b>	<b>Intact</b>	<b>No</b>	<b>Not Analyzed/ Positive Stop</b>	<b>Typical Interior (Appx 40 sq ft)</b>	<b>Category I</b>
2109-7-2	Adhesive/Clear	Intact	No	None Detected	Typical Interior	NA
2109-8-1	12"x12" Floor Tile/Brown	Intact	No	None Detected	Typical Interior	NA
2109-8-1	Adhesive/Clear	Intact	No	None Detected	Typical Interior	NA
2109-8-2	12"x12" Floor Tile/ Brown	Intact	No	None Detected	Typical Interior	NA
2109-8-2	Adhesive/Clear	Intact	No	None Detected	Typical Interior	NA

2109-7  
12"x12" Floor Tile (2% Chrysotile)  
Typical Interior  
(Appx 40 sq ft)

12" x 12" Vinyl Floor Tile (VFT) are National Emission Standard for Hazardous Air Pollutants (NESHAP) Category I non-friable ACMs. NESHAP Category I non-friable ACMs are not required to be removed prior to demolition of the building, provided that wet-demolition practices are implemented during renovations and resulting debris from the structure is properly transported to a landfill permitted for disposal of ACM. If NESHAP Category I non-friable ACMs are in poor condition and become friable during demolition, the material must be treated as a Regulated Asbestos Containing Material (RACM) and be removed by a licensed asbestos abatement contractor and disposed of at a class one landfill prior to renovation, remodeling, or demolition of the building.

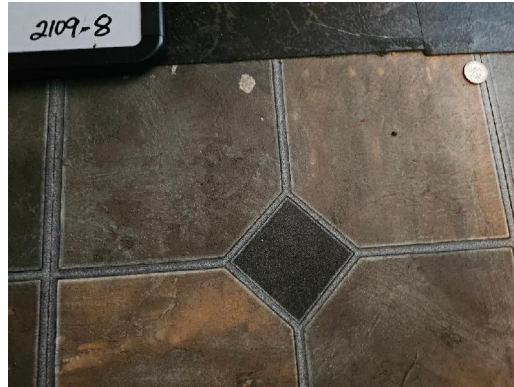
2109-8  
12"x12" Floor Tile/Adhesive  
Typical Interior
