## ASBESTOS SURVEY REPORT

2715 NE 22nd Avenue  
Ocala, FL 34470

October 09, 2025

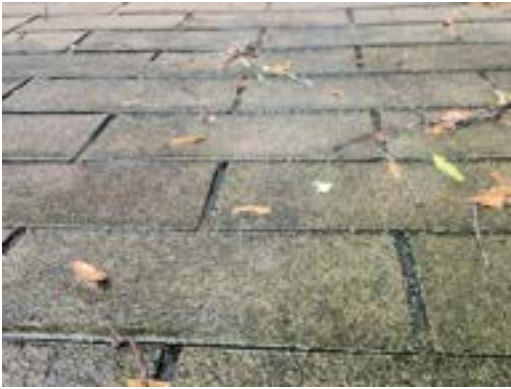
| <b>Bulk Collection and Sample Analysis Results</b> | | | | | | |
|---|---|---|---|---|---|---|
| 2715-1-1 | Asphalt Shingle/Black | Intact | No | None Detected | Typical Exterior Roof | NA |
| 2715-1-1 | Tar/Black | Intact | No | None Detected | Typical Exterior Roof | NA |
| 2715-1-2 | Asphalt Shingle/Black | Intact | No | None Detected | Typical Exterior Roof | NA |
| 2715-1-2 | Tar/Black | Intact | No | None Detected | Typical Exterior Roof | NA |

2715-1  
Asphalt Shingle/Tar  
Typical Exterior Roof

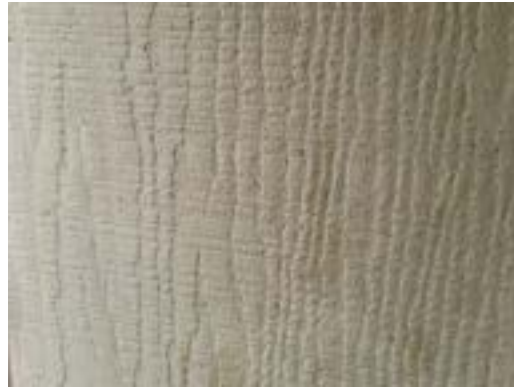
| <b>Bulk Collection and Sample Analysis Results</b> | | | | | | |
|---|---|---|---|---|---|---|
| 2715-2-1 | Siding/Brown | Intact | No | None Detected | Typical Exterior Walls | NA |
| 2715-2-2 | Siding/Brown | Intact | No | None Detected | Typical Exterior Walls | NA |

2715-2  
Siding  
Typical Exterior Walls

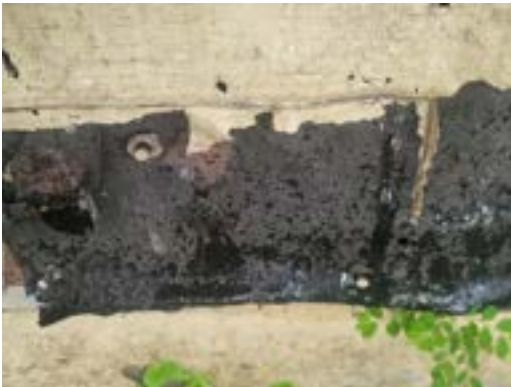
| <b>Bulk Collection and Sample Analysis Results</b> | | | | | | |
|---|---|---|---|---|---|---|
| 2715-3-1 | House Wrap/Tar Paper/ Black | Intact | No | None Detected | Typical Exterior Walls | NA |
| 2715-3-2 | House Wrap/Tar Paper/ Black | Intact | No | None Detected | Typical Exterior Walls | NA |

2715-3  
House Wrap/Tar Paper  
Typical Exterior Walls

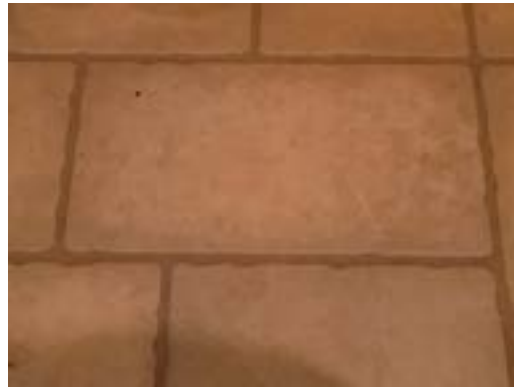
| <b>Bulk Collection and Sample Analysis Results</b> | | | | | | |
|---|---|---|---|---|---|---|
| 2715-4-1 | Rolled Flooring/White | Intact | No | None Detected | Interior Kitchen/Front Entry | NA |
| 2715-4-2 | Rolled Flooring/White | Intact | No | None Detected | Interior Kitchen/Front Entry | NA |

2715-4  
Rolled Flooring  
Interior Kitchen/Front Entry

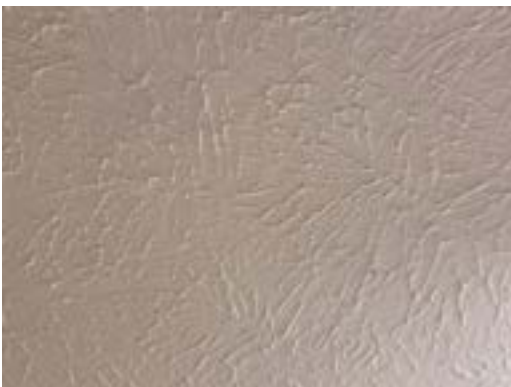
| <b>Bulk Collection and Sample Analysis Results</b> | | | | | | |
|---|---|---|---|---|---|---|
| 2715-5-1 | Ceiling Texture/White | Intact | No | <b>None Detected</b> | Typical Interior | NA |

| <i>Sample Number</i> | <i>Description</i> | <i>Condition</i> | <i>Friable</i> | <i>Asbestos Percent and Type</i> | <i>Location/ Amount</i> | <i>NESHAP Category</i> |
|---|---|---|---|---|---|---|
| 2715-5-2 | Ceiling Texture/White | Intact | No | None<br><b>Detected</b> | Typical Interior | NA |
| 2715-5-3 | Ceiling Texture/White | Intact | No | None<br><b>Detected</b> | Typical Interior | NA |

2715-5  
Ceiling Texture  
Typical Interior

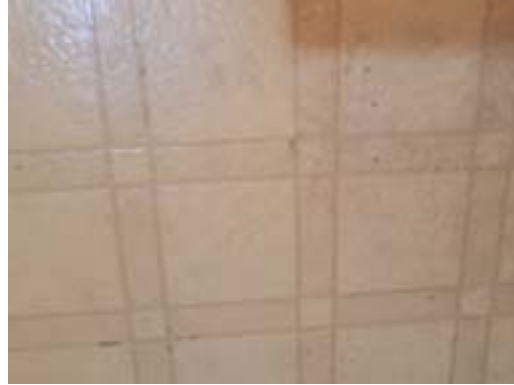
| <i>Sample Number</i> | <i>Description</i> | <i>Condition</i> | <i>Friable</i> | <i>Asbestos Percent and Type</i> | <i>Location/ Amount</i> | <i>NESHAP Category</i> |
|---|---|---|---|---|---|---|
| 2715-8-1 | Mastic/Beige | Intact | No | None<br><b>Detected</b> | Interior Hall Bathroom | NA |
| 2715-8-1 | Rolled Flooring/Cream | Intact | No | None<br><b>Detected</b> | Interior Hall Bathroom | NA |
| 2715-8-2 | Mastic/Beige | Intact | No | None<br><b>Detected</b> | Interior Hall Bathroom | NA |

| <i>Sample Number</i> | <i>Description</i> | <i>Condition</i> | <i>Friable</i> | <i>Asbestos Percent and Type</i> | <i>Location/ Amount</i> | <i>NESHAP Category</i> |
|---|---|---|---|---|---|---|
| 2715-8-2 | Rolled Flooring/Cream | Intact | No | None<br><b>Detected</b> | Interior Hall Bathroom | NA |

2715-8  
Rolled Flooring/Mastic  
Interior Hall Bathroom

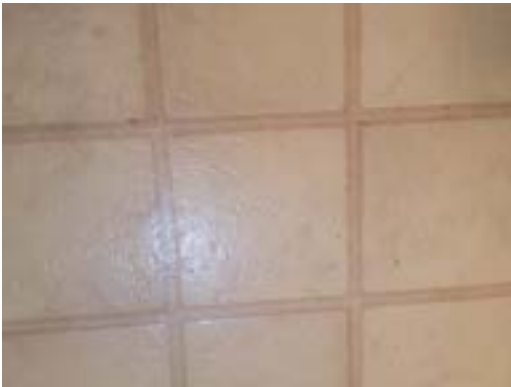
| <i>Sample Number</i> | <i>Description</i> | <i>Condition</i> | <i>Friable</i> | <i>Asbestos Percent and Type</i> | <i>Location/ Amount</i> | <i>NESHAP Category</i> |
|---|---|---|---|---|---|---|
| 2715-9-1 | Rolled Flooring/Off-White | Intact | No | None<br><b>Detected</b> | Interior Master Bathroom | NA |
| 2715-9-2 | Rolled Flooring/Off-White | Intact | No | None<br><b>Detected</b> | Interior Master Bathroom | NA |

2715-9  
Rolled Flooring  
Interior Master Bathroom

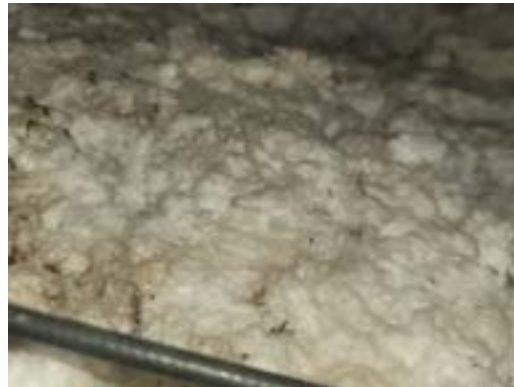
| <i>Sample Number</i> | <i>Description</i> | <i>Condition</i> | <i>Friable</i> | <i>Asbestos Percent and Type</i> | <i>Location/ Amount</i> | <i>NESHAP Category</i> |
|---|---|---|---|---|---|---|
| 2715-10-1 | Insulation/White | Intact | No | None<br><b>Detected</b> | Interior Attic Crawlspace | NA |
| 2715-10-2 | Insulation/White | Intact | No | None<br><b>Detected</b> | Interior Attic Crawlspace | NA |

2715-10  
Insulation  
Interior Attic Crawlspace

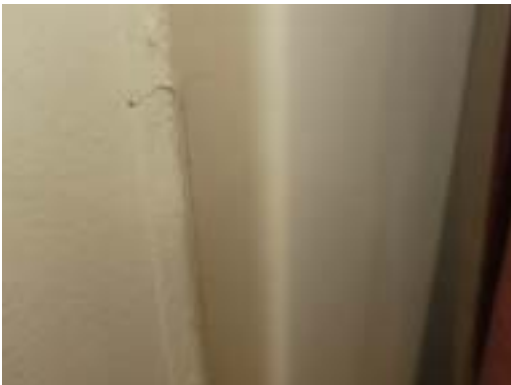
| <i>Sample Number</i> | <i>Description</i> | <i>Condition</i> | <i>Friable</i> | <i>Asbestos Percent and Type</i> | <i>Location/ Amount</i> | <i>NESHAP Category</i> |
|---|---|---|---|---|---|---|
| 2715-11-1 | Caulk/Cream | Intact | No | None<br><b>Detected</b> | Typical Interior Bathrooms/<br>Sinks/Shower | NA |
| 2715-11-2 | Caulk/Cream | Intact | No | None<br><b>Detected</b> | Typical Interior Bathrooms/<br>Sinks/Shower | NA |

2715-11  
Caulk  
Interior Bathrooms/Sinks/showers
