## ASBESTOS SURVEY REPORT

2220 NW 18th Street  
Ocala, FL 34475

## **II. SURVEY SUMMARY**

On February 25, 2025 an Asbestos Survey was performed at 2220 NW 18th Street, Ocala, FL 34475. The property is a single-family detached dwelling. It is approximately 1,192 square feet and was constructed in 1972.

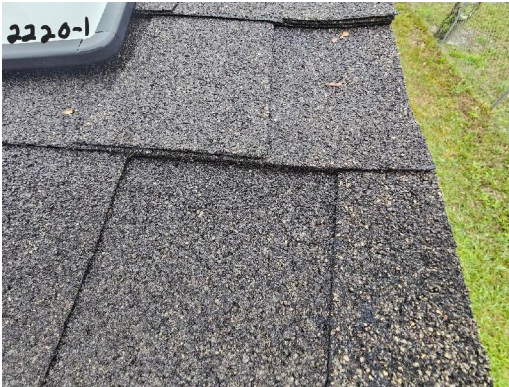
| <b>Bulk Collection and Sample Analysis Results</b> | | | | | | |
|---|---|---|---|---|---|---|
| 2220-1-1 | Asphalt Shingle/Black | Intact | No | None Detected | Typical Exterior Roof | NA |
| 2220-1-2 | Asphalt Shingle/Black | Intact | No | None Detected | Typical Exterior Roof | NA |

2220-1  
Asphalt Shingle/Tar  
Typical Exterior Roof

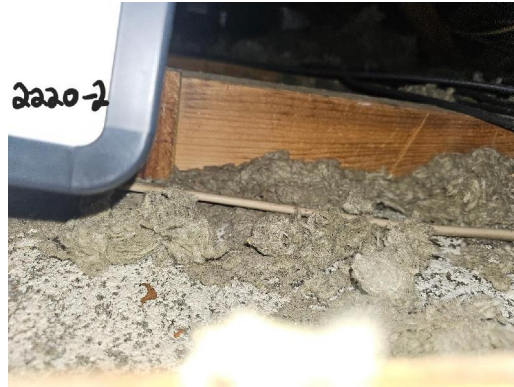
| <b>Bulk Collection and Sample Analysis Results</b> | | | | | | |
|---|---|---|---|---|---|---|
| 2220-2-1 | Insulation/Brown | Intact | No | None Detected | Typical Interior | NA |

2220-2  
Insulation/Brown  
Typical Interior

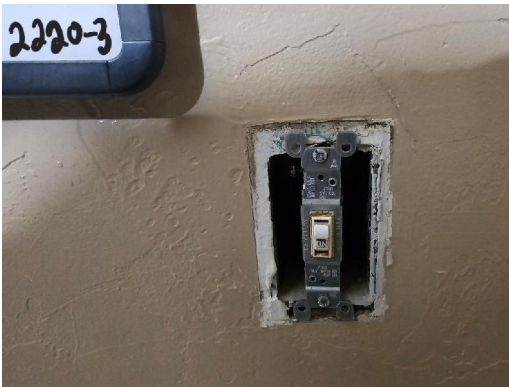
| <b>Bulk Collection and Sample Analysis Results</b> | | | | | | |
|---|---|---|---|---|---|---|
| <b>2220-3-1</b> | <b>Joint Compound/Off-White</b> | <b>Intact</b> | <b>No</b> | <b>2% Chrysotile</b> | <b>Typical Interior Walls/Ceilings</b> | <b>Category II</b> |
| <b>2220-3-2</b> | <b>Joint Compound/Off-White</b> | <b>Intact</b> | <b>No</b> | <b>Not Analyzed/ Positive Stop</b> | <b>Typical Interior Walls/Ceilings</b> | <b>Category II</b> |

2220-3  
Joint Compound (2% Chrysotile)  
Drywall  
Typical Interior Walls/Ceilings

If asbestos containing materials identified within, or on, the property will be disturbed or otherwise caused to become friable within the scope of the renovation, they should be removed from the structures prior to the maneuvers taking place according to applicable regulations.

Joint Compound is a NESHAP Category II non-friable ACM. NESHAP Category II non-friable ACMs must be evaluated on a case-by-case basis. If NESHAP Category II non-friable ACMs are likely to become crushed, pulverized or reduced to powder during renovation activities, they should be removed by a licensed asbestos abatement contractor and disposed of at a class one landfill prior to renovation, remodeling, or demolition of the building. If NESHAP Category II non-friable ACMs are in poor condition and become friable during demolition, the material must be treated as a RACM and be removed by a licensed asbestos abatement contractor and disposed of at a class one landfill prior to renovation, remodeling, or demolition of the building.

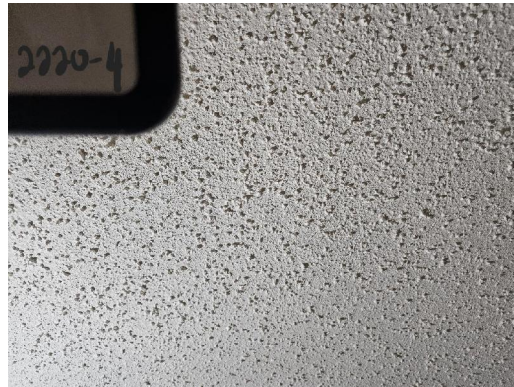
| <b>Bulk Collection and Sample Analysis Results</b> | | | | | | |
|---|---|---|---|---|---|---|
| <b>2220-4-1</b> | <b>Surfacing Texture/ Off-White</b> | <b>Intact</b> | <b>No</b> | <b>3% Chrysotile</b> | <b>Typical Interior Walls/Ceilings</b> | <b>RACM</b> |

2220-4  
Surfacing Texture (3% Chrysotile)  
Typical Interior Walls/Ceilings

The EPA and NESHAP recommend that a point-counting procedure be utilized for confirmation of asbestos percentage in friable materials that are visually estimated by PLM methodology to contain less than 10% asbestos. The 400 Point Count Procedure referenced in EPA 600/M4-82-020 (1987) and EPA 600/R-93/116 (1993) is commonly employed. Without the material being point counted or if point counting determined that material contains greater than one percent asbestos, it would be deemed an asbestos containing material and would need to be removed by a Florida licensed asbestos contractor prior to disturbance.

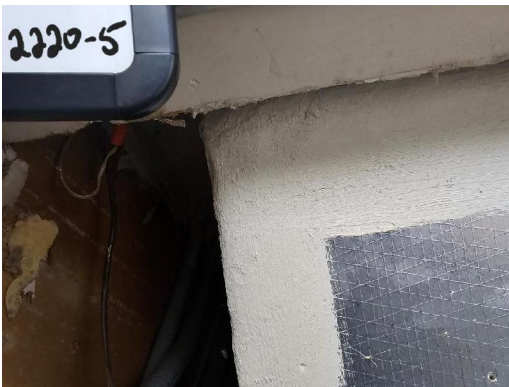
| <i>Sample Number</i> | <i>Description</i> | <i>Condition</i> | <i>Friable</i> | <i>Asbestos Percent and Type</i> | <i>Location/ Amount</i> | <i>NESHAP Category</i> |
|---|---|---|---|---|---|---|
| 2220-5-1 | Duct Mastic/White | Intact | No | None Detected | Typical Interior HVAC | NA |

Duct Mastic  
Typical Interior HVAC
