Project:  
Asbestos Survey for Demolition  
540 NW. 3<sup>rd</sup> Ave.  
Ocala, FL 34475

Client:  
City of Ocala  
Code Enforcement Department  
201 SE 3<sup>rd</sup> St.  
Ocala, FL 34471

Asbestos Survey for Demolition  
540 NW. 3<sup>rd</sup> Ave.  
Ocala, FL 34475

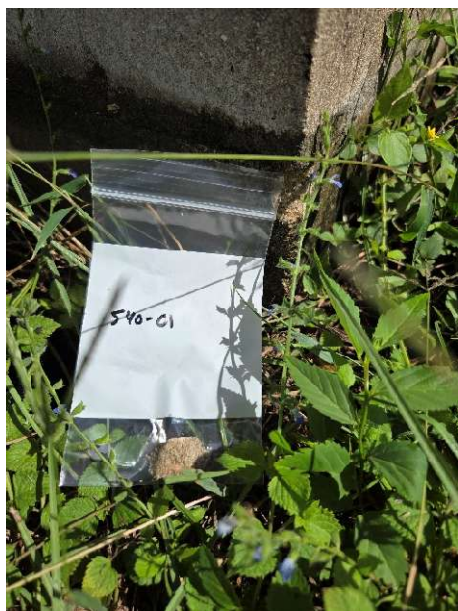
**Sample 540-01**  
**Typical CMU Block Sample**

| Lab Sample Number | Client Sample Number | Layer Type | Lab Gross Description | Asbestos | Other Materials |
|---|---|---|---|---|---|
| 25-10-02165-001 | 540-01 | | Pale Tan-Gray<br>Cementitious;<br>Homogeneous | NAD | 100% Non-Fibrous |

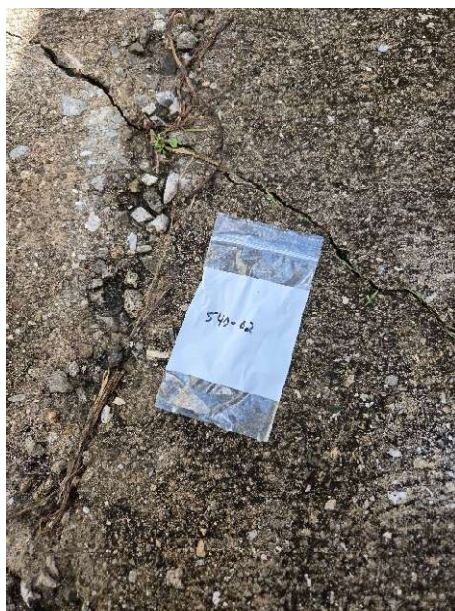
**Sample 540-02**  
**Typical Concrete Sample**

| Lab Sample Number | Client Sample Number | Layer Type | Lab Gross Description | Asbestos | Other Materials |
|---|---|---|---|---|---|
| 25-10-02165-002 | 540-02 | | Pale Tan-Gray<br>Cementitious;<br>Homogeneous | NAD | 100% Non-Fibrous |
