## ASBESTOS SURVEY REPORT

884 NW 15th Avenue  
Ocala, FL 34475

December 19, 2025

On December 19, 2025, an Asbestos Survey was performed at 884 NW 15th Avenue, Ocala, FL 34475. The property is a 2-story detached commercial building. It is approximately 1,360 square feet and was constructed in 1974.

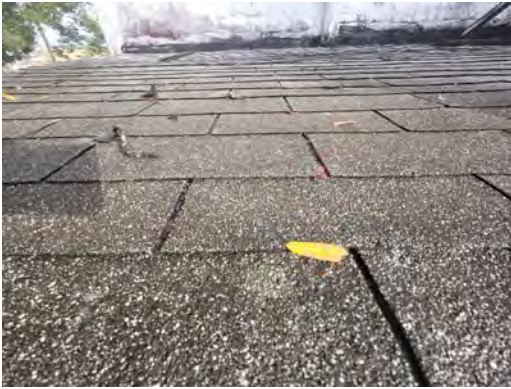
| <b>Bulk Collection and Sample Analysis Results</b> | | | | | | |
|---|---|---|---|---|---|---|
| 884-1-1 | Asphalt Shingle/Black | Intact | No | None Detected | Typical Exterior Roof | NA |
| 884-1-2 | Asphalt Shingle/Black | Intact | No | None Detected | Typical Exterior Roof | NA |

884-1  
Asphalt Shingle  
Typical Exterior Roof

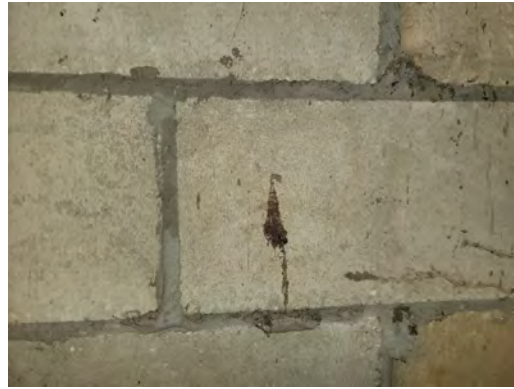
| <b>Bulk Collection and Sample Analysis Results</b> | | | | | | |
|---|---|---|---|---|---|---|
| 884-2-1 | Concrete Block/Gray | Intact | No | None Detected | Typical Walls | NA |
| 884-2-1 | Mortar/Off-White | Intact | No | None Detected | Typical Walls | NA |
| 884-2-2 | Concrete Block/Gray | Intact | No | None Detected | Typical Walls | NA |
| 884-2-2 | Mortar/Off-White | Intact | No | None Detected | Typical Walls | NA |

884-2  
Concrete Block/Mortar  
Typical Walls

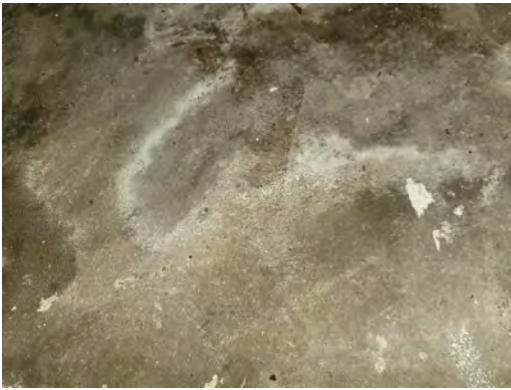
| <b>Bulk Collection and Sample Analysis Results</b> | | | | | | |
|---|---|---|---|---|---|---|
| 884-3-1 | Concrete Slab/Gray | Intact | No | None Detected | Typical Building | NA |
| 884-3-2 | Concrete Slab/Gray | Intact | No | None Detected | Typical Building | NA |

884-3  
Concrete Slab  
Typical Building

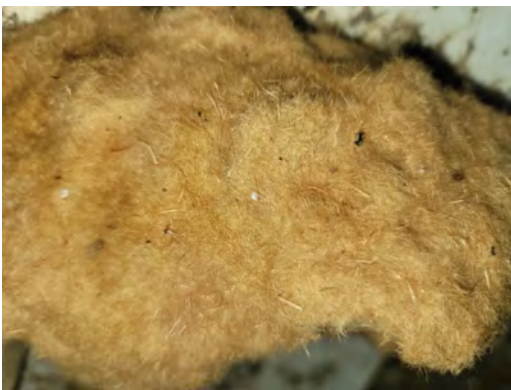
| <i>Sample Number</i> | <i>Description</i> | <i>Condition</i> | <i>Friable</i> | <i>Asbestos Percent and Type</i> | <i>Location/ Amount</i> | <i>NESHAP Category</i> |
|---|---|---|---|---|---|---|
| 884-5-1 | Insulation/Tan | Intact | No | None Detected | Typical Interior | NA |
| 884-5-2 | Insulation/Tan | Intact | No | None Detected | Typical Interior | NA |

884-5  
Insulation  
Typical Interior

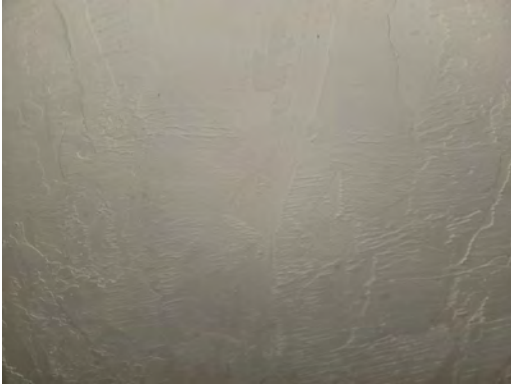
| <i>Sample Number</i> | <i>Description</i> | <i>Condition</i> | <i>Friable</i> | <i>Asbestos Percent and Type</i> | <i>Location/ Amount</i> | <i>NESHAP Category</i> |
|---|---|---|---|---|---|---|
| 884-7-1 | Texture/White | Intact | Yes | None Detected | Typical Interior Walls/Ceilings | NA |
| 884-7-2 | Texture/White | Intact | Yes | None Detected | Typical Interior Walls/Ceilings | NA |
| 884-7-3 | Texture/White | Intact | Yes | None Detected | Typical Interior Walls/Ceilings | NA |

884-7  
Ceiling/Wall Texture  
Typical Interior

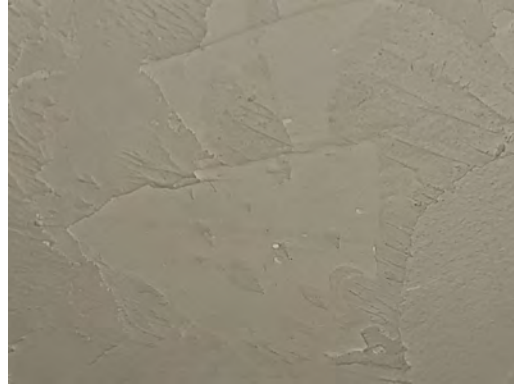
| <i>Sample Number</i> | <i>Description</i> | <i>Condition</i> | <i>Friable</i> | <i>Asbestos Percent and Type</i> | <i>Location/ Amount</i> | <i>NESHAP Category</i> |
|---|---|---|---|---|---|---|
| 884-8-1 | Joint Compound/White | Intact | No | None Detected | Typical Interior Walls/Ceilings | NA |
| 884-8-1 | Drywall/Off-White | Intact | No | None Detected | Typical Interior Walls/Ceilings | NA |
| 884-8-2 | Joint Compound/White | Intact | No | None Detected | Typical Interior Walls/Ceilings | NA |
| 884-8-2 | Drywall/Off-White | Intact | No | None Detected | Typical Interior Walls/Ceilings | NA |

884-8  
Drywall/Joint Compound  
Typical Interior Walls/Ceilings

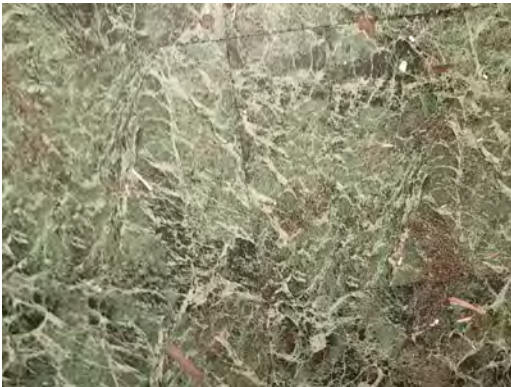
| <i>Sample Number</i> | <i>Description</i> | <i>Condition</i> | <i>Friable</i> | <i>Asbestos Percent and Type</i> | <i>Location/ Amount</i> | <i>NESHAP Category</i> |
|---|---|---|---|---|---|---|
| 884-9-1 | 12"x12" Vinyl Tile/Green | Intact | No | None Detected | Interior 1 <sup>st</sup> Fl Kitchen Floor | NA |
| 884-9-1 | Mastic/Yellow | Intact | No | None Detected | Interior 1 <sup>st</sup> Fl Kitchen Floor | NA |
| 884-9-2 | 12"x12" Vinyl Tile/Green | Intact | No | None Detected | Interior 1 <sup>st</sup> Fl Kitchen Floor | NA |
| 884-9-2 | Mastic/Yellow | Intact | No | None Detected | Interior 1 <sup>st</sup> Fl Kitchen Floor | NA |

884-9  
12"x12" Vinyl Tile/Mastic  
Interior 1<sup>st</sup> FI Kitchen Floor

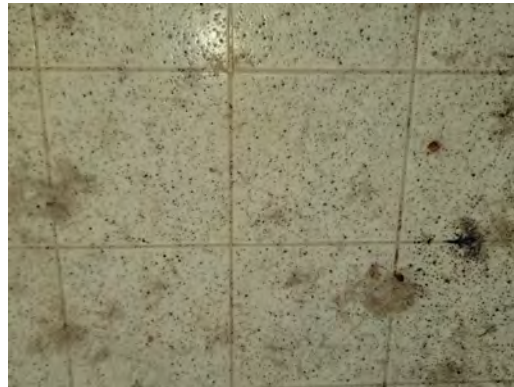
| <i>Sample Number</i> | <i>Description</i> | <i>Condition</i> | <i>Friable</i> | <i>Asbestos Percent and Type</i> | <i>Location/ Amount</i> | <i>NESHAP Category</i> |
|---|---|---|---|---|---|---|
| 884-10-1 | Rolled Flooring/White | Intact | No | None Detected | Interior 2 <sup>nd</sup> Fl Bathroom | NA |
| 884-10-1 | Mastic/Cream | Intact | No | None Detected | Interior 2 <sup>nd</sup> Fl Bathroom | NA |
| 884-10-2 | Rolled Flooring/White | Intact | No | None Detected | Interior 2 <sup>nd</sup> Fl Bathroom | NA |

| <i>Sample Number</i> | <i>Description</i> | <i>Condition</i> | <i>Friable</i> | <i>Asbestos Percent and Type</i> | <i>Location/ Amount</i> | <i>NESHAP Category</i> |
|---|---|---|---|---|---|---|
| 884-10-2 | Mastic/Cream | Intact | No | None Detected | Interior 2 <sup>nd</sup> Fl Bathroom | NA |

884-10  
Rolled Flooring/Mastic  
Interior 2<sup>nd</sup> FI Bathroom

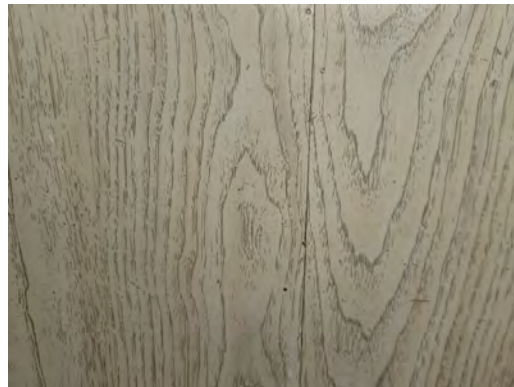
| <i>Sample Number</i> | <i>Description</i> | <i>Condition</i> | <i>Friable</i> | <i>Asbestos Percent and Type</i> | <i>Location/ Amount</i> | <i>NESHAP Category</i> |
|---|---|---|---|---|---|---|
| 884-12-1 | Laminate Wall Paneling/ Off-White | Intact | No | None Detected | Interior 2 <sup>nd</sup> Floor | NA |
| 884-12-2 | Laminate Wall Paneling/ Off-White | Intact | No | None Detected | Interior 2 <sup>nd</sup> Floor | NA |

884-12  
Laminate Wall Paneling  
Interior 2<sup>nd</sup> Floor
