Project:  
Asbestos Survey for Renovation-House  
609 NE 18<sup>th</sup> St.  
Ocala, FL 34470

Client:  
City of Ocala  
Community Development Services Department  
201 SE 3<sup>rd</sup> St.  
Ocala, FL 34471

Asbestos Survey for Renovation-House  
609 NE 18<sup>th</sup> St.  
Ocala, FL 34470

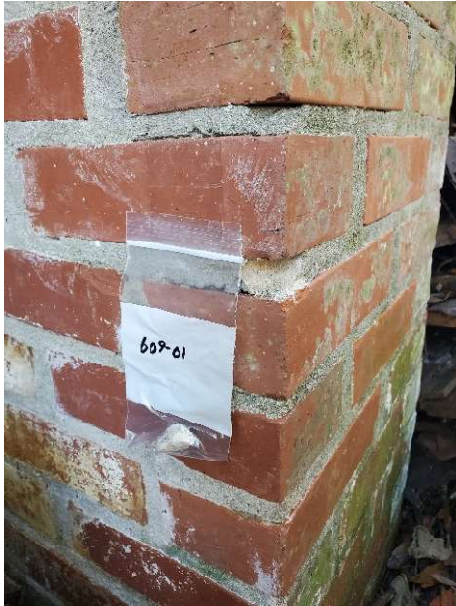
| Lab Sample Number | Client Sample Number | Layer Type | Lab Gross Description | Asbestos | Other Materials |
|---|---|---|---|---|---|
| 25-01-00544-001 | 609-01 | | Beige Granular;<br>Homogenous | NAD | 100% Non-Fibrous |

**Sample 609-01**  
**Typical Brick Mortar Sample**

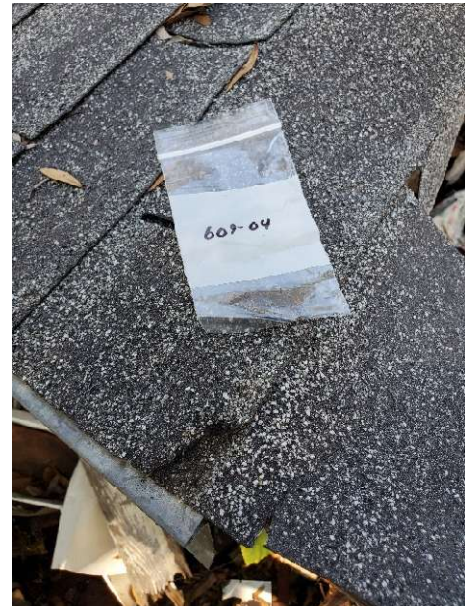
| Lab Sample Number | Client Sample Number | Layer Type | Lab Gross Description | Asbestos | Other Materials |
|---|---|---|---|---|---|
| 25-01-00544-004 | 609-04 | | Gray Aggregate; Black<br>Tar-Like; Inhomogenous | NAD | 20% Fibrous Glass<br>80% Non-Fibrous |

**Sample 609-04**  
**Typical Asphalt Roofing Sample**

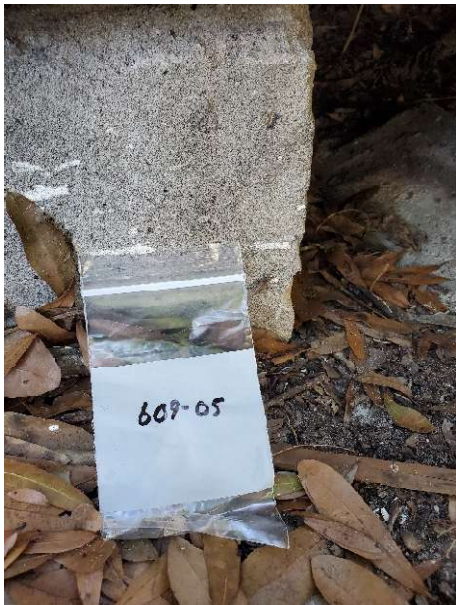
| Lab Sample Number | Client Sample Number | Layer Type | Lab Gross Description | Asbestos | Other Materials |
|---|---|---|---|---|---|
| 25-01-00544-005 | 609-05 | | Tan Granular;<br>Homogenous | NAD | 100% Non-Fibrous |

**Sample 609-05**  
**Typical CMU Block Sample**

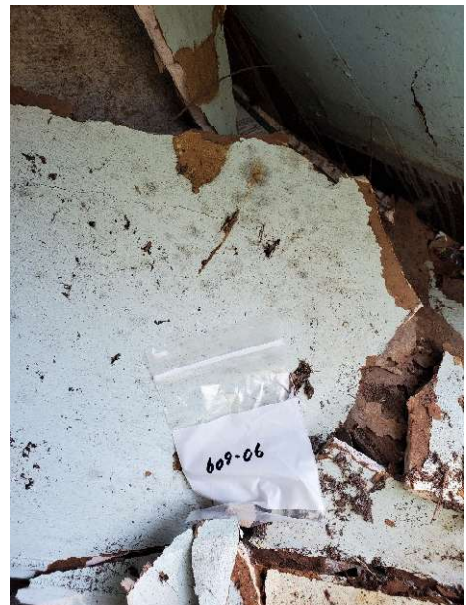
| Lab Sample Number | Client Sample Number | Layer Type | Lab Gross Description | Asbestos | Other Materials |
|---|---|---|---|---|---|
| 25-01-00544-006 | 609-06 | | Brown Fibrous; White Chalky; Inhomogenous | NAD | 15% Cellulose<br>85% Non-Fibrous |

**Sample 609-06**  
**Typical Wall Plaster (Debris) Sample**
