## ASBESTOS SURVEY REPORT

1224 SW 2nd Street  
Ocala, FL 34471

October 06, 2025

On October 06, 2025, an Asbestos Survey was performed at 1224 SW 2nd Street, Ocala, FL 34471. The property is a single-family detached dwelling. It is approximately 786 square feet and was constructed in 1958.

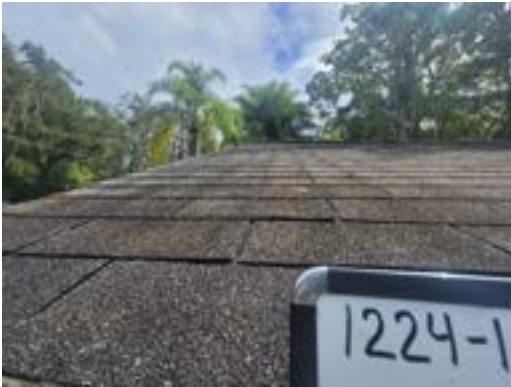
| <b>Bulk Collection and Sample Analysis Results</b> | | | | | | |
|---|---|---|---|---|---|---|
| 1224-1-1 | Asphalt Shingle/Black | Intact | No | None Detected | Typical Exterior Roof | NA |
| 1224-1-1 | Tar/Black | Intact | No | None Detected | Typical Exterior Roof | NA |
| 1224-1-2 | Asphalt Shingle/Black | Intact | No | None Detected | Typical Exterior Roof | NA |
| 1224-1-2 | Tar/Black | Intact | No | None Detected | Typical Exterior Roof | NA |

1224-1  
Asphalt Shingle/Tar  
Typical Exterior Roof

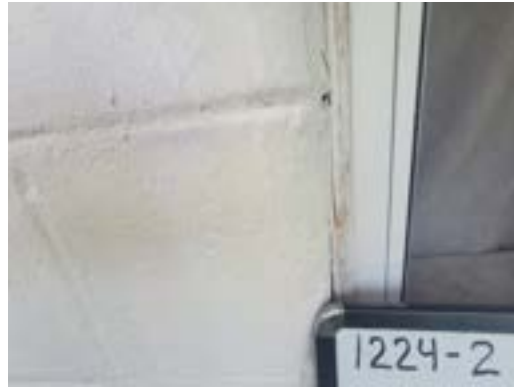
| <b>Bulk Collection and Sample Analysis Results</b> | | | | | | |
|---|---|---|---|---|---|---|
| 1224-2-1 | Caulk/White | Intact | No | None Detected | Typical Exterior Doors/Windows | NA |
| 1224-2-2 | Caulk/White | Intact | No | None Detected | Typical Exterior Doors/Windows | NA |

1224-2  
Caulk  
Typical Exterior Doors/Windows

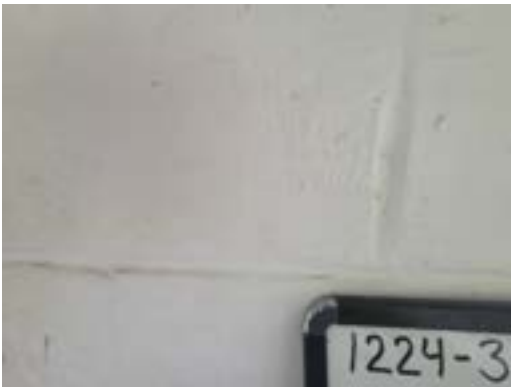
| <b>Bulk Collection and Sample Analysis Results</b> | | | | | | |
|---|---|---|---|---|---|---|
| 1224-3-1 | Concrete Block/Mortar/Gray | Intact | No | None Detected | Typical Exterior Walls | NA |
| 1224-3-2 | Concrete Block/Mortar/Gray | Intact | No | None Detected | Typical Exterior Walls | NA |

1224-3  
Concrete Block/Mortar  
Typical Exterior Walls

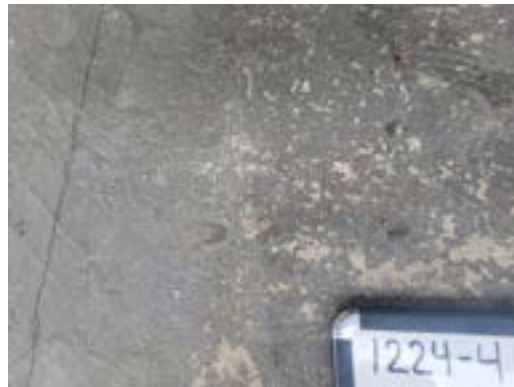
| <b>Bulk Collection and Sample Analysis Results</b> | | | | | | |
|---|---|---|---|---|---|---|
| 1224-4-1 | Concrete/Gray | Intact | No | None Detected | Exterior Front Porch Floor | NA |
| 1224-4-2 | Concrete/Gray | Intact | No | None Detected | Exterior Front Porch Floor | NA |

1224-4  
Concrete  
Exterior Front Porch Floor

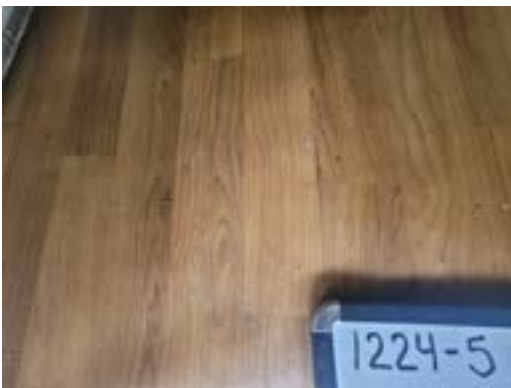
| <b>Bulk Collection and Sample Analysis Results</b> | | | | | | |
|---|---|---|---|---|---|---|
| 1224-5-1 | Laminate Flooring/Brown | Intact | No | <b>None Detected</b> | Typical Interior | NA |

| <i>Sample Number</i> | <i>Description</i> | <i>Condition</i> | <i>Friable</i> | <i>Asbestos Percent and Type</i> | <i>Location/ Amount</i> | <i>NESHAP Category</i> |
|---|---|---|---|---|---|---|
| 1224-5-2 | Laminate Flooring/Brown | Intact | No | None<br><b>Detected</b> | Typical Interior | NA |

1224-5  
Laminate Flooring  
Typical Interior

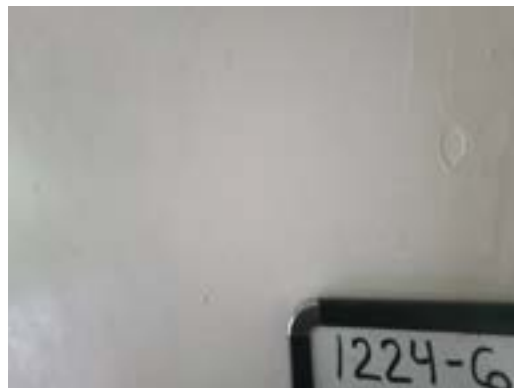
| <i>Sample Number</i> | <i>Description</i> | <i>Condition</i> | <i>Friable</i> | <i>Asbestos Percent and Type</i> | <i>Location/ Amount</i> | <i>NESHAP Category</i> |
|---|---|---|---|---|---|---|
| 1224-6-1 | Joint Compound/White | Intact | No | None<br><b>Detected</b> | Typical Interior Walls | NA |
| 1224-6-1 | Drywall/White | Intact | No | None<br><b>Detected</b> | Typical Interior Walls | NA |
| 1224-6-2 | Joint Compound/White | Intact | No | None<br><b>Detected</b> | Typical Interior Walls | NA |
| 1224-6-2 | Drywall/White | Intact | No | None<br><b>Detected</b> | Typical Interior Walls | NA |

1224-6  
Drywall/Joint Compound  
Typical Interior Walls

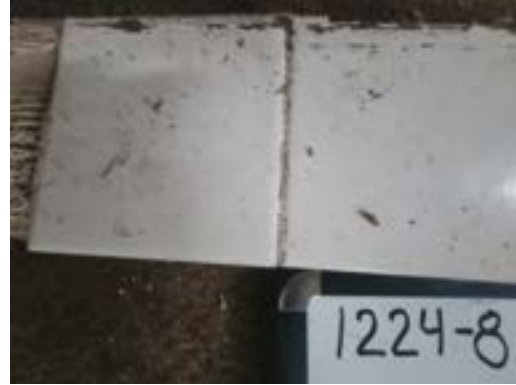
| <i>Sample Number</i> | <i>Description</i> | <i>Condition</i> | <i>Friable</i> | <i>Asbestos Percent and Type</i> | <i>Location/ Amount</i> | <i>NESHAP Category</i> |
|---|---|---|---|---|---|---|
| 1224-8-1 | Ceramic Tile/White | Intact | No | None<br><b>Detected</b> | Interior Bathroom | NA |
| 1224-8-1 | Grout/White | Intact | No | None<br><b>Detected</b> | Interior Bathroom | NA |
| 1224-8-1 | Mortar/Gray | Intact | No | None<br><b>Detected</b> | Interior Bathroom | NA |
| 1224-8-2 | Ceramic Tile/White | Intact | No | None<br><b>Detected</b> | Interior Bathroom | NA |
| 1224-8-2 | Grout/White | Intact | No | None<br><b>Detected</b> | Interior Bathroom | NA |
| 1224-8-2 | Mortar/Gray | Intact | No | None<br><b>Detected</b> | Interior Bathroom | NA |

1224-8  
Ceramic Tile/Grout  
Interior Bathroom

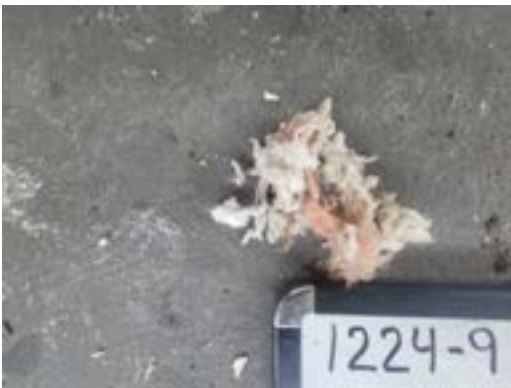
| <i>Sample Number</i> | <i>Description</i> | <i>Condition</i> | <i>Friable</i> | <i>Asbestos Percent and Type</i> | <i>Location/ Amount</i> | <i>NESHAP Category</i> |
|---|---|---|---|---|---|---|
| 1224-9-1 | Insulation/White | Intact | No | None<br><b>Detected</b> | Typical Interior | NA |
| 1224-9-2 | Insulation/White | Intact | No | None<br><b>Detected</b> | Typical Interior | NA |

1224-9  
Insulation  
Typical Interior

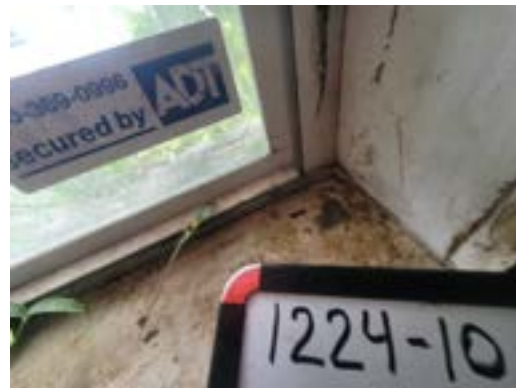
| <i>Sample Number</i> | <i>Description</i> | <i>Condition</i> | <i>Friable</i> | <i>Asbestos Percent and Type</i> | <i>Location/ Amount</i> | <i>NESHAP Category</i> |
|---|---|---|---|---|---|---|
| 1224-10-1 | Caulk/White | Intact | No | None<br><b>Detected</b> | Typical Interior Windows | NA |
| 1224-10-2 | Caulk/White | Intact | No | None<br><b>Detected</b> | Typical Interior Windows | NA |

1224-10  
Caulk  
Typical Interior Windows
