Project:  
Asbestos Survey for Demolition  
2709 NE 12<sup>th</sup> Court  
Ocala, FL 34470

Asbestos Survey for Demolition  
2709 NE 12<sup>th</sup> Court  
Ocala, FL 34470

The structure is a single-story wood framed single-family house on a concrete slab with an asphalt shingle, metal & asphalt built-up roof.

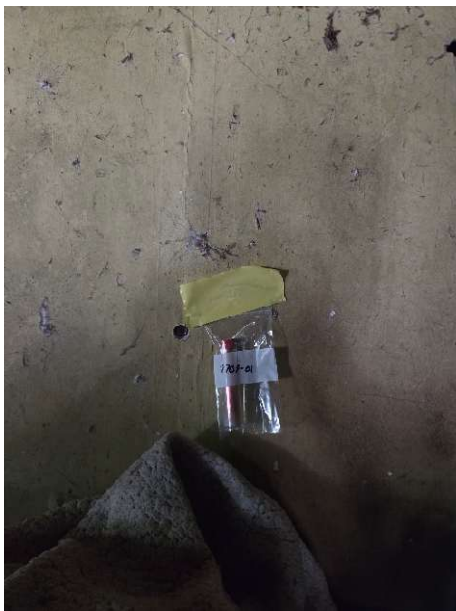
| Lab Sample Number | Client Sample Number | Layer Type | Lab Gross Description | Asbestos | Other Materials |
|---|---|---|---|---|---|
| 26-06-05039-001 | 2709-01 | | Off-White/Beige Brittle;<br>Tan/Light Beige Fibrous;<br>Pale Green/Coral Pink<br>Pliable to Brittle;<br>Inhomogeneous | Trace <1% Chrysotile | 18% Cellulose<br>82% Non-Fibrous |
| Chrysotile present in beige brittle joint compound layers; this material alone contains 2% chrysotile. | | | | | |

Sample 2709-01  
Typical Drywall & Joint Compound

| Lab Sample Number | Client Sample Number | Lab Gross Description | % Asbestos | Narrative ID |
|---|---|---|---|---|
| 26-06-05463-001 | 2709-01 | Off-White/Beige Brittle; Tan/Light Beige Fibrous; Pale Green/Coral Pink Pliable to Brittle | <0.25 % Chrysotile | A12 |

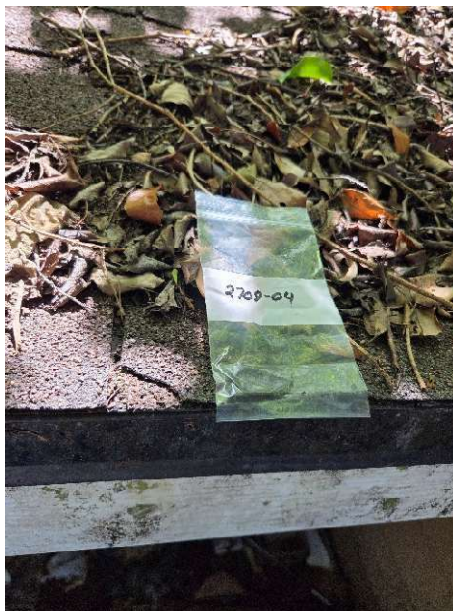
| Lab Sample Number | Client Sample Number | Layer Type | Lab Gross Description | Asbestos | Other Materials |
|---|---|---|---|---|---|
| 26-06-05039-004 | 2709-04 | | Black Pliable to Brittle;<br>Brown/Gray Aggregate;<br>Inhomogeneous | NAD | 18% Fibrous Glass<br>82% Non-Fibrous |

Sample 2709-04  
Asphalt Shingle Roofing Sample

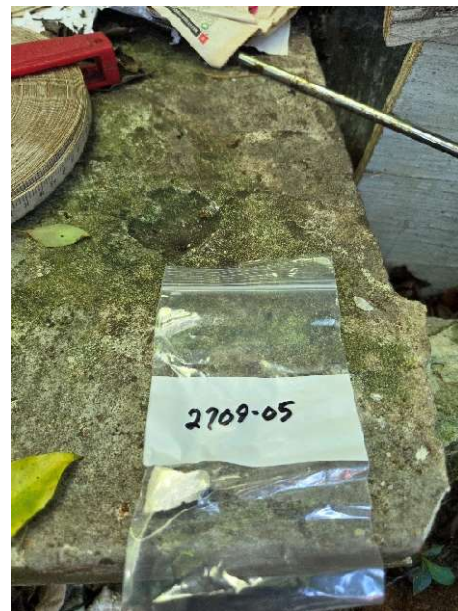
| Lab Sample Number | Client Sample Number | Layer Type | Lab Gross Description | Asbestos | Other Materials |
|---|---|---|---|---|---|
| 26-06-05039-005 | 2709-05 | | Off-White Cementitious;<br>Homogeneous | NAD | 100% Non-Fibrous |

Sample 2709-05  
Concrete Sample

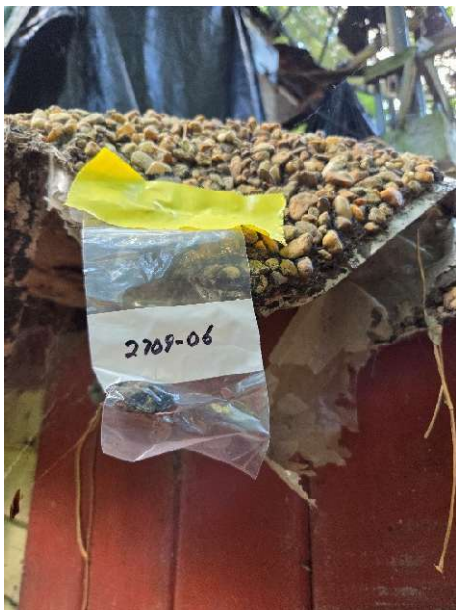
| Lab Sample Number | Client Sample Number | Layer Type | Lab Gross Description | Asbestos | Other Materials |
|---|---|---|---|---|---|
| 26-06-05039-006 | 2709-06 | | Black Brittle; Black Pliable<br>to Brittle; Tan/Off-White<br>Aggregate;<br>Inhomogeneous | NAD | 3% Cellulose<br>97% Non-Fibrous |

| <b>Project Number:</b><br><b>Project Name:</b> Demolition<br><b>Project Address:</b> 2709 NE 12 <sup>th</sup> Ct. Ocala, FL 34470<br><b>Client Name:</b> City of Ocala<br><b>Inspector:</b> J. Spadt | | <b>Lab Name:</b> Environmental Hazards Services LLC<br><b>Address:</b> 7469 Whitepine Road<br>N. Chesterfield, VA 23237<br><b>Phone:</b> 1-800-347-4010 ext 116<br><b>Turnaround:</b> Same Day 24 Hrs 48Hrs 3 Days <input checked="" type="checkbox"/><br><b>Other:</b> _____<br><b>Analysis Type:</b> Asbestos Bulk <input checked="" type="checkbox"/> Positive Stop <input checked="" type="checkbox"/><br>Lead _____ OTHER _____ | | |
|---|---|---|---|---|
| | -06 | Built-up Roofing | Exterior (Rear Garage) | Approx. 100sq. ft. |

Sample 2709-06  
Asphalt Built-up Roof Sample
