## ASBESTOS SURVEY REPORT

1628 SW 2nd Street  
Ocala, FL 34471

December 30, 2024

On December 30, 2024 an Asbestos Survey was performed at 1628 SW 2nd Street, Ocala, FL 34471. The property is a single-family detached dwelling. It is approximately 847 square feet and was constructed in 1943.

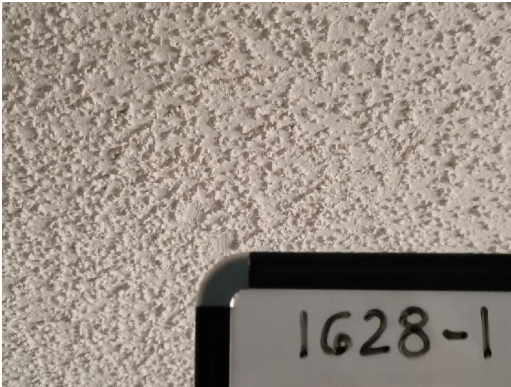
| <b><i>Bulk Collection and Sample Analysis Results</i></b> | | | | | | |
|---|---|---|---|---|---|---|
| 1628-1-1 | Popcorn Texture/White | Intact | No | None Detected | Typical Interior Ceilings | NA |
| 1628-1-2 | Popcorn Texture/White | Intact | No | None Detected | Typical Interior Ceilings | NA |
| 1628-1-3 | Popcorn Texture/White | Intact | No | None Detected | Typical Interior Ceilings | NA |

1628-1  
Popcorn Texture  
Typical Interior Ceilings

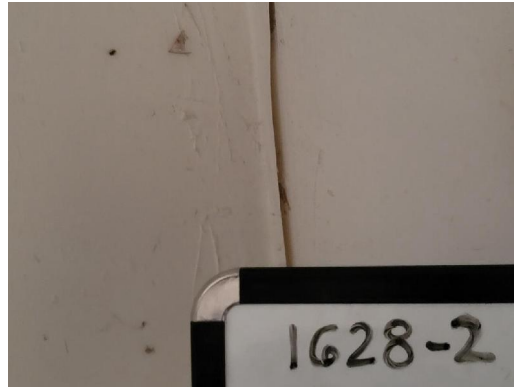
| <b><i>Bulk Collection and Sample Analysis Results</i></b> | | | | | | |
|---|---|---|---|---|---|---|
| 1628-2-1 | Joint Compound/White | Intact | No | None Detected | Typical Interior Walls/Ceilings | NA |
| 1628-2-1 | Drywall/White/Brown | Intact | No | None Detected | Typical Interior Walls/Ceilings | NA |
| 1628-2-2 | Joint Compound/White | Intact | No | None Detected | Typical Interior Walls/Ceilings | NA |
| 1628-2-2 | Drywall/White/Brown | Intact | No | None Detected | Typical Interior Walls/Ceilings | NA |

1628-2  
Joint Compound/Drywall  
Typical Interior Walls/Ceilings

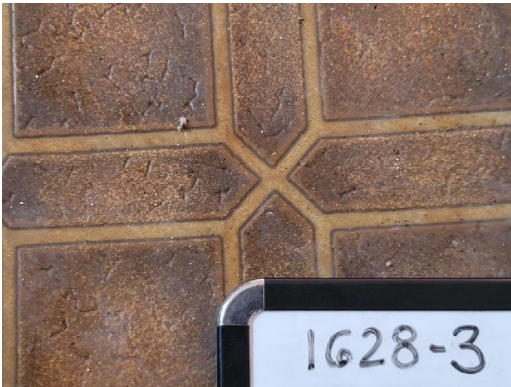
| <b><i>Bulk Collection and Sample Analysis Results</i></b> | | | | | | |
|---|---|---|---|---|---|---|
| 1628-3-1 | Rolled Flooring/Brown | Intact | No | None Detected | Interior Utility Room | NA |
| 1628-3-1 | Mastic/Yellow | Intact | No | None Detected | Interior Utility Room | NA |
| 1628-3-2 | Rolled Flooring/Brown | Intact | No | None Detected | Interior Utility Room | NA |
| 1628-3-2 | Mastic/Yellow | Intact | No | None Detected | Interior Utility Room | NA |

1628-3  
Rolled Flooring/Mastic  
Interior Utility Room

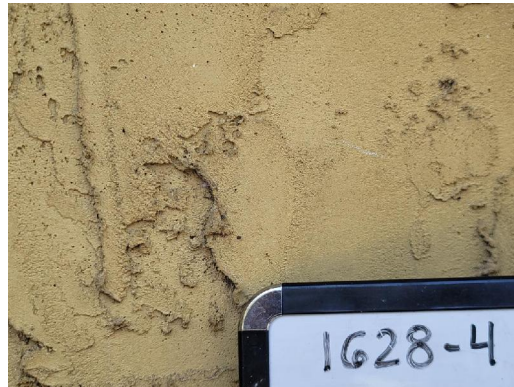
| <i>Sample Number</i> | <i>Description</i> | <i>Condition</i> | <i>Friable</i> | <i>Asbestos Percent and Type</i> | <i>Location/ Amount</i> | <i>NESHAP Category</i> |
|---|---|---|---|---|---|---|
| 1628-4-1 | Stucco/Yellow | Intact | No | None Detected | Typical Exterior Walls | NA |
| 1628-4-2 | Stucco/Yellow | Intact | No | None Detected | Typical Exterior Walls | NA |

1628-4  
Stucco  
Typical Exterior Walls
