## ASBESTOS SURVEY REPORT

2216 SW 2nd Street  
Ocala, FL 34471

December 30, 2024

On December 30, 2024 an Asbestos Survey was performed at 2216 SW 2nd Street, Ocala, FL 34471. The property is a single-family detached dwelling. It is approximately 747 square feet and was constructed in 1948.

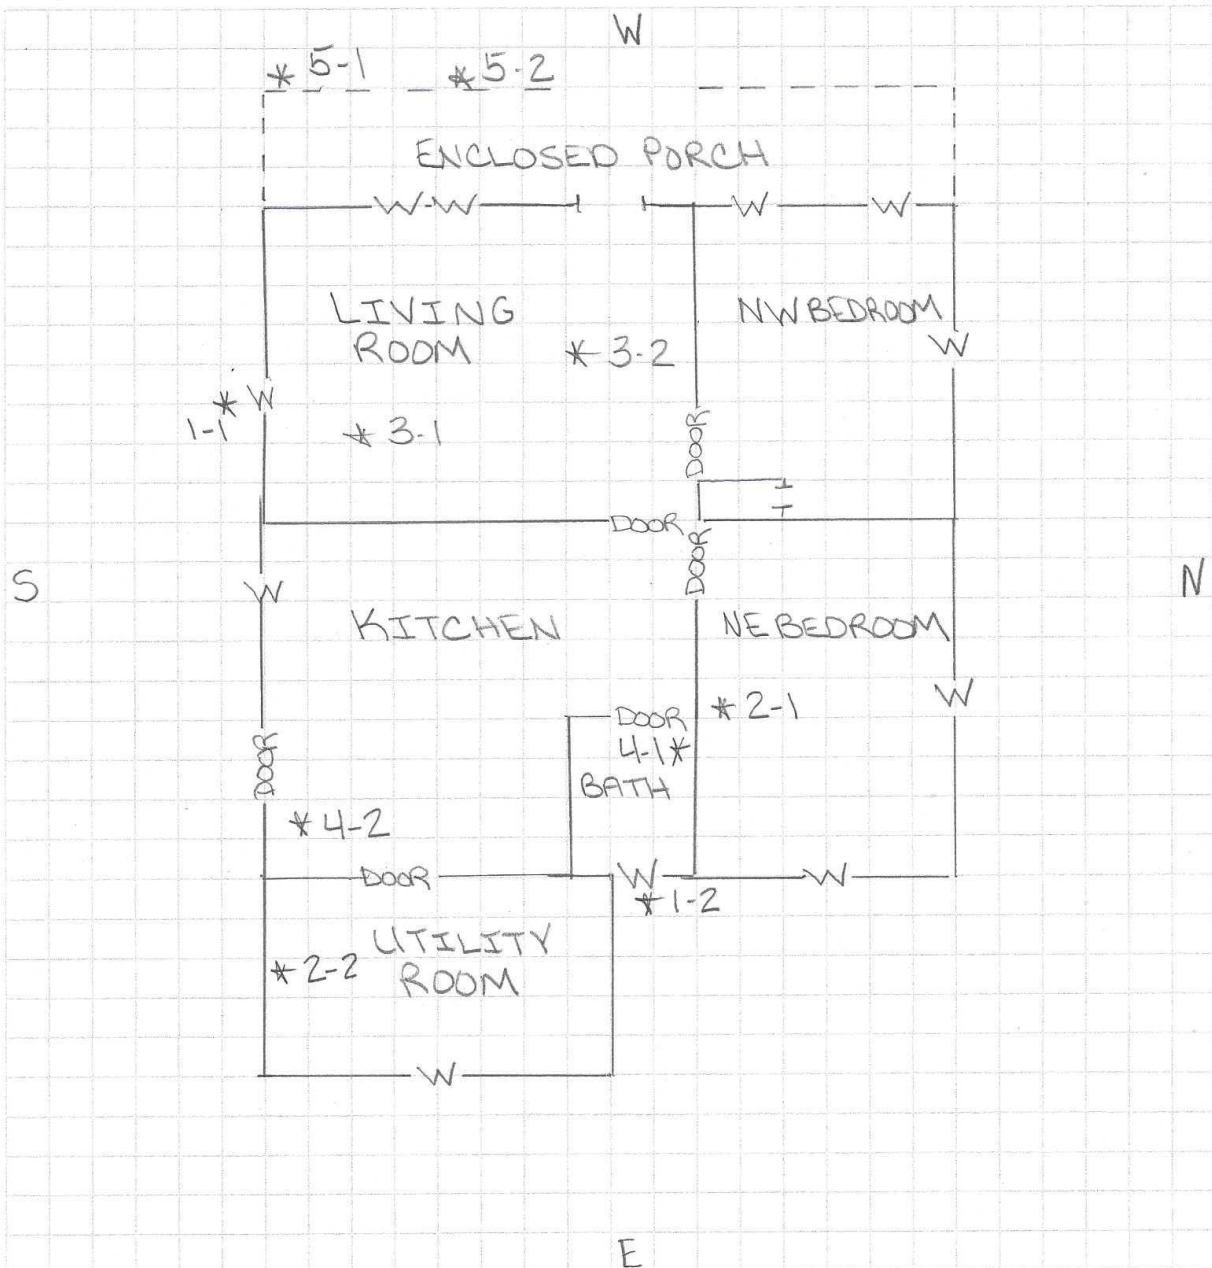
## SITE PLAN

Address 2216 SW 2<sup>ND</sup> Street  
Ocala, FL 34471

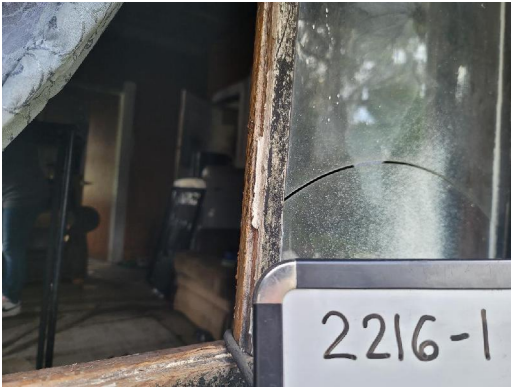
| <b>Bulk Collection and Sample Analysis Results</b> | | | | | | |
|---|---|---|---|---|---|---|
| 2216-1-1 | Caulk/Off-White | Intact | No | None Detected | Typical Exterior Windows | NA |
| 2216-1-2 | Caulk/Off-White | Intact | No | None Detected | Typical Exterior Windows | NA |

2216-1  
Caulk  
Typical Exterior Windows

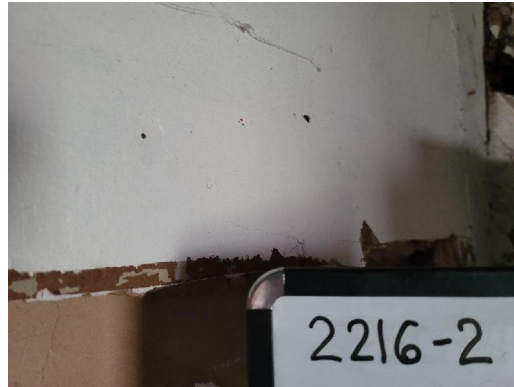
| <b>Bulk Collection and Sample Analysis Results</b> | | | | | | |
|---|---|---|---|---|---|---|
| 2216-2-1 | Drywall/White/Brown | Intact | No | None Detected | Typical Interior Walls | NA |
| 2216-2-2 | Drywall/White/Brown | Intact | No | None Detected | Typical Interior Walls | NA |

2216-2  
Drywall  
Typical Interior Walls

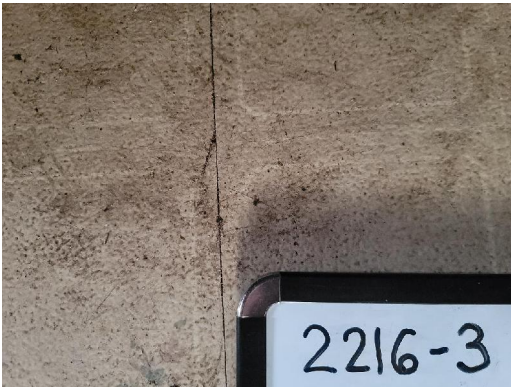
| <b>Bulk Collection and Sample Analysis Results</b> | | | | | | |
|---|---|---|---|---|---|---|
| 2216-3-1 | 12"x12" Floor Tile/Beige | Intact | No | None Detected | Interior Living Room | NA |
| 2216-3-1 | Mastic/Brown | Intact | No | None Detected | Interior Living Room | NA |
| 2216-3-2 | 12"x12" Floor Tile/Beige | Intact | No | None Detected | Interior Living Room | NA |
| 2216-3-2 | Mastic/Brown | Intact | No | None Detected | Interior Living Room | NA |

2216-3  
12"x12" Floor Tile/Mastic  
Interior Living Room

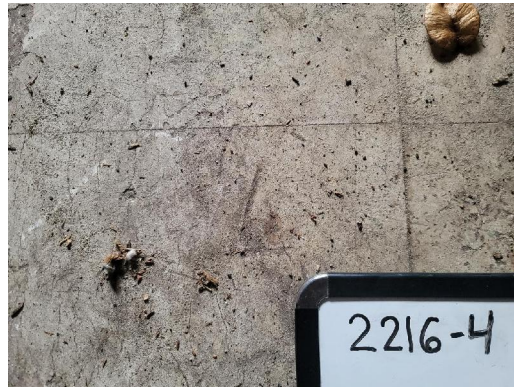
| <b>Bulk Collection and Sample Analysis Results</b> | | | | | | |
|---|---|---|---|---|---|---|
| <b>2216-4-1</b> | <b>12"x12" Floor Tile/Brown</b> | <b>Intact</b> | <b>No</b> | <b>2% Chrysotile</b> | <b>Interior Kitchen/Bathroom Appx 70 sq ft</b> | <b>Category I</b> |
| 2216-4-1 | Mastic/Brown | Intact | No | None Detected | Interior Kitchen/Bathroom | NA |
| <b>2216-4-2</b> | <b>12"x12" Floor Tile/Brown</b> | <b>Intact</b> | <b>No</b> | <b>Not Analyzed/ Positive Stop</b> | <b>Interior Kitchen/Bathroom Appx 70 sq ft</b> | <b>Category I</b> |

| <i>Sample Number</i> | <i>Description</i> | <i>Condition</i> | <i>Friable</i> | <i>Asbestos Percent and Type</i> | <i>Location/ Amount</i> | <i>NESHAP Category</i> |
|---|---|---|---|---|---|---|
| 2216-4-2 | Mastic/Brown | Intact | No | None Detected | Interior Kitchen/Bathroom | NA |

2216-4  
12"x12" Floor Tile (2% Chrysotile)  
Mastic  
Interior Kitchen/Bathroom  
(Appx 70 sq ft)

The EPA and NESHAP recommend that a point-counting procedure be utilized for confirmation of asbestos percentage in friable materials that are visually estimated by PLM methodology to contain less than 10% asbestos. The 400 Point Count Procedure referenced in EPA 600/M4-82-020 (1987) and EPA 600/R-93/116 (1993) is commonly employed. Without the material being point counted or if point counting determined that material contains greater than one percent asbestos, it would be deemed an asbestos containing material and would need to be removed by a Florida licensed asbestos contractor prior to disturbance.

If asbestos containing materials identified within, or on, the property will be disturbed or otherwise caused to become friable within the scope of the renovation, they should be removed from the structures prior to the maneuvers taking place according to applicable regulations.

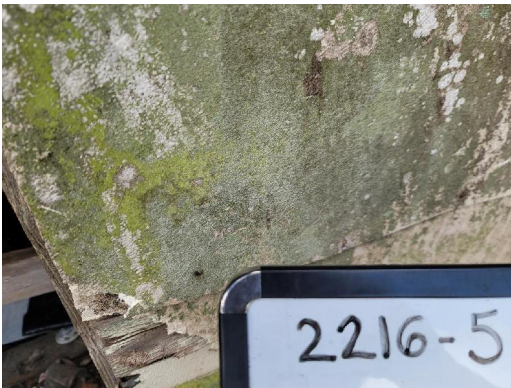
| <i>Sample Number</i> | <i>Description</i> | <i>Condition</i> | <i>Friable</i> | <i>Asbestos Percent and Type</i> | <i>Location/ Amount</i> | <i>NESHAP Category</i> |
|---|---|---|---|---|---|---|
| 2216-5-1 | Siding/White | Intact | No | None Detected | Exterior Front Porch Wall | NA |
| 2216-5-2 | Siding/White | Intact | No | None Detected | Exterior Front Porch Wall | NA |

2216-5  
Siding  
Exterior Front Porch Wall
