Project:  
Asbestos Survey for Demolition  
1002 W. Silver Springs Place  
Ocala, FL 34475

Asbestos Survey for Demolition  
1002 W. Silver Springs Place  
Ocala, FL 34475

The structure is a single-story wood framed single family house on concrete piers with an asphalt shingle roof.

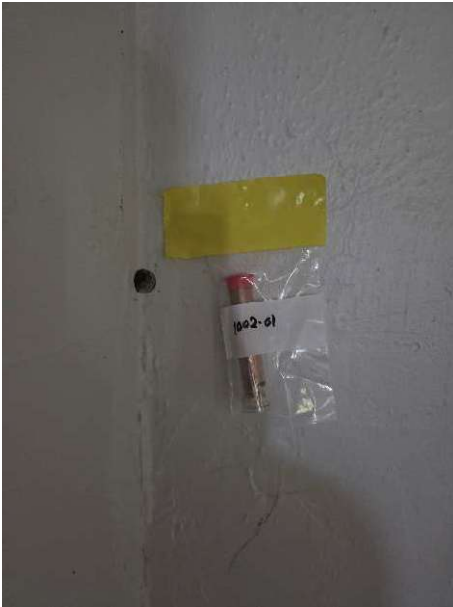
| Date | Sample Number | Description | Location | Comments/Measurements |
|---|---|---|---|---|
| 6/22/2026 | 1002-01 | Plaster | Kitchen | |

Sample 1002-01  
Typical Plaster Sample

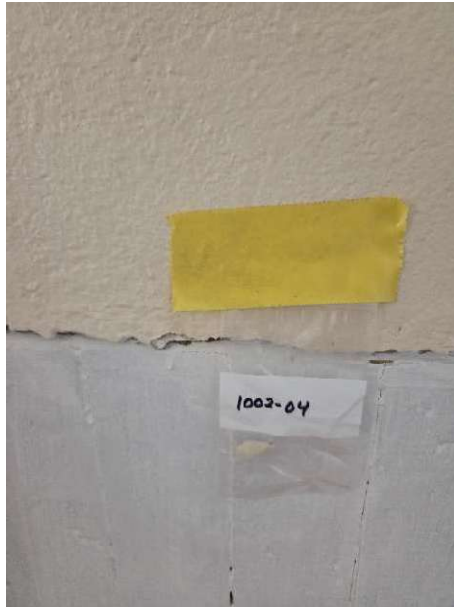
| Date | Sample Number | Description | Location | Comments/Measurements |
|---|---|---|---|---|
| | -04 | Wall Texture | | Throughout |

Sample 1002-04  
Typical Wall Texture Sample

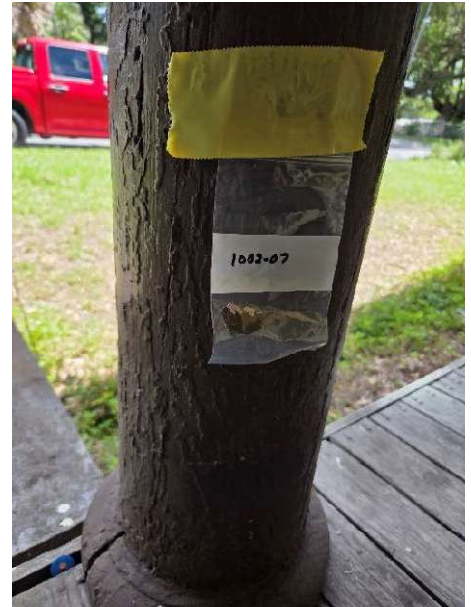
| Date | Sample Number | Description | Location | Comments/Measurements |
|---|---|---|---|---|
| | -07 | Stucco | Exterior A Porch Column | |

Sample 1002-07  
Typical Stucco Sample

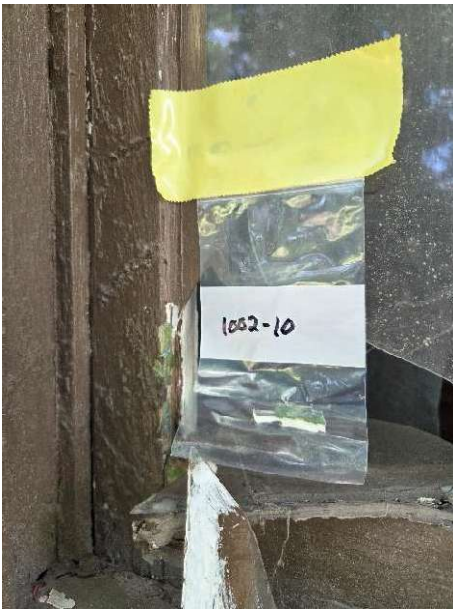
| Date | Sample Number | Description | Location | Comments/Measurements |
|---|---|---|---|---|
| | -10 | Exterior Caulking | Exterior | Approx. 260 linear ft. |

Sample 1002-10  
Typical Exterior Caulking Sample

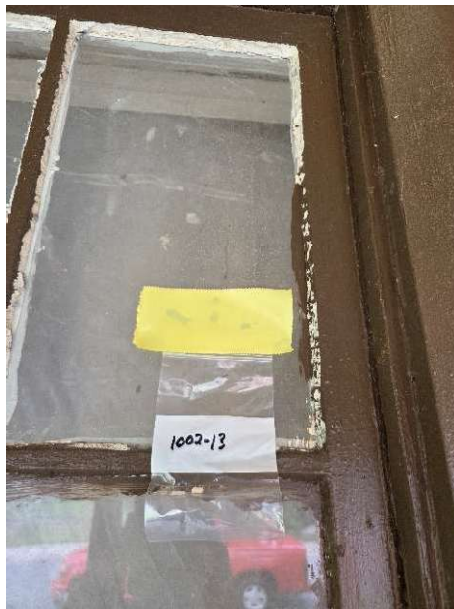
| Date | Sample Number | Description | Location | Comments/Measurements |
|---|---|---|---|---|
| | -13 | Window Glazing | | Approx. 360 linear ft. |

Sample 1002-13  
Typical Window Glazing Sample

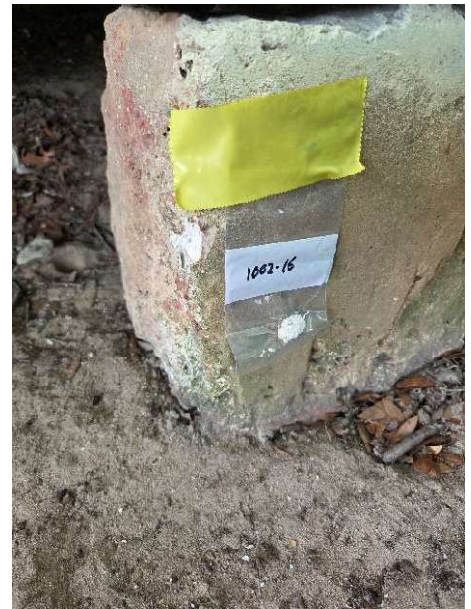
| Date | Sample Number | Description | Location | Comments/Measurements |
|---|---|---|---|---|
| | -16 | CMU Block | | |

Sample 1002-16  
CMU Block Sample

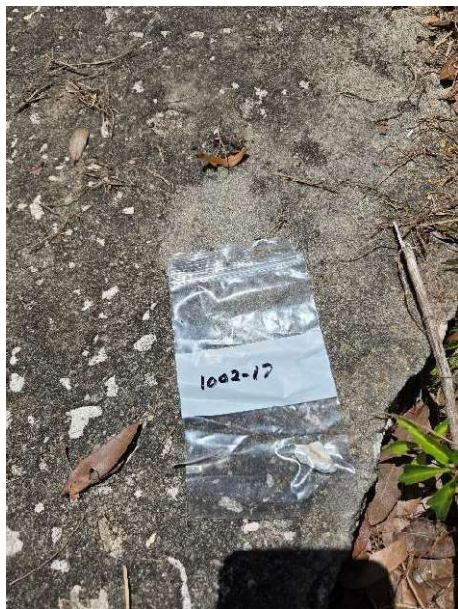
| Date | Sample Number | Description | Location | Comments/Measurements |
|---|---|---|---|---|
| | -17 | Concrete Slab (Sidewalk) | | |

Sample 1002-17  
Concrete Sample
