## ASBESTOS SURVEY REPORT

1810 NW 24<sup>th</sup> Court  
Ocala, FL 34475

April 04, 2023

**RE: Limited Asbestos Survey  
Single-Family Detached Dwelling  
1810 NW 24<sup>th</sup> Court  
Ocala, FL 34475**

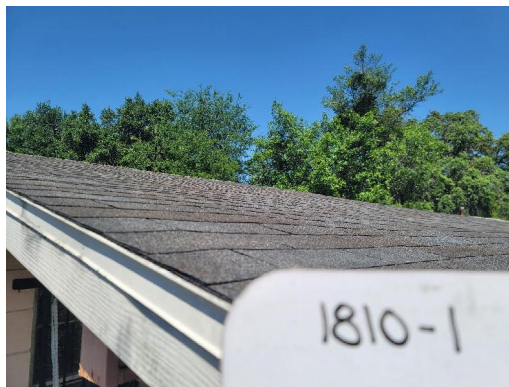
<b>Bulk Collection and Sample Analysis Results</b>						
<i>Sample Number</i>	<i>Description</i>	<i>Condition</i>	<i>Friable</i>	<i>Asbestos Percent and Type</i>	<i>Location/ Amount</i>	<i>NESHAP Category</i>
1810-1-1	Asphalt Shingle/Black	Intact	No	None Detected	Typical Exterior Roof	NA
1810-1-2	Asphalt Shingle/Black	Intact	No	None Detected	Typical Exterior Roof	NA
1810-1-2	Tar/Black	Intact	No	None Detected	Typical Exterior Roof	NA
1810-2-1	Caulk/White	Intact	No	2% Chrysotile	Typical Exterior Windows	Category II
1810-2-2	Caulk/White	Intact	No	Not Analyzed/ Positive Stop	Typical Exterior Windows	Category II
1810-3-1	12"x12" Floor Tile/Beige	Intact	No	2% Chrysotile	Typical Interior (Appx 1,600 sf)	Category I
1810-3-1	Adhesive/Yellow	Intact	No	Not Analyzed PACM	Typical Interior (Appx 1,600 sf)	Category I
1810-3-2	12"x12" Floor Tile/Beige	Intact	No	Not Analyzed/ Positive Stop	Typical Interior (Appx 1,600 sf)	Category I

1810-1  
Asphalt Shingle/Tar  
Typical Exterior Roof

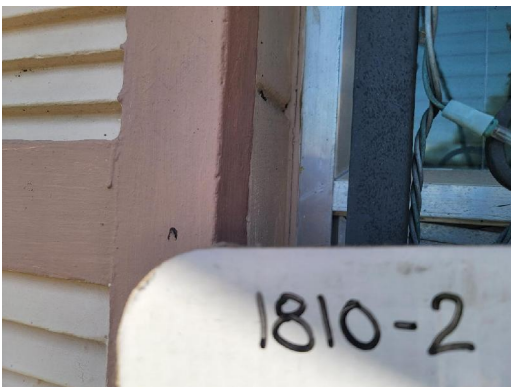
1810-2  
Caulk/White (2% Chrysotile)  
Typical Exterior Windows

- Caulk (White), Typical Exterior Windows, Homogeneous Sample Area 1810-2-1, showed 2% Chrysotile Asbestos
- 12" x 12" Vinyl Floor Tile (Beige) and Associated Adhesive (Yellow), Typical Interior Floors, Homogeneous Sample Area 1810-3-1 and 1810-3-2, showed 2% Chrysotile Asbestos; the adhesive was identified in the laboratory but was not analyzed due to insufficient material and is assumed to be asbestos containing

Caulk is a National Emission Standard for Hazardous Air Pollutants (NESHAP) Category II non-friable ACM. NESHAP Category II non-friable ACMs must be evaluated on a case-by-case basis. If NESHAP Category II non-friable ACMs are likely to become crushed, pulverized or reduced to powder during renovation activities, they should be removed by a licensed asbestos abatement contractor and disposed of at a class one landfill prior to renovation, remodeling, or demolition of the building. If NESHAP Category II non-friable ACMs are in poor condition and become friable during demolition, the material must be treated as a Regulated Asbestos Containing Material (RACM) and be removed by a licensed asbestos abatement contractor and disposed of at a class one landfill prior to renovation, remodeling, or demolition of the building.

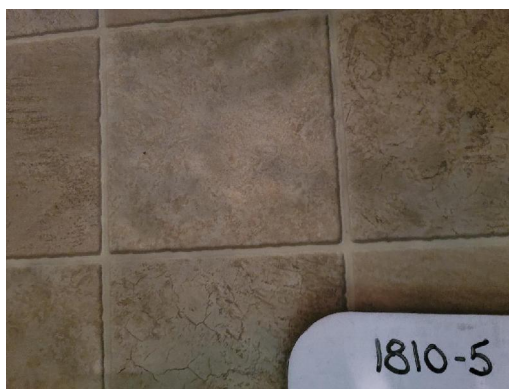
1810-5  
Rolled Vinyl Flooring/Beige  
Interior Bathrooms/Dining Room

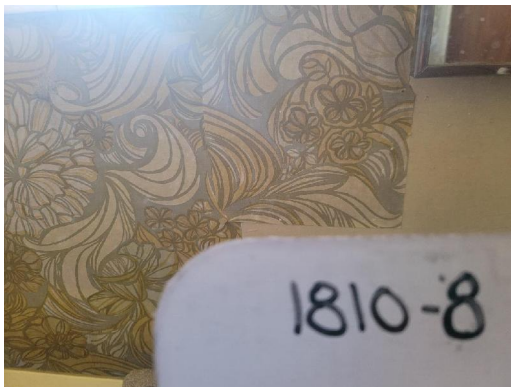
1810-8  
Wallpaper/Multi-Colored  
Interior Half-Bathroom

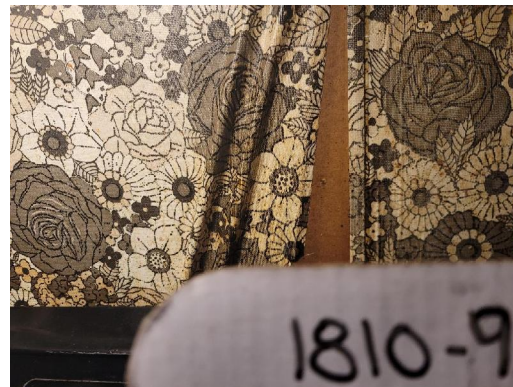
1810-9  
Wallpaper/Multi-Colored  
Interior Kitchen

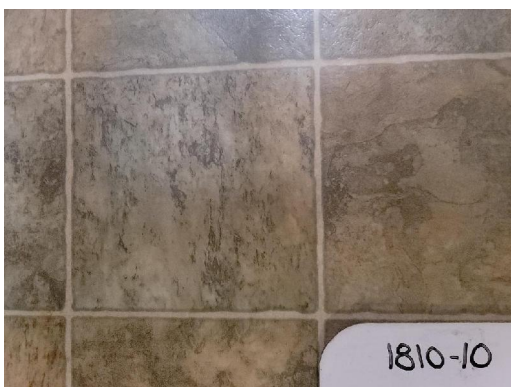
1810-10  
Rolled Vinyl Flooring/Beige  
Interior Kitchen
