## ASBESTOS SURVEY REPORT

1656 SW 3rd Street  
Ocala, FL 34471

July 02, 2024

On July 02, 2024 an Asbestos Survey was performed at 1656 SW 3rd Street, Ocala, FL 34471. The property is a single-family detached dwelling. It is approximately 872 square feet and was constructed in 1957.

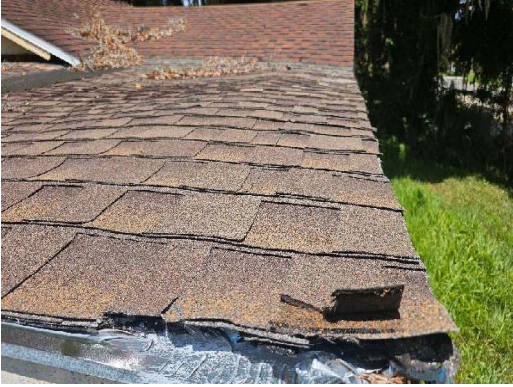
| <b>Bulk Collection and Sample Analysis Results</b> | | | | | | |
|--|---|---|---|---|---|---|
| 1656-1-1 | Asphalt Shingle/Gray/Black | Intact | No | None Detected | Typical Exterior Roof | NA |
| 1656-1-1 | Tar/Black | Intact | No | None Detected | Typical Exterior Roof | NA |
| 1656-1-2 | Asphalt Shingle/Gray/Black | Intact | No | None Detected | Typical Exterior Roof | NA |
| 1656-1-2 | Tar/Black | Intact | No | None Detected | Typical Exterior Roof | NA |

1656-1  
Asphalt Shingle/Tar  
Typical Exterior Roof

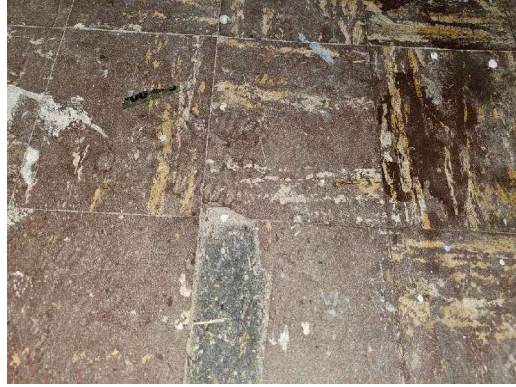
| <b>Bulk Collection and Sample Analysis Results</b> | | | | | | |
|--|---|---|---|---|---|---|
| <b>1656-2-1</b> | <b>9"x9" Floor Tile/Brown</b> | <b>Intact</b> | <b>No</b> | <b>4% Chrysotile</b> | <b>Interior Bedroom (Appx 25 sq ft)</b> | <b>Category I</b> |
| 1656-2-1 | Mastic/Black | Intact | No | None Detected | Interior Bedroom | NA |
| <b>1656-2-2</b> | <b>9"x9" Floor Tile/Brown</b> | <b>Intact</b> | <b>No</b> | <b>Not Analyzed/ Positive Stop</b> | <b>Interior Bedroom (Appx 25 sq ft)</b> | <b>Category I</b> |
| 1656-2-2 | Mastic/Black | Intact | No | None Detected | Interior Bedroom | NA |

1656-2  
9"x9" Floor Tile/Brown (4% Chrysotile)  
Mastic  
Interior Bedroom (Appx 250 sq ft)

If asbestos containing materials identified within, or on, the property will be disturbed or otherwise caused to become friable within the scope of the renovation, they should be removed from the structures prior to the maneuvers taking place according to applicable regulations.

9" x 9" Vinyl Floor tile (VFT), Cove Base and associated mastics are National Emission Standard for Hazardous Air Pollutants (NESHAP) Category I non-friable ACMs. NESHAP Category I non-friable ACMs are not required to be removed prior to demolition of the building, provided that wet-demolition practices are implemented during renovations and resulting debris from the structure is properly transported to a landfill permitted for disposal of ACM. If NESHAP Category I non-friable ACMs are in poor condition and become friable during demolition, the material must be treated as a Regulated Asbestos Containing Material (RACM) and be removed by a licensed asbestos abatement contractor and disposed of at a class one landfill prior to renovation, remodeling, or demolition of the building.

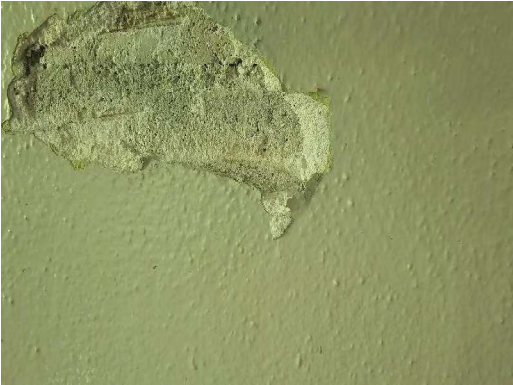
| <b>Bulk Collection and Sample Analysis Results</b> | | | | | | |
|--|---|---|---|---|---|---|
| 1656-3-1 | Plaster/Rough Coat/ Off-White | Intact | No | None Detected | Typical Interior Walls | NA |
| 1656-3-2 | Plaster/Rough Coat/ Off-White | Intact | No | None Detected | Typical Interior Walls | NA |
| 1656-3-3 | Plaster/Rough Coat/ Off-White | Intact | No | None Detected | Typical Interior Walls | NA |

1656-3  
Plaster/Rough Coat  
Typical Interior Walls

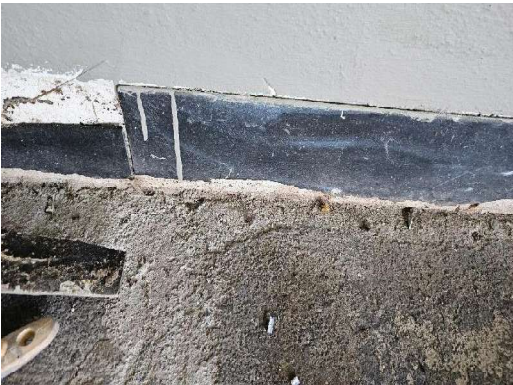
| <i>Sample Number</i> | <i>Description</i> | <i>Condition</i> | <i>Friable</i> | <i>Asbestos Percent and Type</i> | <i>Location/ Amount</i> | <i>NESHAP Category</i> |
|---|---|---|---|---|---|---|
| 1656-5-1 | Cove Base/Black | Intact | No | 6% Chrysotile | Interior Living Room/Bedroom (Appx 60 lin ft) | Category I |
| 1656-5-1 | Mastic/Black | Intact | No | 4% Chrysotile | Interior Living Room/Bedroom (Appx 60 lin ft) | Category I |
| 1656-5-2 | Cove Base/Black | Intact | No | Not Analyzed/<br>Positive Stop | Interior Living Room/Bedroom (Appx 60 lin ft) | Category I |
| 1656-5-2 | Mastic/Black | Intact | No | Not Analyzed/<br>Positive Stop | Interior Living Room/Bedroom (Appx 60 lin ft) | Category I |

1656-5  
Cove Base/Black (6% Chrysotile)  
Mastic/Black (4% Chrysotile)  
Interior Living Room/Bedroom  
(Appx 60 lin ft)
