December 23, 2025

Project:
Asbestos Survey for Demolition
1005 SW 2nd St.
Ocala, FL 34471

Client:
City of Ocala
Code Enforcement Department
201 SE 3rd St.
Ocala, FL 34471

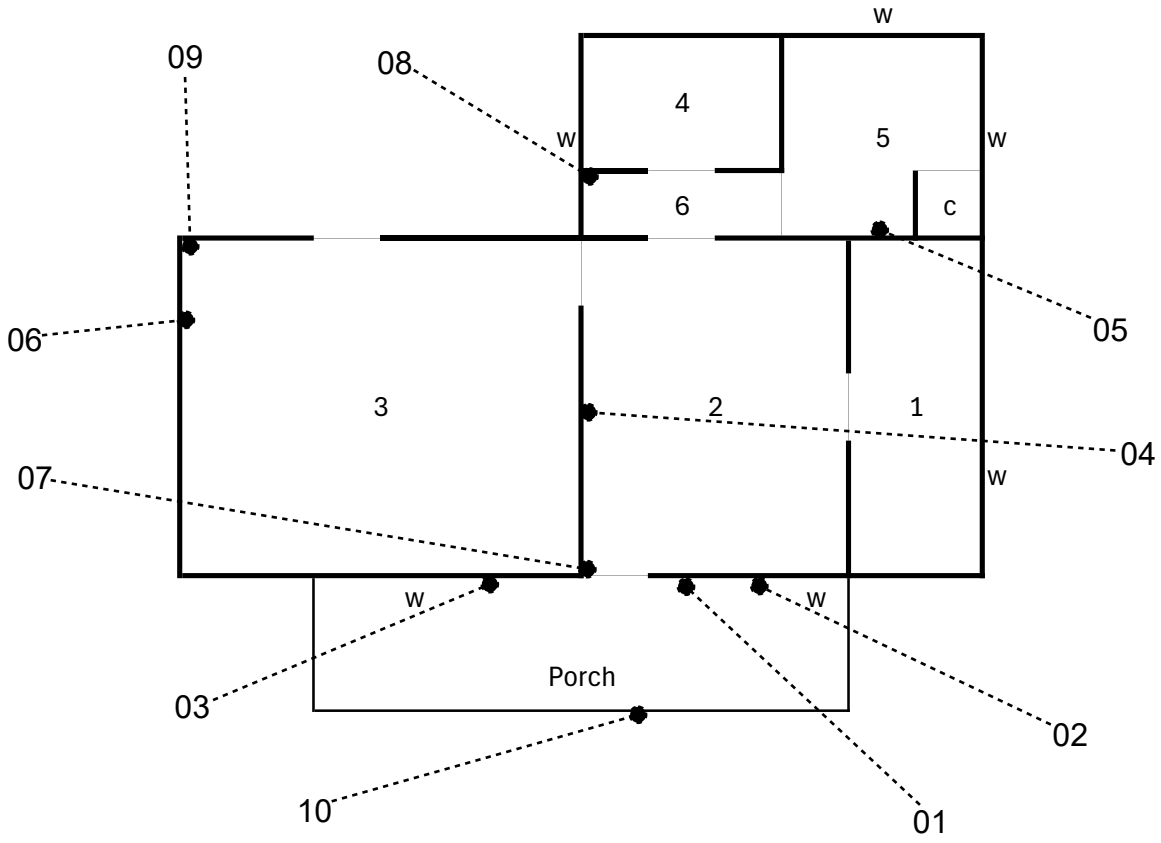
Sample Key

1005 SW 2nd St.
Ocala, FL 34471
