ASBESTOS SURVEY REPORT

1635 NW 24th Avenue
Ocala, FL 34475

October 13, 2022

City of Ocala
Community Development Services
201 SE 3rd Street, 2nd Floor
Ocala, FL 34471

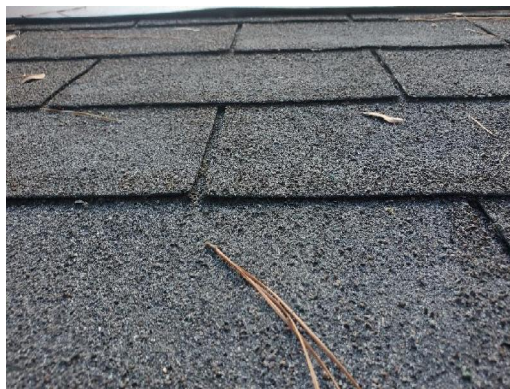
Bulk Collection and Sample Analysis Results						
<i>Sample Number</i>	<i>Description</i>	<i>Condition</i>	<i>Friable</i>	<i>Asbestos Percent and Type</i>	<i>Location/ Amount</i>	<i>NESHAP Category</i>
1635-1-1	Asphalt Shingle/Black	Intact	No	None Detected	Typical Exterior Roof	NA
1635-1-1	Tar/Black	Intact	No	None Detected	Typical Exterior Roof	NA
1635-1-2	Asphalt Shingle/Black	Intact	No	None Detected	Typical Exterior Roof	NA
1635-1-2	Tar/Black	Intact	No	None Detected	Typical Exterior Roof	NA
1635-2-1	Rolled Flooring/Tan	Intact	No	None Detected	Interior Living Room/Bedrooms	NA
1635-2-2	Rolled Flooring/ Tan/White	Intact	No	None Detected	Interior Living Room/Bedrooms	NA
1635-3-1	Drywall/Brown/White	Intact	Yes	None Detected	Typical Interior Walls/Ceilings	NA
1635-3-1	Joint Compound/Beige	Intact	Yes	<1% Chrysotile	Typical Interior Walls/Ceilings	NA
1635-3-2	Drywall/Brown/Beige	Intact	Yes	None Detected	Typical Interior Walls/Ceilings	NA

1635-1
Asphalt Shingle/Tar
Typical Exterior Roof

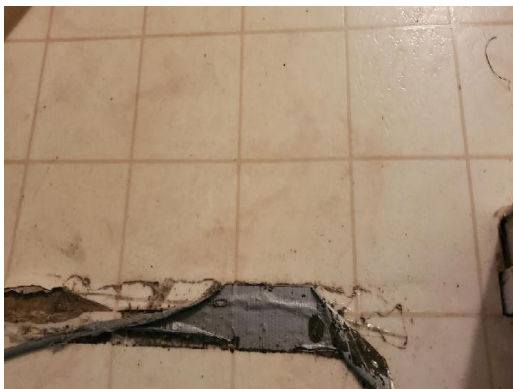
1635-2
Rolled Flooring/Mastic
Living Room/Bedrooms

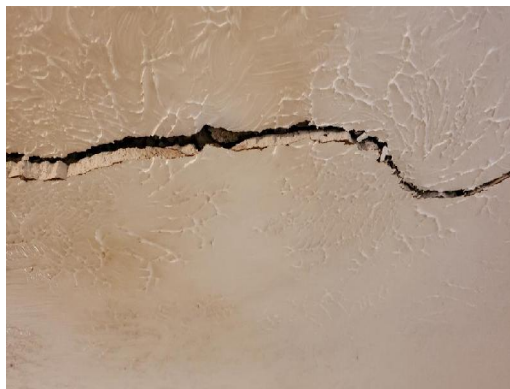
1635-3-2	Joint Compound/ Tan/White	Intact	Yes	<1% Chrysotile	Typical Interior Walls/Ceilings	NA

1635-3
Drywall/Joint Compound
Interior Walls/Ceilings

If asbestos containing materials identified within, or on, the property will be disturbed or otherwise caused to become friable within the scope of the renovation, they should be removed from the structures prior to the maneuvers taking place according to applicable regulations.

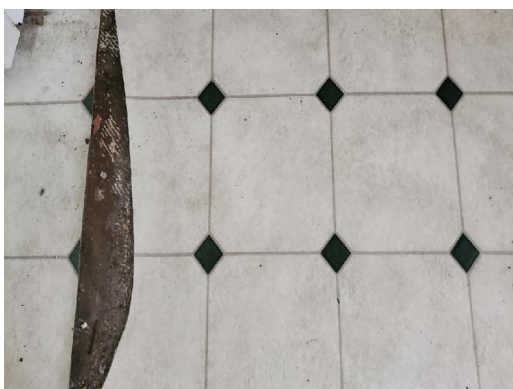
<i>Sample Number</i>	<i>Description</i>	<i>Condition</i>	<i>Friable</i>	<i>Asbestos Percent and Type</i>	<i>Location/ Amount</i>	<i>NESHAP Category</i>
1635-4-1	Rolled Flooring/Tan	Intact	No	None Detected	Interior Kitchen	NA
1635-4-1	Mastic/Yellow	Intact	No	None Detected	Interior Kitchen	NA
1635-4-2	Rolled Flooring/ Tan/White	Intact	No	None Detected	Interior Kitchen	NA
1635-4-2	Mastic/Tan	Intact	No	None Detected	Interior Kitchen	NA
1635-5-1	Insulation/White	Intact	No	None Detected	Typical Interior	NA
1635-5-2	Insulation/White	Intact	No	None Detected	Typical Interior	NA

1635-4
Rolled Flooring/Mastic
Interior Kitchen

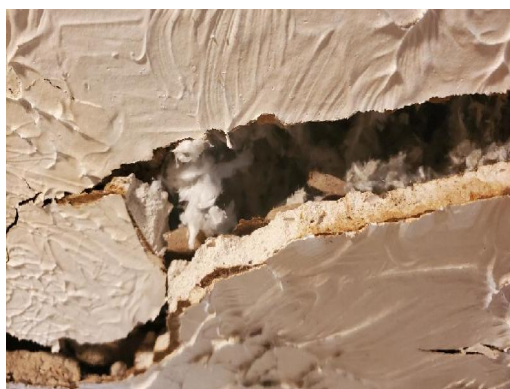
1635-5
Insulation
Typical Interior
