ASBESTOS SURVEY REPORT

924 NW 4th Street
Ocala, FL 34475

November 02, 2023

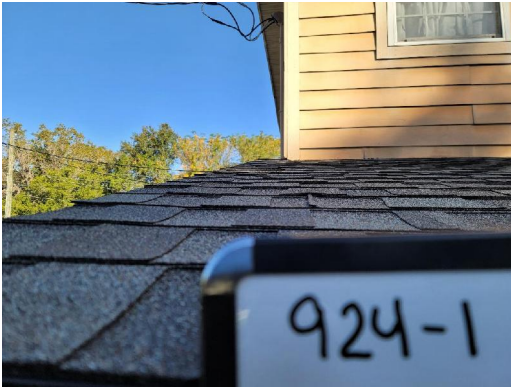
| Bulk Collection and Sample Analysis Results | | | | | | |
|--|---|---|---|---|---|---|
| 924-1-1 | Asphalt Shingle/Black | Intact | No | None Detected | Typical Exterior Roof | NA |
| 924-1-2 | Asphalt Shingle/Black | Intact | No | None Detected | Typical Exterior Roof | NA |

924-1
Asphalt Shingle
Typical Exterior Roof

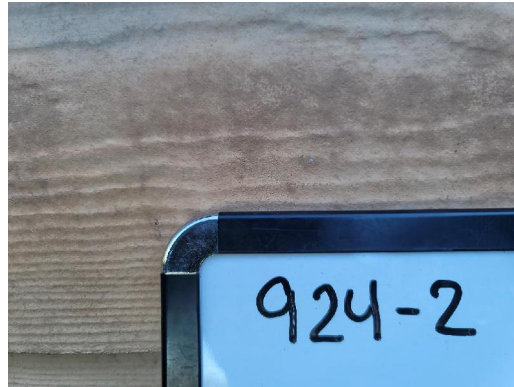
| Bulk Collection and Sample Analysis Results | | | | | | |
|--|---|---|---|---|---|---|
| 924-2-1 | Cement Board/Beige | Intact | No | None Detected | Typical Exterior Siding | NA |
| 924-2-2 | Cement Board/Beige | Intact | No | None Detected | Typical Exterior Siding | NA |

924-2
Cement Board
Typical Exterior Siding

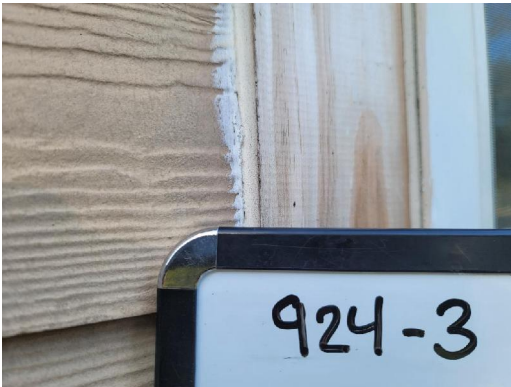
| Bulk Collection and Sample Analysis Results | | | | | | |
|--|---|---|---|---|---|---|
| 924-3-1 | Caulk/Off-White | Intact | No | None Detected | Typical Exterior Siding | NA |
| 924-3-2 | Caulk/Off-White | Intact | No | None Detected | Typical Exterior Siding | NA |

924-3
Caulk
Typical Exterior Siding

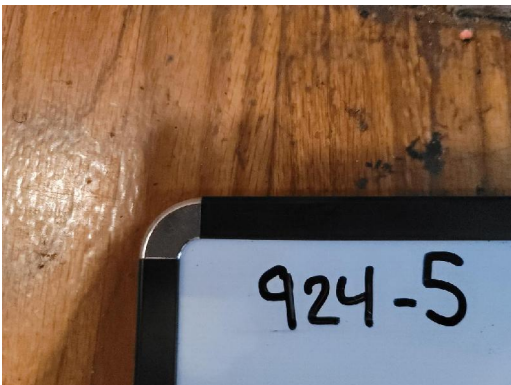
| <i>Sample Number</i> | <i>Description</i> | <i>Condition</i> | <i>Friable</i> | <i>Asbestos Percent and Type</i> | <i>Location/ Amount</i> | <i>NESHAP Category</i> |
|---|---|---|---|---|--|---|
| 924-5-1 | Laminate Flooring/Brown | Intact | No | None Detected | Typical Interior 1 st Floor | NA |
| 924-5-2 | Laminate Flooring/Brown | Intact | No | None Detected | Typical Interior 1 st Floor | NA |

924-5
Laminate Flooring
Typical Interior 1st Floor
